## Deterioration and Damage Evaluation of the Monument of Qasr al-Bint, Petra-Jordan and a Suggested Conservation Program

Mohamed A. H. Abdel-Halim <sup>1)\*</sup> and Ziad Al-Saad <sup>2)</sup>

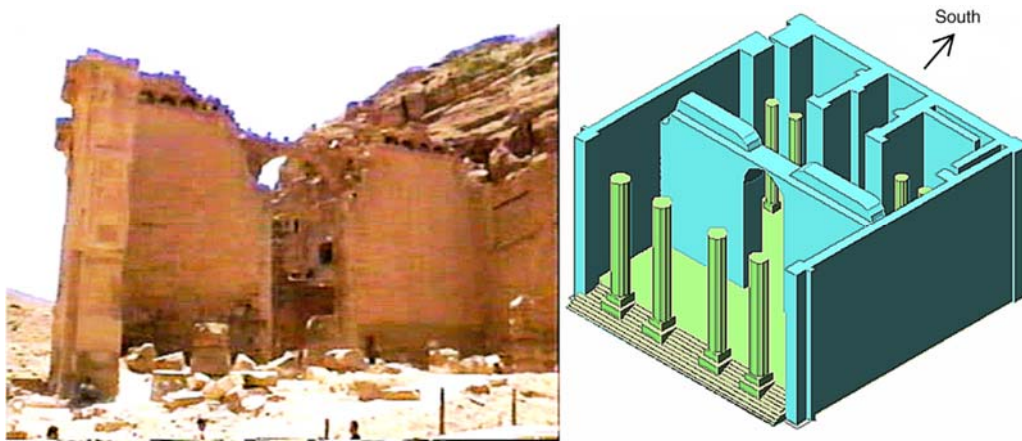
**Figure (1-b): The current view of Qasr al-Bint compared to the original view before damage (Khaldoon Bani-Hani and Samer Barakat, 2006)**

standing without any support, which represents a real danger. Similar to the previous walls, the lower part of the wall suffers from bad weathering caused by groundwater and salts, as shown in the picture in Figure (1-b). Different forms of weathering are observed, mainly scaling, flaking and disintegration.

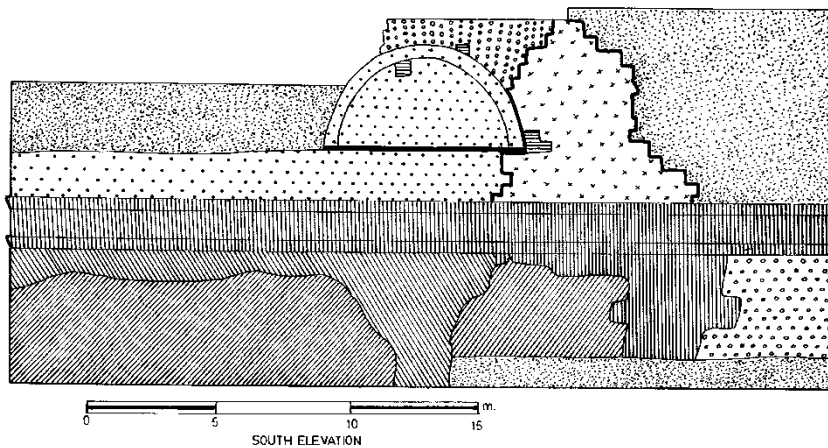
**The Southern Wall:** The notations used to represent the different forms of weathering are shown in Figure 2. The distribution of the weathering forms observed on the southern wall is shown in Figure 3. It is quite evident that this wall has suffered from strong shocks caused by successive earthquakes. This has led to the development of major structural cracks propagating and increasing in width from the bottom of the wall upwards. The eastern part of the wall was rebuilt in a restoration campaign in 1961/62 using original sandstone (Zayadine, 1985). Figure 4 shows the south-east corner of Qasr al-Bint which was restored in 1961/62. The sand stones used in this restoration were cut from the parent rock in the same old quarry used in building Qasr al-Bint. The figure shows the vertical movement which occurred in the southern and eastern walls. This movement varies in magnitude from 10 cm at the bottom of the walls to 30 cm at their tops. The wooden laces inserted in between the stone courses are badly deteriorated, which helped in the dismantling of the wall. The lower part of the southern wall suffers from severe weathering and deterioration. The stone blocks in this part suffer from granular disintegration, outbursts, scales and flakes as shown in Figure 5. The upper part is in a better condition and the stones are covered with thick crust layers. There is a general disintegration and loss of mortar that binds the stones together.

Figure (3): The weathering forms observed on the southern wall

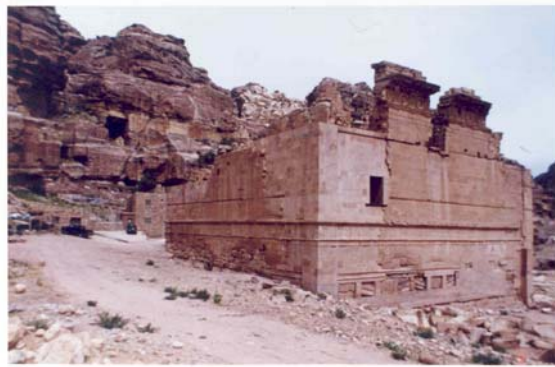
**The Eastern Wall:** The distribution of the weathering forms observed on this wall is shown in Figure 6. This wall suffers from a series of vertical structural cracks caused by earthquake tremors, as shown in Figure 4. The cracks divided the wall into vertical segments that are free standing without any support. In particular, the upper part of the wall might fall down due to any slight vibration caused by even a very weak earthquake. Major concrete construction was carried out at the lower part of the wall, trying to support the wall. The added concrete elements caused severe

**Figure (4): The south-eastern corner**

4. Large vertical cracks and separations exist at wall intersections and corners. Stone stitching across the crack is one method which can be used to make sufficient interconnection between the walls. Steel tie plates could be used, as another method, to tie separated wall sections. These plates must be embedded in rich mortar between stone courses and painted or coated with epoxy to resist corrosion.

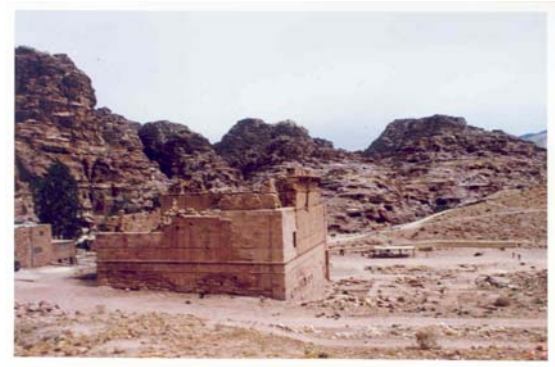
**Figure (5): The lower part of the southern wall**

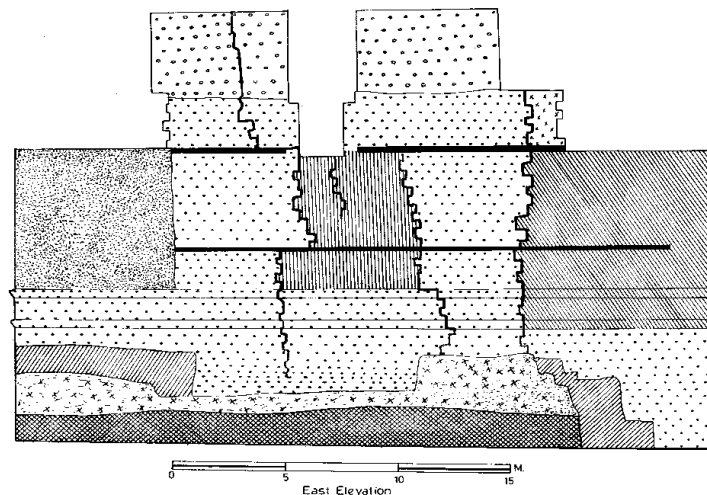
damage to the adjacent stones, mainly due to salt efflorescence. In addition, the concrete elements look very odd, which harms and disturbs the aesthetic value of the wall. Major restoration work was done on this

wall using cut sandstone. As in the southern wall, the old lower part which was not repaired shows severe weathering and disintegration, mainly caused by capillary water and salt efflorescence.

**Figure (6): The weathering forms observed on the eastern wall**

cracking, complete separation (detachment) and vertical splitting, such as the upper portions of the eastern and northern walls, must be removed and rebuilt in the same style using the same sandstones and the appropriate mortar. For misaligned segments, small shifting can be allowed.

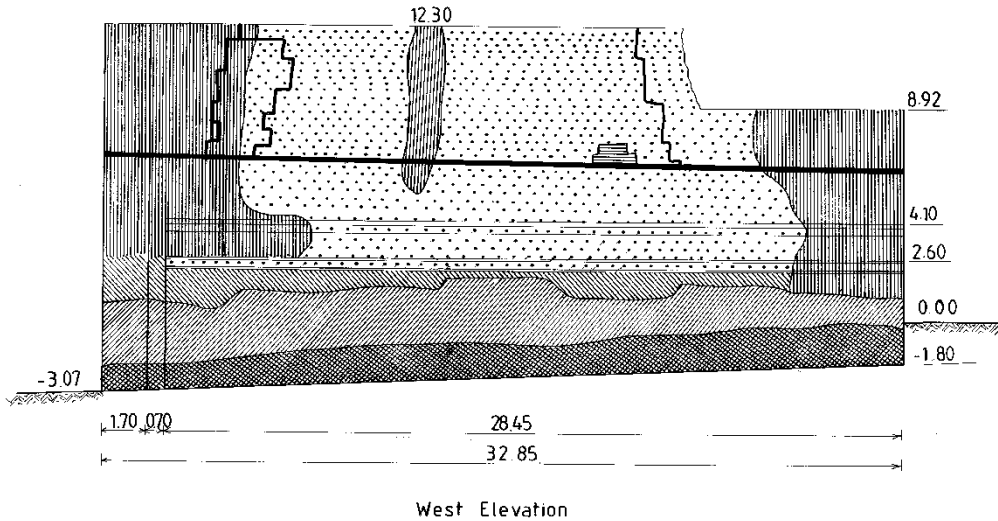
**The Western Wall:** This is the most preserved wall of Qasr al-Bint. Although there are some structural cracks, they are not as large as those of the southern and eastern walls. Figure 7 shows the weathering forms observed on this wall. Only the lower 2 meters of the wall show extensive weathering. Groundwater, salt

crystallization and extensive use of cement mortar in restoration works are the main causes of the extensive weathering of the lower part. The deterioration of that part is manifested by extensive disintegration, outbursts, flaking and scaling.

Figure (7): The weathering forms observed on the western wall

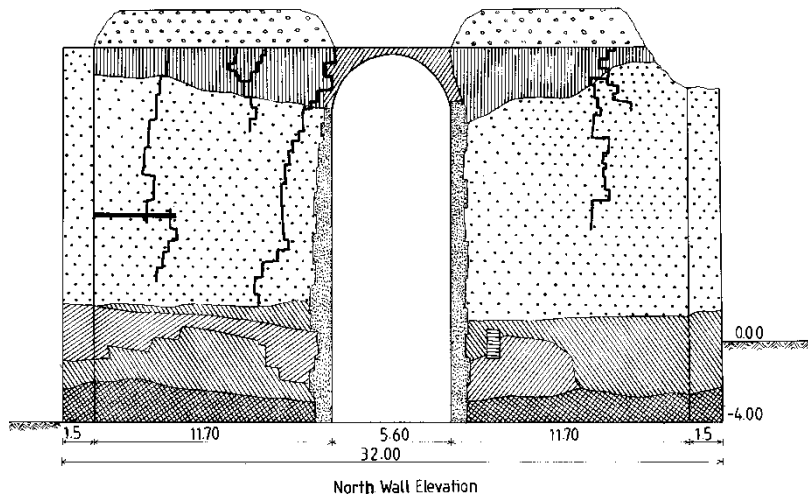
**The Northern Wall:** As shown in Figure 8, the northern wall suffers from severe shocks and vibrations manifested by extensive structural cracks that cover the façade and penetrate deep into the wall. These cracks represent a real threat to the wall. This danger is quite real and the whole wall may collapse if an earthquake occurs. The upper portions of the wall are almost free

Figure (8): The weathering forms observed on the northern wall

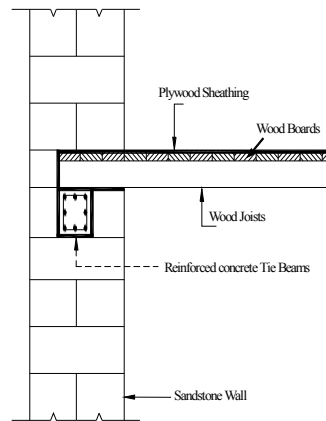
Figure (9): Tie beams positioned in the middle third of the wall thickness

**Construction of Reinforced Concrete Tie Beams:** One of the major deficiencies of Qasr al-Bint is the lack of proper horizontal diaphragms and interconnections between these diaphragms and the supporting masonry walls. The structure needs to be tied together along wall lines, in both directions, and at the floor and roof levels to properly survive any future earthquake. After repairing all the walls as explained before and raising them to the floor and roof levels, reinforced concrete tie beams can be used along the walls at the floor and roof levels and in both directions to tie the walls together. These tie beams will also connect the walls and diaphragms together and all these elements with the walls will work together as one unit in resisting lateral forces caused by earthquakes. Since wall thicknesses are

very large, the tie beams can be placed in the middle third of the wall at the floor and roof levels as shown in Figure 9. Polystyrene or isolation sheets can be used around the reinforced concrete tie beams to protect the sandstones from any adverse effects that may result from the concrete.
