Integrated Detection and Restoration Program of Water Gushing Induced Cracks in Shield Segments for Xi'an Metro in China

J.L. Qiu^{1,2)}, J.X. Lai^{1,2)*}, H.B. Fan²⁾, J.X. Chen^{1,2)} and C. Liu²⁾

ABSTRACT

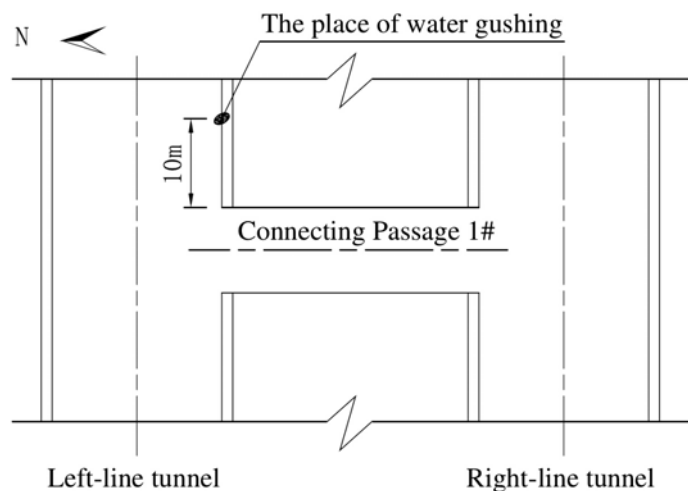
Figure (2): Location of water gushing

the underground pipeline was damaged. As a result, the back of segment near the tunnel bottom, 10 m east of the connecting passage, began to gush water and sand. The location of water gushing is shown in Figure 2 and the corresponding stake number is ZDK20+616. However, plugging the hole with sand bags was not effective. The water level at the connecting passage of the left tunnel reached 2.5 m at 10 a.m. that day. The water inflow was approximately 350 m³ every hour. Until Dec. 24, 2011, the total amount of water inflow was approximately 120,000 m³. The sand carried out by the water was approximately 300 m³. The scene of the accident is shown in Figure 3.

First, the sand bags were piled up at the location where the water started to gush to reduce the head pressure. This pressure reduction could protect the sand from washing away and prevent cavities from forming in the connecting passage. The second step was supporting the top pilot tunnel. Next, two 4-m anchor pipes were buried at the water gushing hole and the hole was simultaneously sealed using without-shrink two-shot grouting (WSS). However, the amount of water inflow did not decrease after a long time of grouting.

Thereafter, an anti-grouting wall was built at the tunnel portal to drain away the water gradually. Next, grouting wells were drilled at Point Location 5 of Circle 493 of the right tunnel and Point Location 7 of Circles 484, 486 and 488 of the left tunnel to block off the upstream water. As the segments near the grouting well changed abruptly, some of the segments suffered from cracks, dislocation and breakage. The point and depth of each grouting well were adjusted timely according to the monitoring results. Each grouting well was drilled to the silty clay layer under the left tunnel, so that it could be

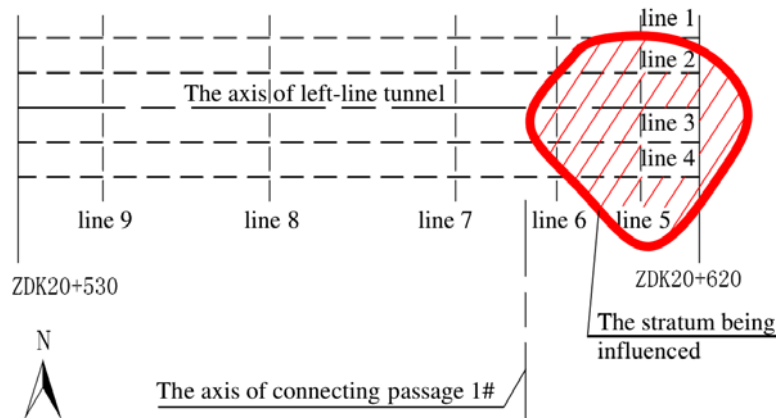
Figure (4): Layout of GPR measuring line

The earth's surface within ZDK20+530 ~ ZDK20+620 subsided after the accident. The subsidence mainly occurred at the left tunnel. GPR detection was used on the earth's surface at an antenna frequency of 100 MHz; the line layout is shown in Figure 4 and the waveform of Line 3 is shown in Figure 5. The following conclusion can be reached through the analysis of Line 3: because strong reflections are detected at 2-4 m and 13-23 m within ZDK20+590~ZDK20+620, the stratum is incompact or saturated. There must be a differential settlement in the stratum because of the line-up fracture in the above-mentioned stratum. Since there are no strong reflections detected or fractures exhibited in the line-up, the stratum within ZDK20+530~ZDK20+590 is normal. The survey lines indicate that the stratum within ZDK20+590~ZDK20+620 suffers from differential settlement and is partly incompact or saturated. The strata in Line 5, Line 6, Line 7 and Line 8 suffer from differential settlement and are partly incompact or saturated; the strata in Line 4 and Line 9 are equally distributed and show no obvious abnormality. The stratum influenced by water gushing ranges from 13 m to 23 m in depth and the surface area of the stratum is shown in Figure 4.

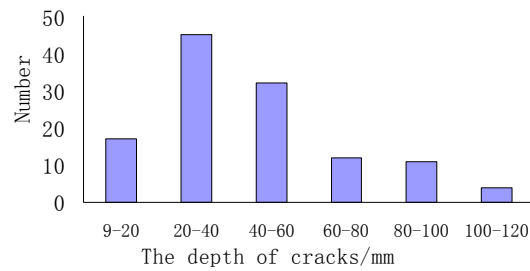
Figure (7): Statistical results of the cracks

The depth of the crack can be determined by measuring the crack width using a calibrated magnifying glass, positioned with handheld reinforced concrete detection radar and measurements using ultrasonic waves. The principle of ultrasonic detection is shown in Figure 6. As shown in Figure 7, cracks mainly range from 20 mm to 60 mm in depth; among those, 45 range from 20 mm to 40 mm and 32 range from 40 mm to 60 mm. The cracks primarily range from 0.05 mm to 0.3 mm in width; among those, 93 are between 0.05 mm and 0.2 mm, 14 are between 0.2 mm and 0.3 mm, 10 are between 0.3 mm and 0.5 mm and 4 are over 0.5 mm. The largest crack appears at the adjacent plate of L2B5 on Circle 495, with a maximum width of 1.0 mm and a maximum depth of 134.9 mm (Pan, 2012).

As 77% of the segment cracks range from 20 mm to 60 mm in depth and from 0.05 mm to 0.2 mm in width, repair instead of reinforcement is required to ensure the structural durability and water proofness of the tunnel. For that reason, the BICS method was used in repairing the segment cracks of this tunnel. BICS is a construction method patented by a Japanese company named SHOBOND. Adding intumescent resin into a synthetic rubber injector generates a constant pressure of approximately 300 kPa that continuously presses the polymer resin into the crack gradually so it can reach the depth of the crack. The advantage of using the resin is to press the air in the gap into the capillary tube of the concrete. Because the air is exhausted naturally through the concrete, air-lock is effectively avoided. Therefore, the grouting material can be effectively injected into the tiniest end of the capillary tube. As a result, the structure is perfectly restored. More specifically, the advantages of BICS method compared with other methods in crack treatment are as follows:

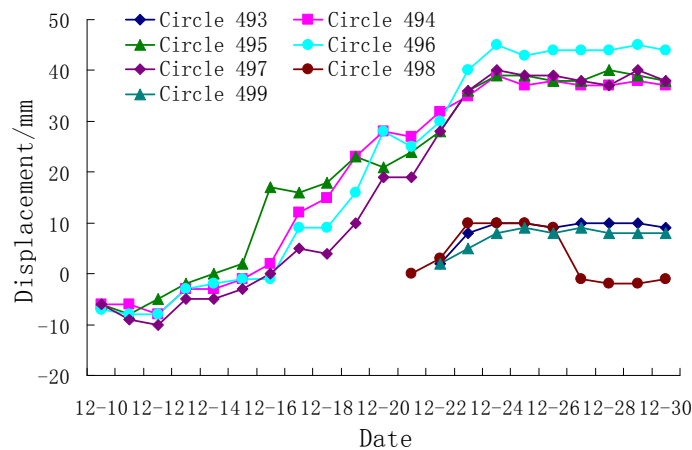
Figure (8): Vault settlements vs. time

Due to environmental limitations, some of the sections could not be monitored. According to the monitoring results (Figure 8), at the beginning of water gushing, Section C of the tunnel, affected by the hogging moment, was pulled from the outside and pushed from the inside. The soil around the segment fell apart, failing

in a manner that offered sufficient subgrade reaction for the segments. As a consequence, the convergence value continued to increase as the segment moved towards the outside. As grouting continued, the convergence value decreased, because the subgrade reaction was replaced by the grouting pressure. As grouting continued, the grouting pressure on the segment surpassed the subgrade reaction, leading to additional stress on the structure. Pushed from the outside and pulled from the inside, the segment moved toward the inner side of the tunnel. The lateral displacement of the segment totalled 4.5 cm when grouting was complete. The segment subsided after water gushing. Because the subsidence did not last long and the volume of subsidence was small, the segment started to rise two days after grouting. The segment rose rapidly from Dec. 16 to Dec. 24. The maximum of longitudinal displacement was 5.5 cm.

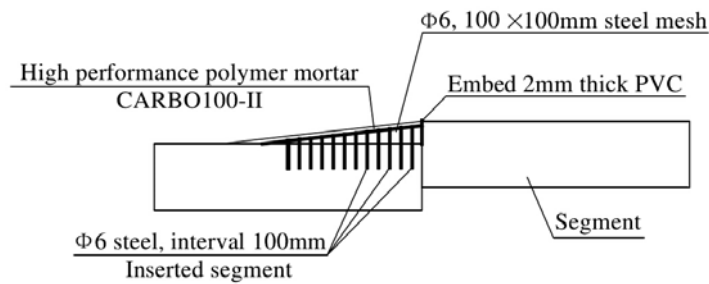
Figure (10): Strengthening scheme of segment dislocation

Circular dislocations among different plates in one circle decrease the contact area between the plates. Among the 11 circular dislocations, the largest one is 2 cm. Water gushing and sand gushing lead to different longitudinal dislocations of the segment. The largest

dislocation, which is located in Circles 492 and 493 of the tunnel, is approximately 8 cm and the effective

height of the section is 14 cm.

The longitudinal dislocation of the segment affects the safety of the structure. The effective height of the section of the largest dislocation is 14 cm. Hence, the dislocation should be reinforced in its bearing capacity of stress through high-performance polymer mortar CARBO100-II and reinforcing steel mesh. The structure is shown in Figure 10.

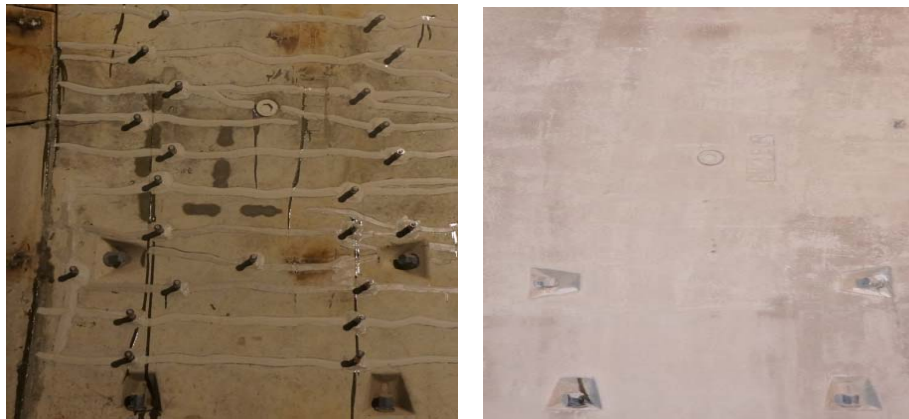
(a) Image before treatment (b) Image after treatment
Figure (11): Comparison shots before and after treatment

The contrast of the appearance before and after treatment is shown in Figure 11. The surface of the segment is relatively smooth after the treatment and the filling is dense in the cracks. To study the treatment effect of segments, the ultrasonic crack detector was used to detect the segment after treatment. The finite element method was used to analyze the stress of the segment.

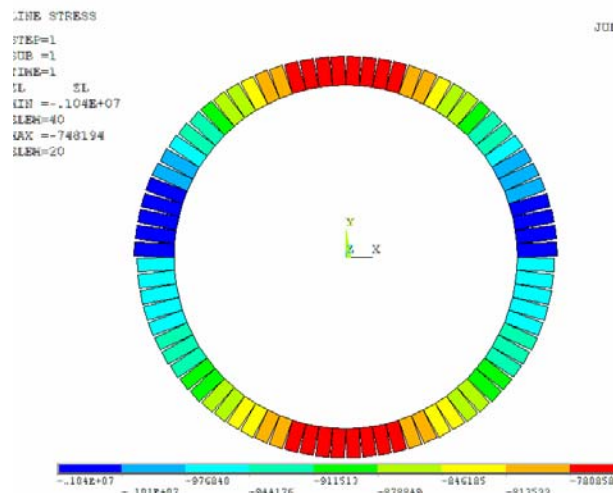
Figure (12): Axial force of the segment after treatment

The segment stress is relatively uniform after treatment and the maximum axial force is 1040 kN. The compressive strength of the segment is only 3.8 MPa. It is far less than the allowable compressive strength (36.5 MPa) of the C50 concrete. The segment complies with the safety requirements. In addition, the safety factor of

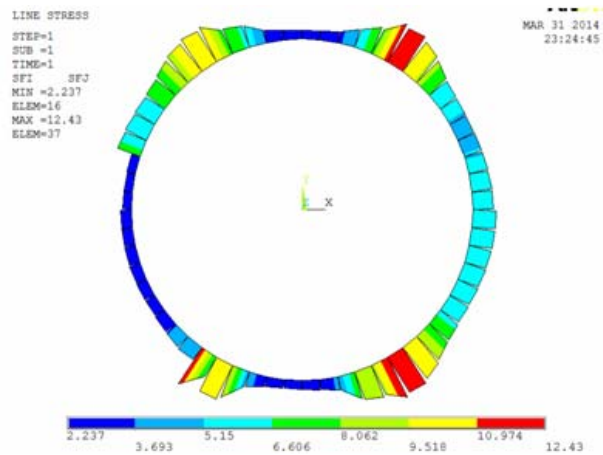
Figure (13): Safety factor of the segment after treatment

the reinforced concrete structure under permanent load and variable load should be greater than 2.0. The safety factors of the segment (Figure 13) after treatment are all greater than 2.0. As a result, the segments meet the strength requirements (Ye et al., 2014; Lai, 2012).
