Cracking of RC School Building Due to Soil Expansion

ABSTRACT

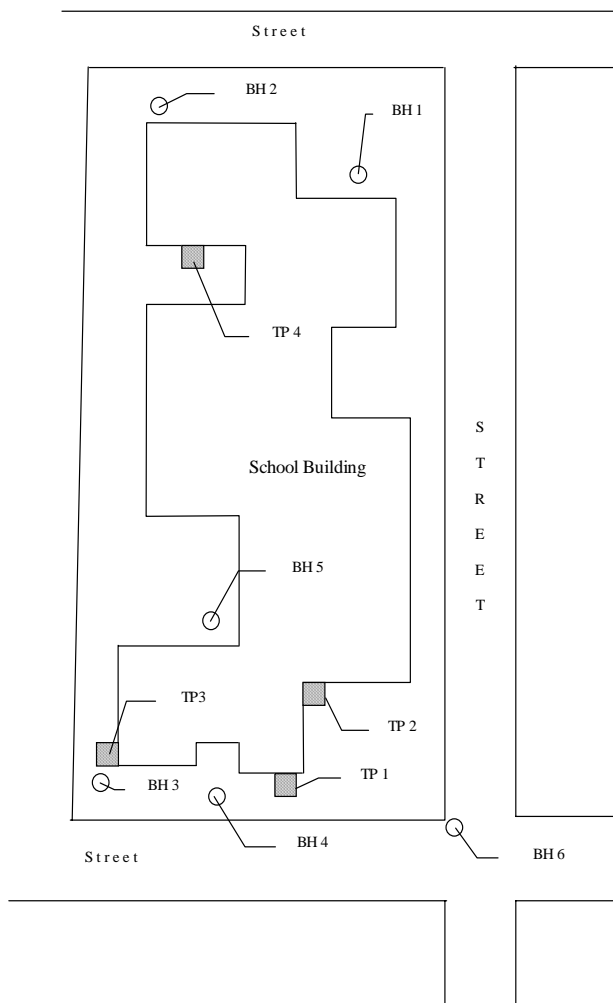
Figure (1): Plan for the school under study with locations of drilled bore holes and test pits.

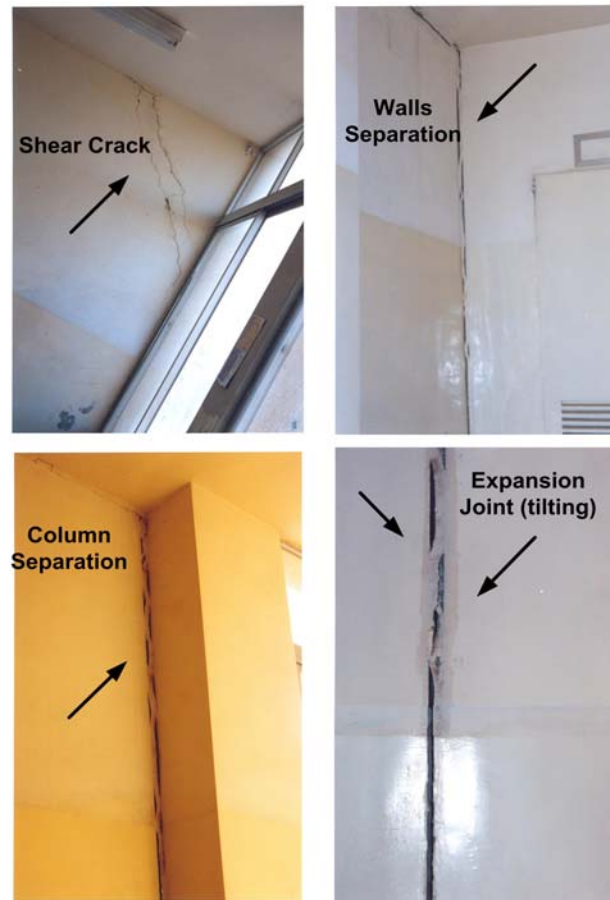
The southeastern part of the building suffered cracks in the walls over the windows and door corners due to change in water content over the period of the structure life. A crack width up to 5 cm was measured between the expansion joints with a tilting towards the east where the trees are planted around the perimeter (Figure 2). It was in 1999 when the cracks were observed in the building for the first time. In the first year, the cracks were insignificant and were not of concern to students and teachers. Thereafter, the cracks propagated and more tilting appeared to the southeastern part of the building which attracted the attention of the administration. In December 2000 the authors were called by the owner (Ministry of Education) to investigate the causes of the destructions and to propose appropriate remedial measures. The authors visited the building site promptly and the geotechnical investigations, structural analysis and remedial measures presented in this paper were carried out.

Figure (2): Illustrations of structural cracks and damage.

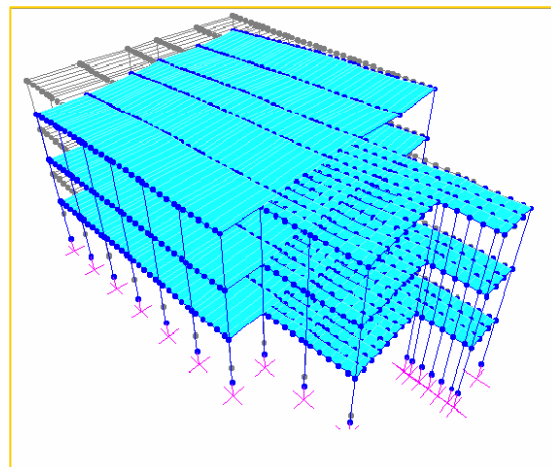
heave and shrinkage of the expansive soil that bears the footings. Additionally, soil investigation showed that the maximum relative soil movement due to drying and wetting can reach up to 7.15 cm. For safety considerations, 10 cm was used in the analysis. Therefore, it has been assumed that the far corner of the structure at (1-1, E-E) axes is settled by 20 cm, the corner at (7-7, E-E) axes settled by 10 cm, the corner at (1-1, A-A) axes settled by 10 cm, and the other columns settled relative to these values up to zero value at the opposite corner at (7-7,A-A) axes as shown in Figure (8). This generated a maximum differential settlement of 10 cm.

Figure (9): Deformed shape due to (DLLLST) loading case (the assumed settlements).

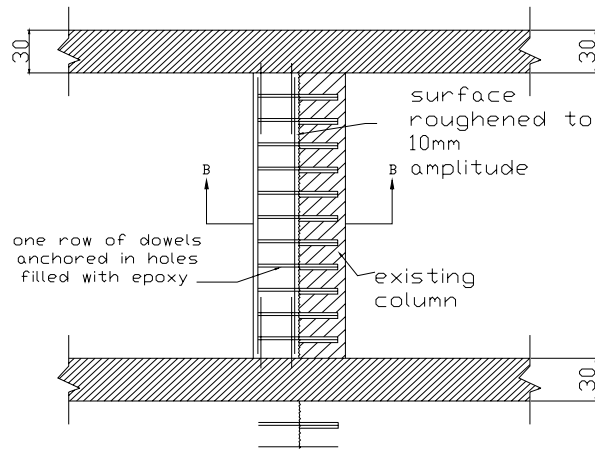
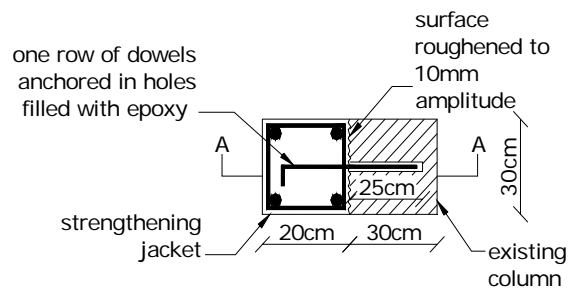
As for the structural elements, they were analyzed using the slope-deflection method and the moments were examined for design requirements. The loads were computed by distributing the slab loads. The analysis results and the steel design for the columns and the beams are shown in Table (1) and Table (2), respectively. The analysis and the required steel showed that some of the columns were over-stressed and require a larger cross-sectional area. Specifically, the results showed that column C8 at axis 2-C was potentially overstressed.

Figure (12): Method of increasing the cross-sectional area of the columns.

Figure (13): Plan-view of the column cross-section after repair.

Figures (12) and (13) show the remedial work suggested to increase the cross-sectional area of column C8. Although column C1 at axis 7-A, axis 7-E and axis 1-A were not overstressed, a larger cross-sectional area is recommended due to some cracks. On the other hand, some of the beams were under-reinforced and either did not satisfy the minimum steel ratio of 0.004 for concrete compressive strength, f'_c , of 20 MPa and steel yield strength, f_y , of 285 MPa or the anticipated settlements that require more reinforcements.

The shaded column (C8) in Table (1) is recommended to be strengthened by increasing the cross-sectional area of the column as shown in Figures (12) and (13). The same procedure is to be used for strengthening the other columns mentioned earlier.

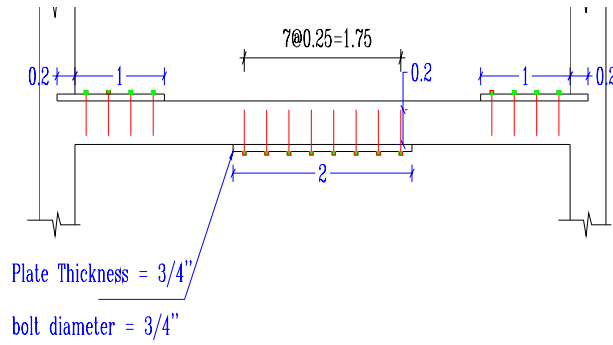
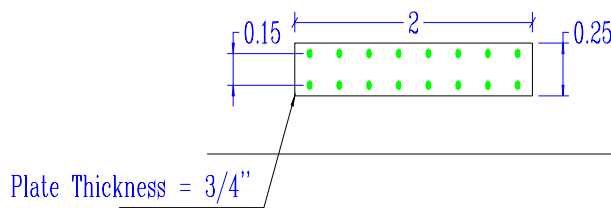
Figure (14): Beam strengthening using steel plates.

Figure (15): Top/bottom view of the steel plates attached to the beam.

The in Table (2) shaded beams, which represent the problem beams, are decided to be strengthened by using a steel plate bolted at the top sections and at the bottom sections of the beams as shown in Figures (14) and (15).

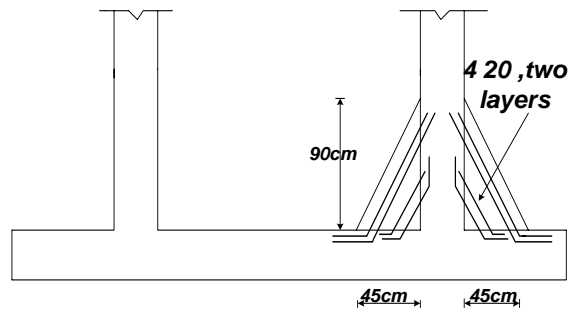
$$q_{ult} = 2445 / 3.8 * 2.7 = 238.4 \text{ kN/m}^2 \\ V_{ult} = 238.4 [10.28 - (0.575 * 0.975) - (0.575 * 0.675)] = \\ 2225 \text{ kN.}$$

$$V_c = 0.85/3 (20)^{1/2} 275 * [(4*575) + (2*675) + (2*975)] \\ = 1950 \text{ kN.}$$

$$V_{ult} > V_c \text{ (not Safe).}$$

Figure (16): Strengthening of strip footing B-B against bunching shear.

Footing analysis showed that only strip footing B-B is overstressed and needed to be strengthened against bunching. The remedial measures shown in Figure (16) were suggested and implemented.
