Integrated Detection and Restoration Program of Water Gushing Induced Cracks in Shield Segments for Xi'an Metro in China

ABSTRACT

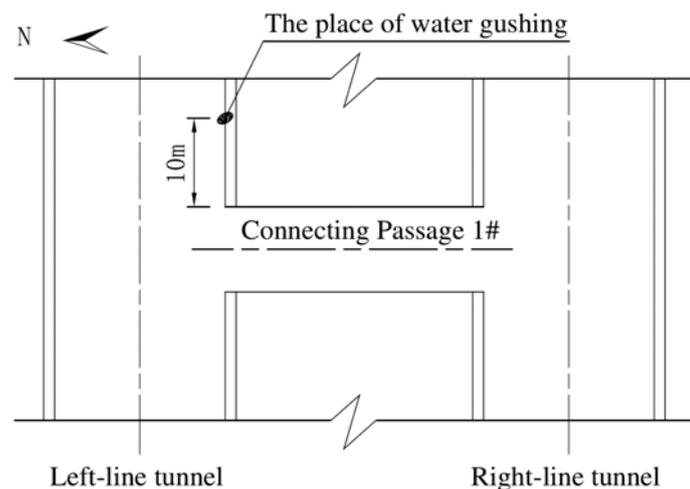
Figure (2): Location of water gushing

the underground pipeline was damaged. As a result, the back of segment near the tunnel bottom, 10 m east of the connecting passage, began to gush water and sand. The location of water gushing is shown in Figure 2 and the corresponding stake number is ZDK20+616. However, plugging the hole with sand bags was not effective. The water level at the connecting passage of the left tunnel reached 2.5 m at 10 a.m. that day. The water inflow was approximately 350 m³ every hour. Until Dec. 24, 2011, the total amount of water inflow was approximately 120,000 m³. The sand carried out by the water was approximately 300 m³. The scene of the accident is shown in Figure 3.

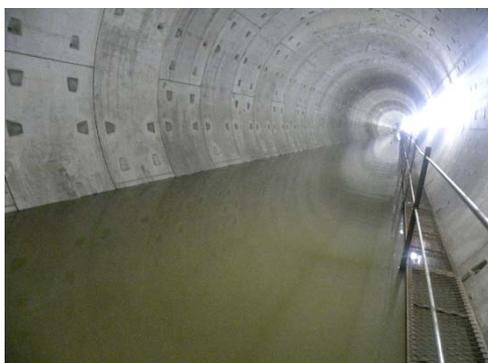
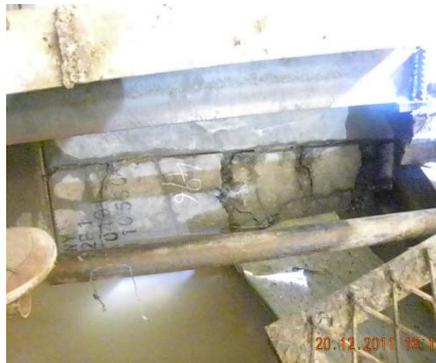
Figure (3): Scene photos of tunnel water gushing

Monitoring results indicated that the segment significantly rose, so the grouting was immediately stopped.

First, the sand bags were piled up at the location where the water started to gush to reduce the head pressure. This pressure reduction could protect the sand from washing away and prevent cavities from forming in the connecting passage. The second step was supporting the top pilot tunnel. Next, two 4-m anchor pipes were buried at the water gushing hole and the hole was simultaneously sealed using without-shrink two-shot grouting (WSS). However, the amount of water inflow did not decrease after a long time of grouting.

Thereafter, an anti-grouting wall was built at the tunnel portal to drain away the water gradually. Next, grouting wells were drilled at Point Location 5 of Circle 493 of the right tunnel and Point Location 7 of Circles 484, 486 and 488 of the left tunnel to block off the upstream water. As the segments near the grouting well changed abruptly, some of the segments suffered from cracks, dislocation and breakage. The point and depth of each grouting well were adjusted timely according to the monitoring results. Each grouting well was drilled to the silty clay layer under the left tunnel, so that it could be

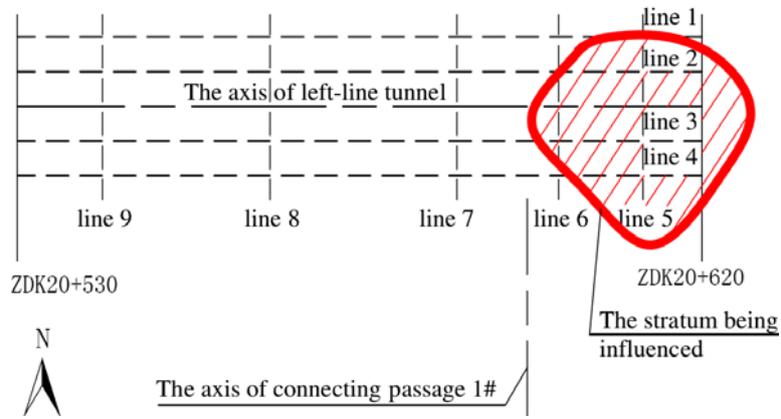
Figure (4): Layout of GPR measuring line

The earth's surface within ZDK20+530 ~ ZDK20+620 subsided after the accident. The subsidence mainly occurred at the left tunnel. GPR detection was used on the earth's surface at an antenna frequency of 100 MHz; the line layout is shown in Figure 4 and the waveform of Line 3 is shown in Figure 5. The following conclusion can be reached through the analysis of Line 3: because strong reflections are detected at 2-4 m and 13-23 m within ZDK20+590~ZDK20+620, the stratum is incompact or saturated. There must be a differential settlement in the stratum because of the line-up fracture in the above-mentioned stratum. Since there are no strong reflections detected or fractures exhibited in the line-up, the stratum within ZDK20+530~ZDK20+590 is normal. The survey lines indicate that the stratum within ZDK20+590~ZDK20+620 suffers from differential settlement and is partly incompact or saturated. The strata in Line 5, Line 6, Line 7 and Line 8 suffer from differential settlement and are partly incompact or saturated; the strata in Line 4 and Line 9 are equally distributed and show no obvious abnormality. The stratum influenced by water gushing ranges from 13 m to 23 m in depth and the surface area of the stratum is shown in Figure 4.

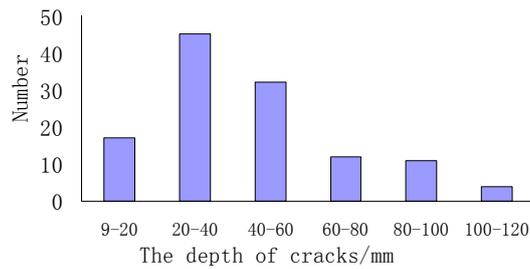
Figure (7): Statistical results of the cracks

The depth of the crack can be determined by measuring the crack width using a calibrated magnifying glass, positioned with handheld reinforced concrete detection radar and measurements using ultrasonic waves. The principle of ultrasonic detection is shown in Figure 6. As shown in Figure 7, cracks mainly range from 20 mm to 60 mm in depth; among those, 45 range from 20 mm to 40 mm and 32 range from 40 mm to 60 mm. The cracks primarily range from 0.05 mm to 0.3 mm in width; among those, 93 are between 0.05 mm and 0.2 mm, 14 are between 0.2 mm and 0.3 mm, 10 are between 0.3 mm and 0.5 mm and 4 are over 0.5 mm. The largest crack appears at the adjacent plate of L2B5 on Circle 495, with a maximum width of 1.0 mm and a maximum depth of 134.9 mm (Pan, 2012).

As 77% of the segment cracks range from 20 mm to 60 mm in depth and from 0.05 mm to 0.2 mm in width, repair instead of reinforcement is required to ensure the structural durability and water proofness of the tunnel. For that reason, the BICS method was used in repairing the segment cracks of this tunnel. BICS is a construction method patented by a Japanese company named SHOBOND. Adding intumescent resin into a synthetic rubber injector generates a constant pressure of approximately 300 kPa that continuously presses the polymer resin into the crack gradually so it can reach the depth of the crack. The advantage of using the resin is to press the air in the gap into the capillary tube of the concrete. Because the air is exhausted naturally through the concrete, air-lock is effectively avoided. Therefore, the grouting material can be effectively injected into the tiniest end of the capillary tube. As a result, the structure is perfectly restored. More specifically, the advantages of BICS method compared with other methods in crack treatment are as follows:

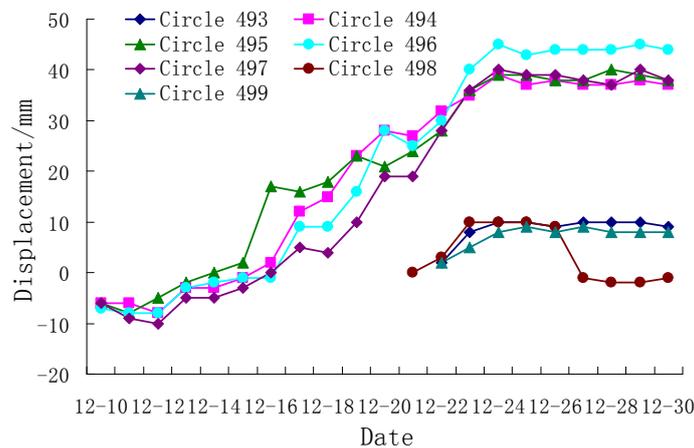
Figure (8): Vault settlements vs. time

Due to environmental limitations, some of the sections could not be monitored. According to the monitoring results (Figure 8), at the beginning of water gushing, Section C of the tunnel, affected by the hogging moment, was pulled from the outside and pushed from the inside. The soil around the segment fell apart, failing

in a manner that offered sufficient subgrade reaction for the segments. As a consequence, the convergence value continued to increase as the segment moved towards the outside. As grouting continued, the convergence value decreased, because the subgrade reaction was replaced by the grouting pressure. As grouting continued, the grouting pressure on the segment surpassed the subgrade reaction, leading to additional stress on the structure. Pushed from the outside and pulled from the inside, the segment moved toward the inner side of the tunnel. The lateral displacement of the segment totalled 4.5 cm when grouting was complete. The segment subsided after water gushing. Because the subsidence did not last long and the volume of subsidence was small, the segment started to rise two days after grouting. The segment rose rapidly from Dec. 16 to Dec. 24. The maximum of longitudinal displacement was 5.5 cm.

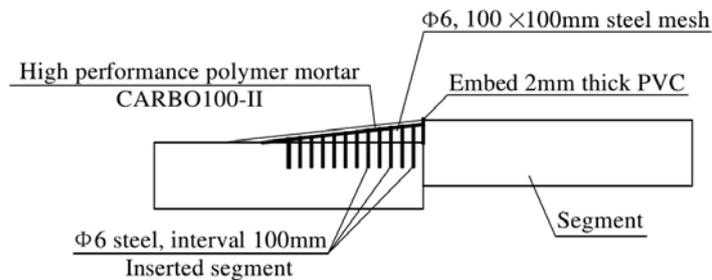
Figure (10): Strengthening scheme of segment dislocation

dislocation, which is located in Circles 492 and 493 of the tunnel, is approximately 8 cm and the effective

height of the section is 14 cm.

The longitudinal dislocation of the segment affects the safety of the structure. The effective height of the section of the largest dislocation is 14 cm. Hence, the dislocation should be reinforced in its bearing capacity of stress through high-performance polymer mortar CARBO100-II and reinforcing steel mesh. The structure is shown in Figure 10.

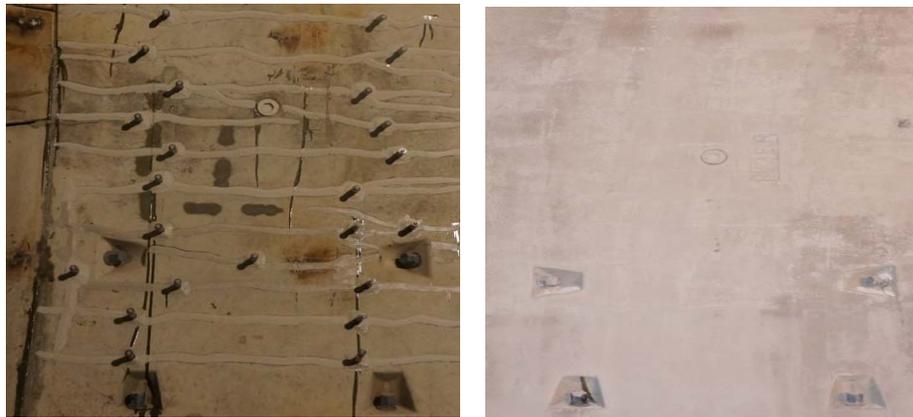
(a) Image before treatment (b) Image after treatment
Figure (11): Comparison shots before and after treatment

The contrast of the appearance before and after treatment is shown in Figure 11. The surface of the segment is relatively smooth after the treatment and the filling is dense in the cracks. To study the treatment effect of segments, the ultrasonic crack detector was used to detect the segment after treatment. The finite element method was used to analyze the stress of the segment.

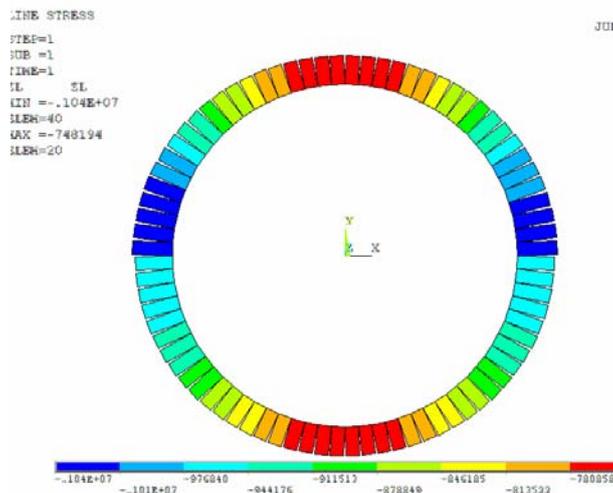
Figure (12): Axial force of the segment after treatment

The segment stress is relatively uniform after treatment and the maximum axial force is 1040 kN. The compressive strength of the segment is only 3.8 MPa. It is far less than the allowable compressive strength (36.5 MPa) of the C50 concrete. The segment complies with the safety requirements. In addition, the safety factor of

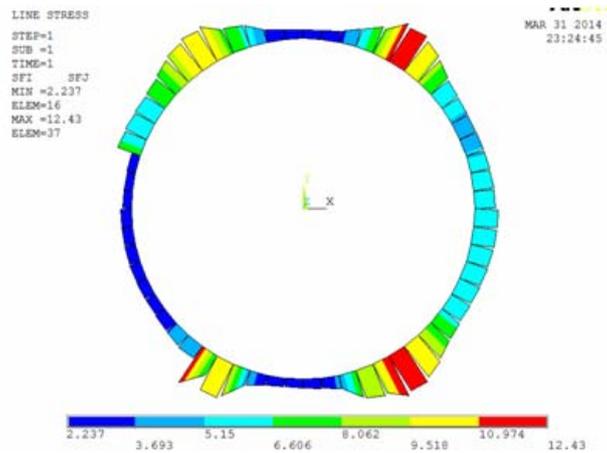
Figure (13): Safety factor of the segment after treatment

the reinforced concrete structure under permanent load and variable load should be greater than 2.0. The safety factors of the segment (Figure 13) after treatment are all greater than 2.0. As a result, the segments meet the strength requirements (Ye et al., 2014; Lai, 2012).
