Estimation of Failure Surface of Pa Bon Dam from Site Investigation

Kobid Panthi¹⁾ and Suttisak Soralump²⁾

ABSTRACT

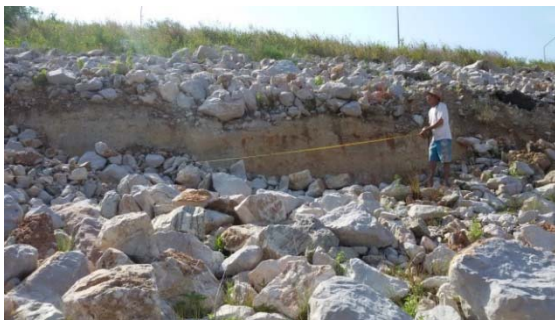
The movement was specifically observed at three locations; i.e., 0+272, 0+297, 0+332 meters and their vicinity. From the initial inspection, it was found out that the horizontal movement was approximately 80 meters, while the vertical movement was 2 meters (Figure 3). After failure, maintenance work was carried out by excavating the estimated failure zone and re-compacting it with stock material (Figure 4).

Figure (3): Upstream slope of Pa Bon dam after the first movement

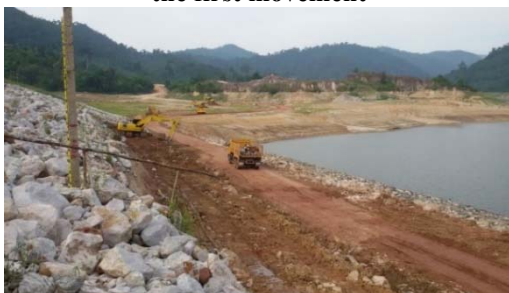
Figure (4): Rehabilitation work after first failure

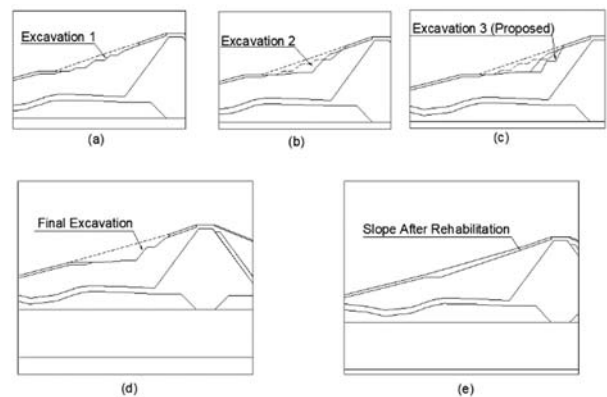
The proposed excavation plan is shown in Figure 5, but excavation could not be completed as per design. Excavation 1 and excavation 2 (Figure 5a and Figure 5b) were executed as per design, but soon after the second excavation, cracks were observed at the slope and the top of the crest, as shown in Figure 6.

So, excavation work was halted and the slope was rehabilitated without excavating the third portion (Figure 5c). Consequently, general operation of the dam continued after its maintenance. Since the movement of the dam did not stop even after the rehabilitation work, various site investigation works were carried out to determine the probable failure surface.

Figure (5): (a) Excavation 1, (b) excavation 2 (c) proposed excavation 3, (d) dam after excavation and (e) dam after filling and compaction

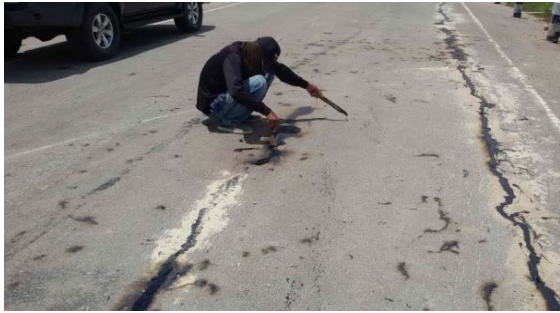
Figure (6): Observation of cracks at the crest of the embankment during excavation

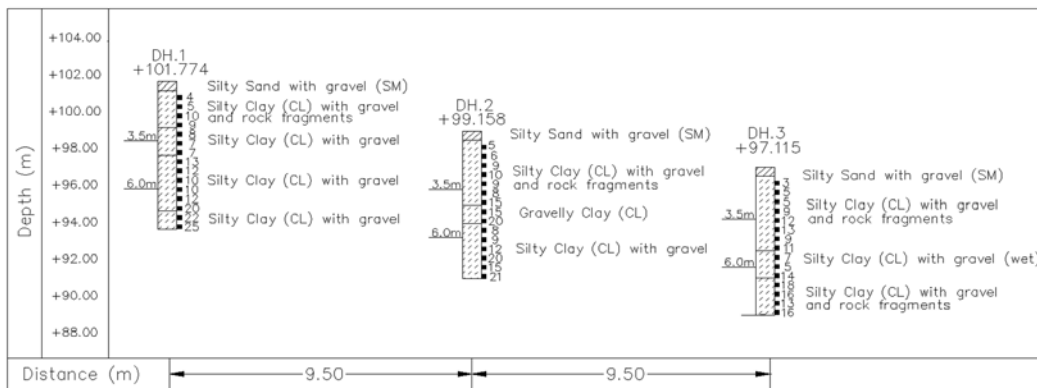
Figure (7): Bore hole investigation at failure zone; i.e., 0+272m (2014)

Failure surface was found to be in a section containing silty clay with gravel for all the investigated sections. The corrected N value (N60) in each section (0+272, 0+297 and 0+332) was determined from this test. From the investigation, the reduction in N value was observed at two sections; i.e., around 3.5 meters and 6 meters (Figure 7) and was preliminarily identified as the location of failure surface.

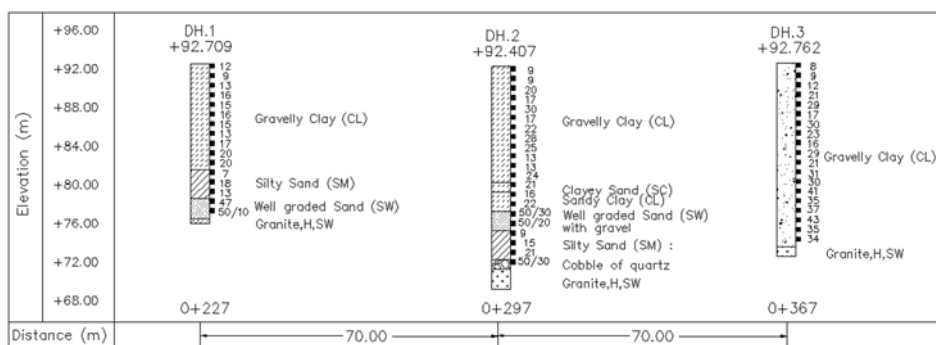
Figure (8): Bore hole investigation at toe zone (2017)

investigation, the toe of the dam looked intact, but at +82.00 meters, it seemed to have undergone some reduction in strength and has the possibility of failure in a long run (Figure 8).

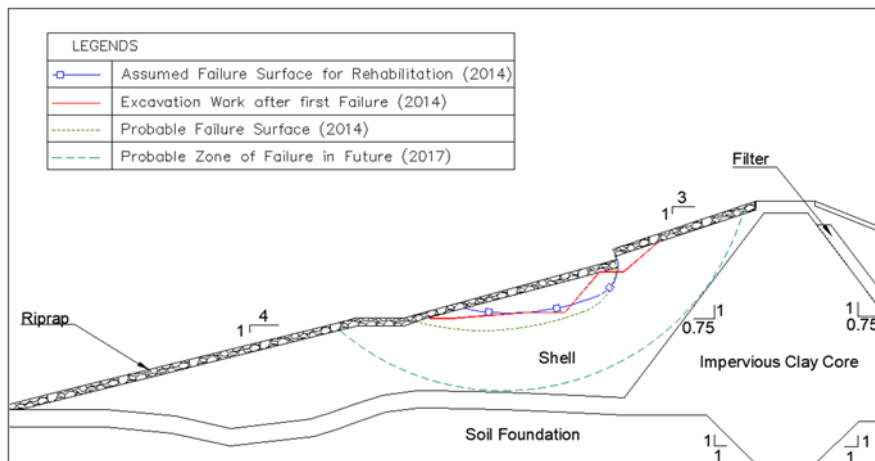
Hence, from the investigations in 2014 and 2017, the surface of failure was estimated, as shown in Figure 10. A total of three curvilinear failure surfaces were estimated from the bore hole investigation. Two shallow failure surfaces and one probable deep failure surface were estimated based on the logging results.

Figure (10): Failure surface estimated from bore hole investigation (2014 and 2017)

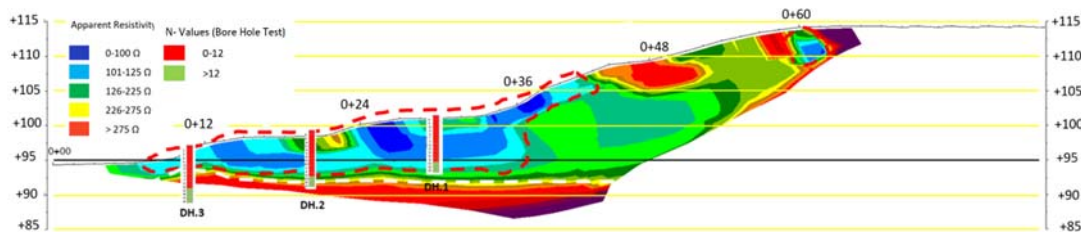
Figure (12): Comparison of results from resistivity test and bore hole investigation (0+272 m)

Likewise, the area with high electrical resistance and having N-value greater than 12 was categorized as stiff to hard clay (silty clay). It was found that the results from electrical resistivity test and bore hole investigation are consistent for all the locations tested. The failure surface was obtained for three sections, where the investigation was conducted, as shown in Figure 13. The results show the shallow immediate surface of failure for all sections as well as a probable deep failure surface. The section with very low resistivity needs immediate attention, but in the long run, the section with medium resistivity might also fail along with other zones. So, attention is required to prevent further movement of the slope in the future.

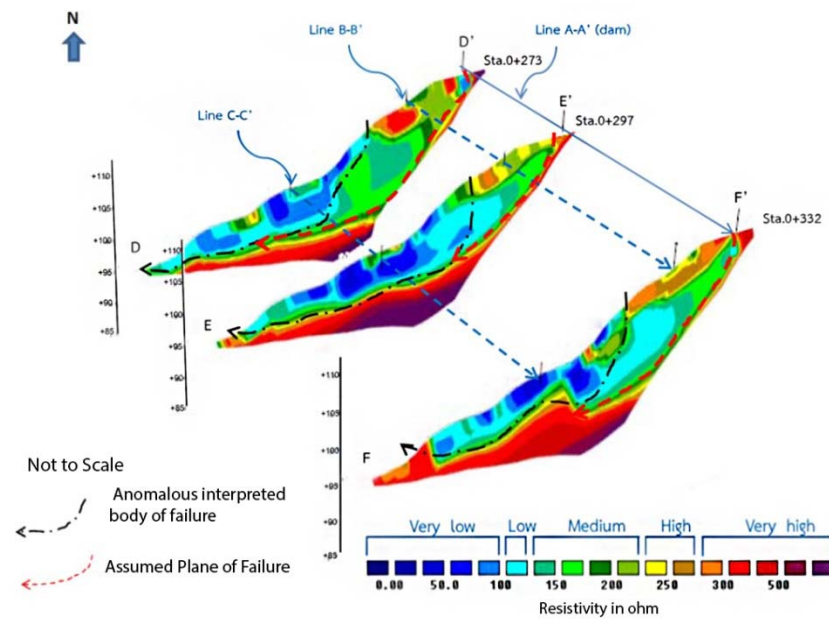
Figure (13): Diagram showing the pattern and extent of slope movement from electrical resistivity test

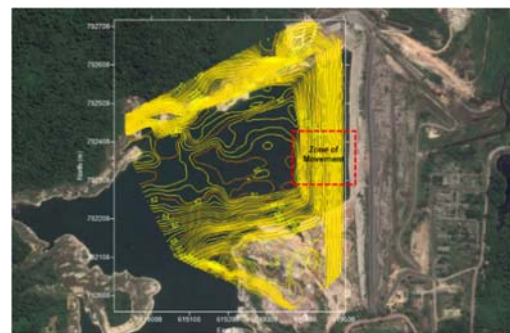
Figure (14): Plan section showing the results of echo sounding

The plan view shows the zone of movement in the embankment structure. Likewise, the cross-section was plotted at every 20 meters and was compared with the initial condition of embankment structure. There was no

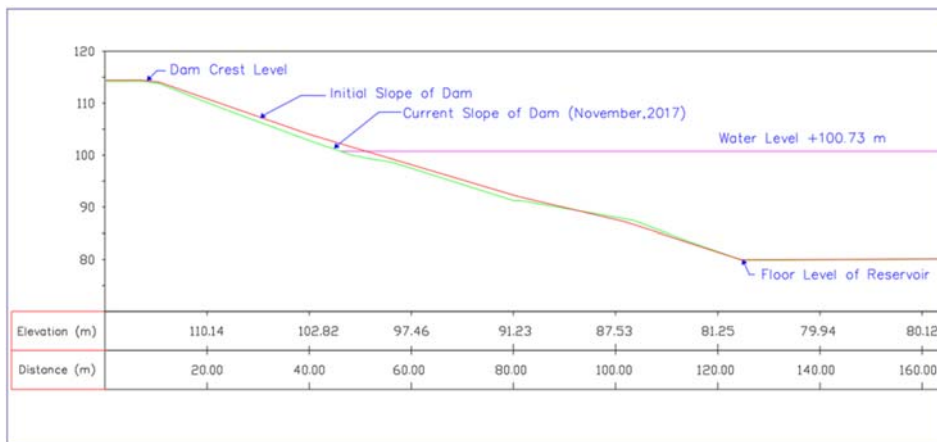
major movement observed at other sections, but it was distinctly visible at the failure zone; i.e., 0+270 – 0+350

meters. The movement of the slope at 0+297m is as shown in Figure 15.

Figure (15): Cross-section of embankment at failure location (0+297)

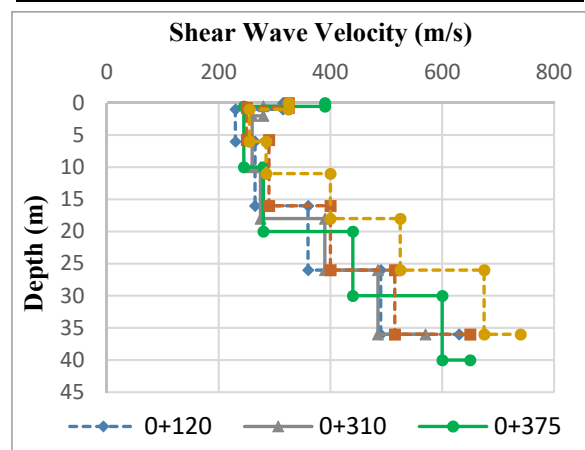
Figure (16): Comparison of shear wave with depth for failure and non-failure zones

6m from the crest of the dam and as can be seen, the G modulus in that section is 15,000 kPa, indicating an intact core. It can hence be confirmed that the core zone had not undergone any reduction in shear strength.

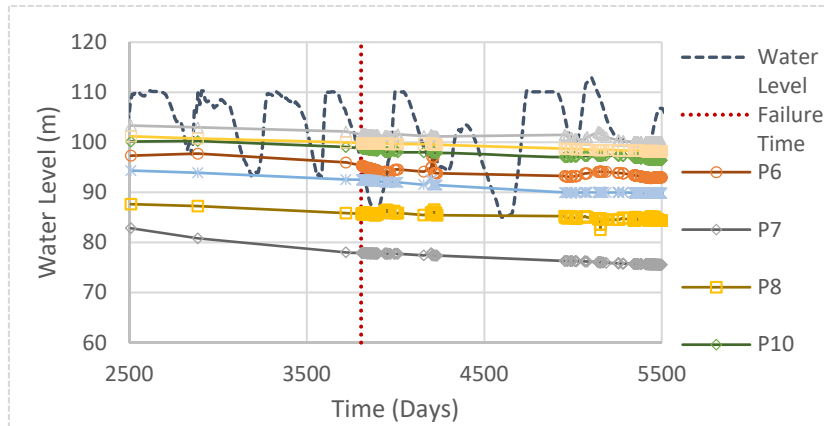
Instrumentation results from various piezometers were compared with exact water levels observed during that period of time. The comparison of results obtained from various piezometers in the clay core from 2500 days to 5000 days is shown in Figure 18. The results from all the piezometers in the clay core indicate that the permeability of the clay core is very low and no significant variation of water level was observed in piezometer with actual fluctuation of water level. This behavior is observed for all the piezometers installed in the clay core as shown in Figure 18.

Figure (18): Variation of water level in piezometer with water level fluctuation

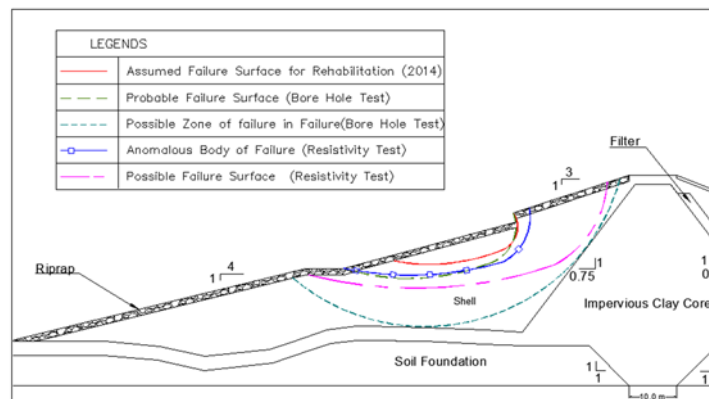
The failure surface of the embankment structure was determined from various site investigations (Figure 19). Bore hole investigation and electrical resistivity test helped in determining the failure surface. Likewise, SASW test helped in verifying that the core was intact and had not undergone any movement. It further helped in confirming the failure surface obtained from previous investigations. The results obtained from these tests helped in determining the actual failure surface. The current status of the slope of the embankment and the length of movement were determined from echo sounding test.

Figure (19): Failure surface determined from bore hole investigation and resistivity test

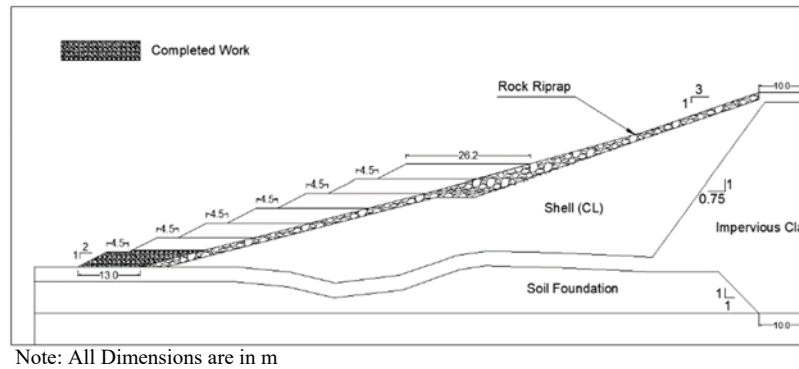
Figure (20): Proposed rehabilitation work of Pa Bon dam (Soralump, Pien-Wej et al., 2019)

started in 2014 and has been continuing to date. After failure, the soil was assumed to have undergone reduction in shear strength and residual shear strength was calculated using reversal direct shear test (Panthi and Soralump, 2020). To prevent further movement of the slope, berm construction on the upstream slope was proposed from chainage 0+145 to 0+405m. Since the width of the failure zone has been increasing each year, the berm length has also been increased. Berms with a slope of 1:2 and each berm having 3m height have been proposed, as shown in Figure 20. A total of 108,000 m³ of rock riprap of 30-100 cm size was proposed for the rehabilitation work of the upstream slope of Pa Bon dam. The total work of 23,190 m³ was completed by February 2019 (Figure 20).
