Repair Effectiveness of Damaged RC Beams with Web Opening Using CFRP and Steel Plates

A. Ahmed, Sivakumar Naganathan*, K. Nasharuddin, Moatasem M. Fayyadh and Shojaeddin Jamali

Department of Civil Engineering, Universiti Tenaga Nasional.

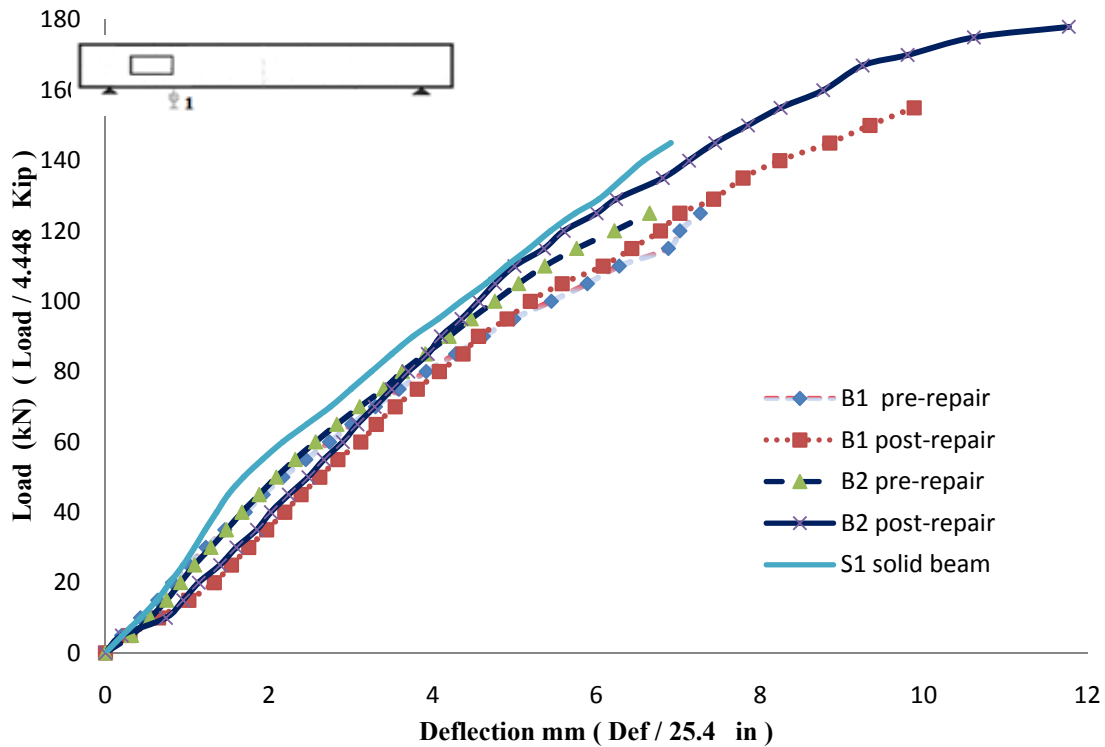
Figure (4): Load vs. deflection curves at the edge of the opening for beams repaired by CFRP

presented in this section. Figure 4 and Figure 5 show the load against deflection curves at the edge of the opening for beams repaired by CFRP and steel plates,

the edge of the opening, as can be seen from Figures 4 and 5. This indicates the weakness of this type of configuration for steel plates, because hexagonal configuration contributed a little area on the top and bottom chords. Beam B2 has the highest effect on deflection at the edge of the opening. As shown in Table 4 and Table 5, for deflection at the edge of the opening in the pre-repaired stage at a failure load of 125.2 kN (28.146 kips), the deflection was 6.65 mm

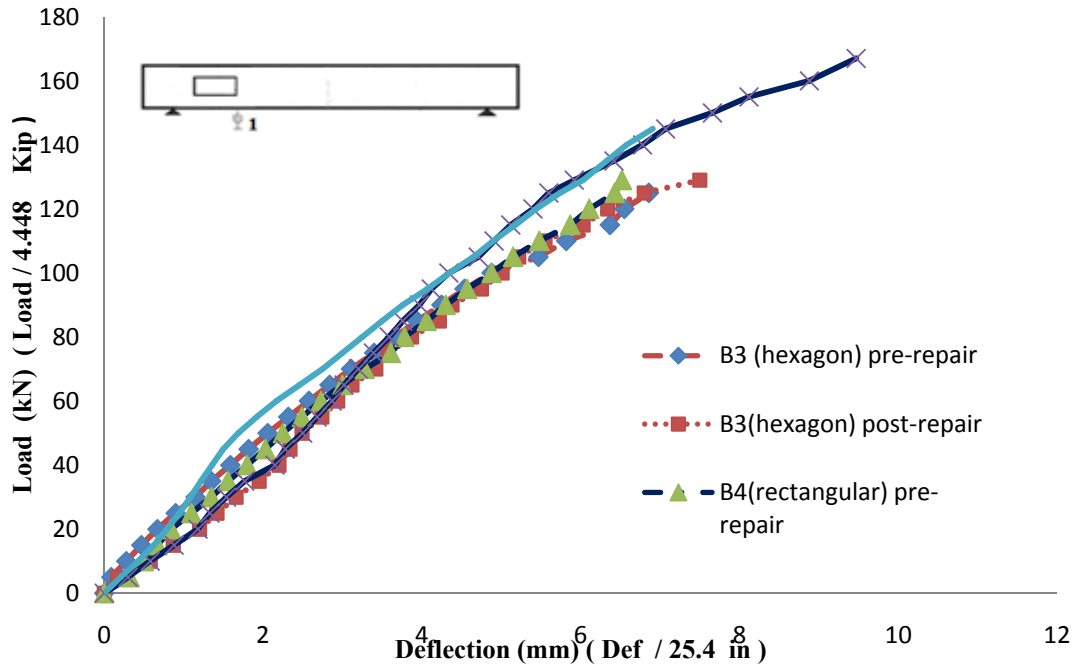
Figure (5): Load vs. deflection curves at the edge of the opening for beams repaired by steel plates

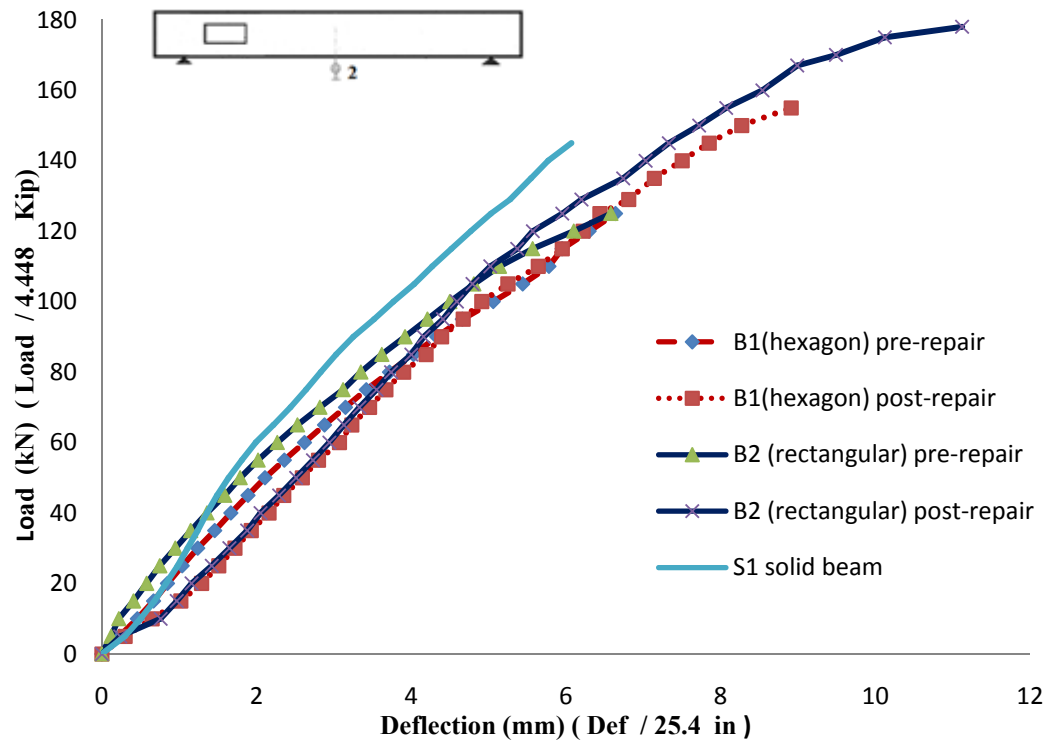
Figure (6): Load vs. deflection curves at the mid-span for beams repaired by CFRP

respectively. Figure 6 and Figure 7 show the load against deflection curves at the mid-span for beams repaired by CFRP and steel plates, respectively. The solid beam, as expected, show the highest value of deflection at the mid-span, while beams with openings show the highest value of deflection at the edge of the opening. For deflection at the edge of the opening, the reduction in deflection values is found to be 10% and 9% for rectangular configuration of CFRP and steel

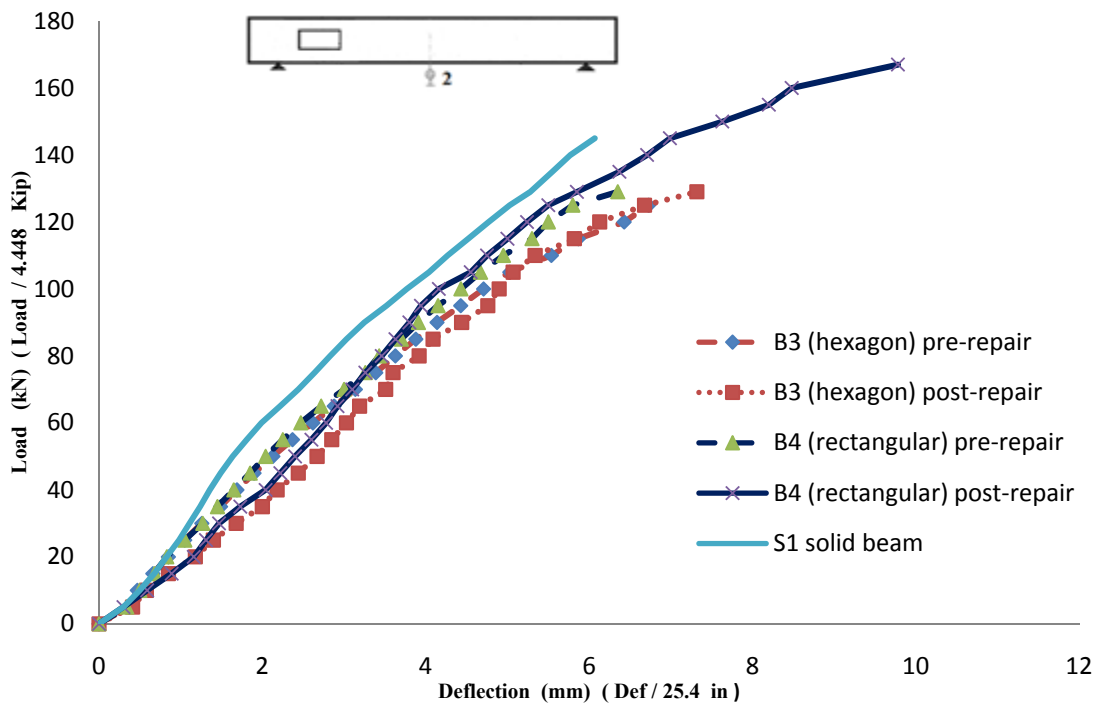
Figure (7): Load vs. deflection curves at the mid-span for beams repaired by steel plates

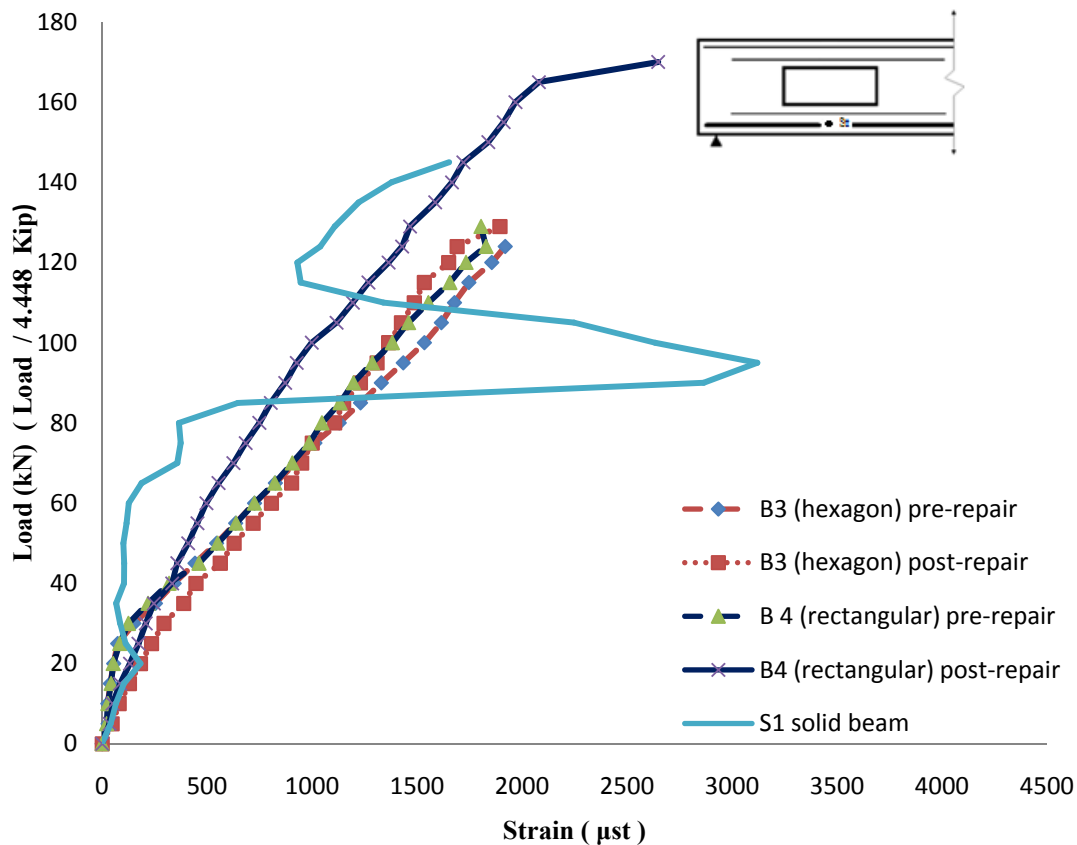
Figure (9): Load vs. steel bar strain curves at St for beams repaired by steel plates

The load-strain relationship of steel reinforcement is presented in this section. A strain gauge (St) was attached onto a main steel bar reinforcement at the middle of the opening in the bottom chord. Figure 8

and Figure 9 show the load-steel bar strain of the strain gauge (St) at the pre-repair stage and post-repair stage. In all the beams at the pre-repair stage, the strain gauge (St) shows an increase in strain value with the increase being in applied load and reaching the yielded point strain of the maximum load. At the post-repair stage, the externally bonded CFRP and steel plate shared the strain with steel bars, where the strain gauge (St) reached a strain less than the strain at the pre-repair condition with the same load, but with different

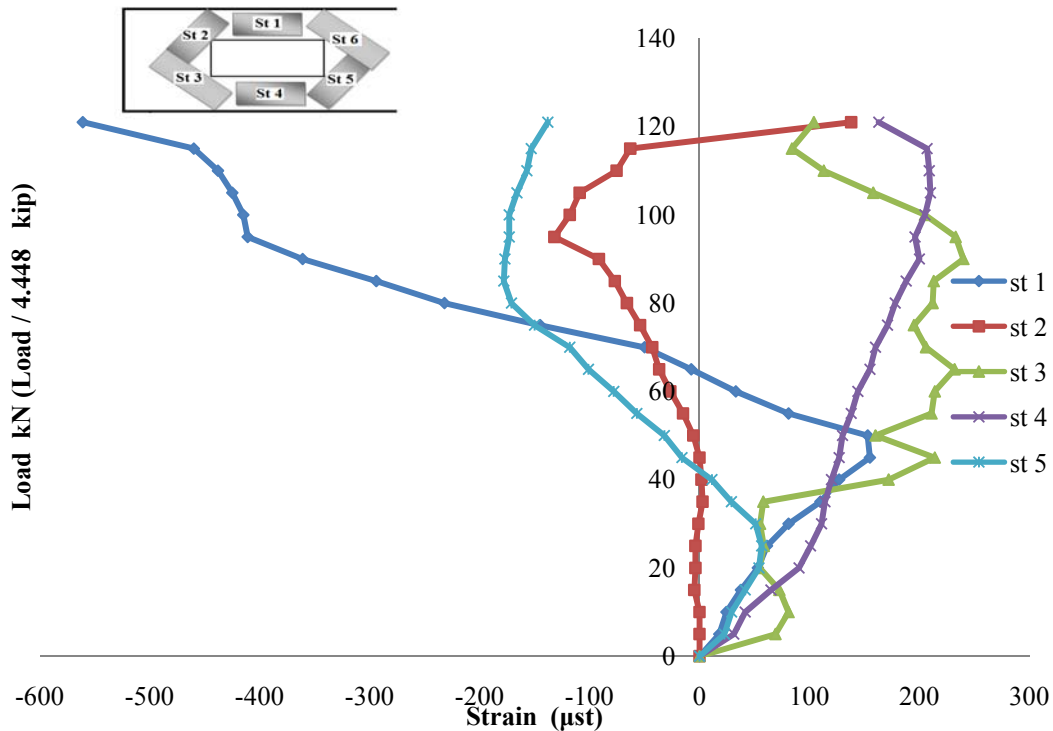
Figure (12): Load vs. strain curves of externally bonded steel plates for beam B3

For beam B3, the steel plate strain was measured at failure in six points and found to be of different values, because the value of strain is greatly dependent on the location of the strain gauge with respect to a crack, as shown in Figure 12, which shows the load-steel plate strain relationship for beam B3. In six points, all the pieces did not reach the steel plate ultimate strain, and strain gauge 6 (St6) was broken during the test. Figure 13 shows the load-steel plate strain relationship for beam B4 in four points. For beam B4, the maximum

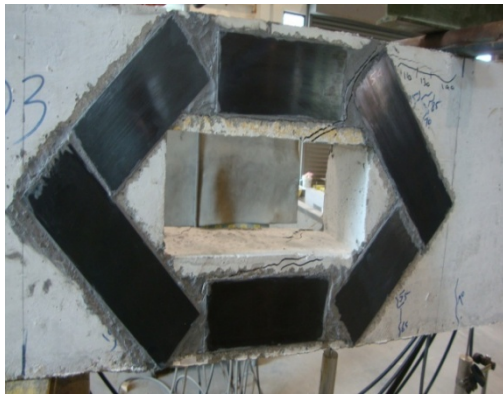
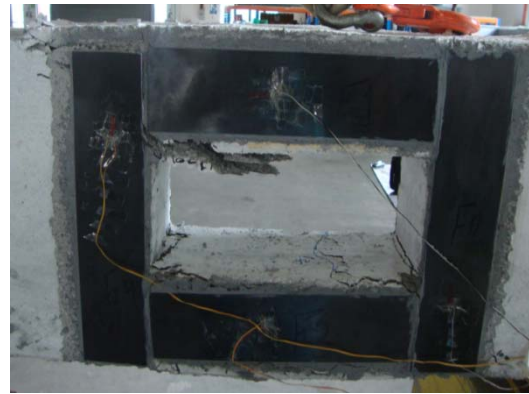
Figure (15): Failure modes at the post-repair stage

occurred at a load of 178.5 kN (40.109 kip). At failure, crushing of the concrete was observed on the top face and bottom face of the chord members, as shown in Figure 15 (b). This mode of failure is called splitting failure, which is due to relatively high longitudinal compressive stress which developed at the top of the chords, creating transverse tension and leading to splitting failure, according to (Khalifa and Nanni, 2002). The CFRP sheet did not fracture or debond from the concrete surface at the ultimate load. As can be seen from Figure 14 (d), the first diagonal crack for beam B4 was observed at the corner of the opening at a load of 35 kN (7.865 kip); additional cracks were formed with the increase of the applied load. Failure of the beam occurred when the total applied load reached 129 kN (29 kip). As shown in Figure 15(d) for beam B4, at the post-repair stage many cracks were formed at the solid span of the beam and the failure of the beam occurred at a load of 167 kN (37.525 kip). At failure, crushing of the concrete was observed on the top face and bottom face of the chord members due to high compressive stress in concrete before the externally bonded plates reach the maximum strain.
