Experimental Studies on Reinforced Hollow-Block Concrete Sections

Falah M. Wegian¹⁾ and Falah A. Almottiri²⁾

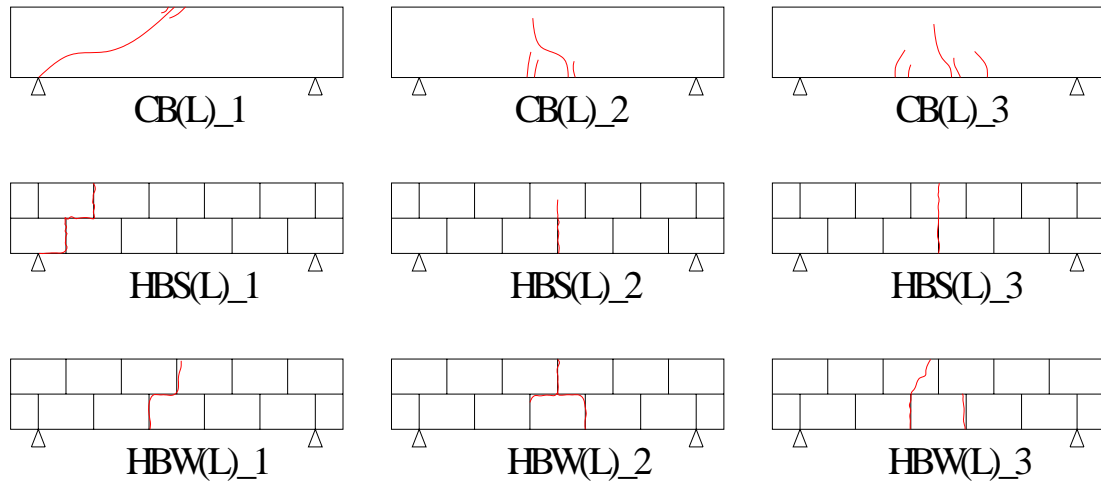
Figure 2(b): Crack Patterns for Long Beams.

Figure 2(b) shows that failure modes of CB (L) and HBS (L) varied from flexural to shear failure. Here, it has to be noted that the ratio of span-to-depth of the beam specimens is five. Flexural cracks in HBS (L) specimens always passed through the masonry joints located at the mid sections of the beams. HBW (L) beam specimen failed in flexure. Here, it has to be noted that the flexural cracks were initiating from masonry joints nearest to the mid-span. In two cases, two cracks developed in the bottom part and they were joined in the upper half. This indicates that the cracks propagated easier through the masonry joints.

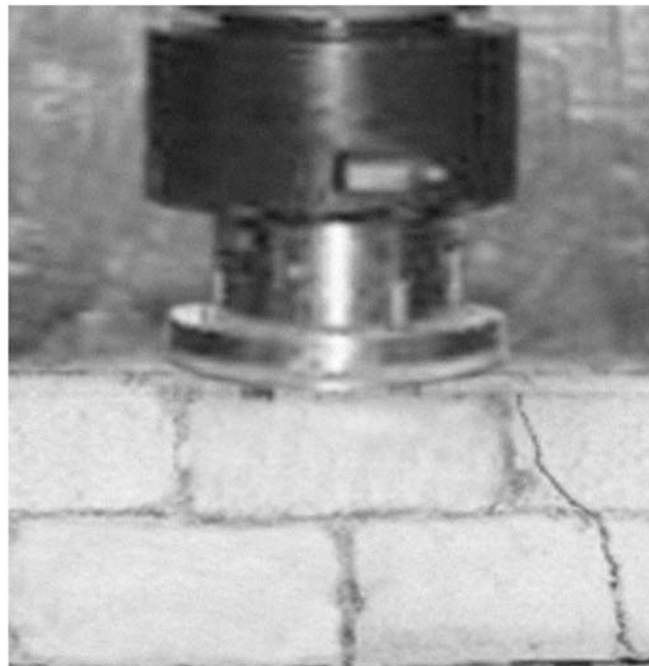
Figure (3): Shear Failure for Beam Tests.

After the initial fracture, the cracks for both groups (small and long beams) opened relatively rapidly. In all cases of the beams failing in shear, the complete collapse of the specimens was prevented due to the dowel action of the reinforcing bars, as shown in Fig. (3).

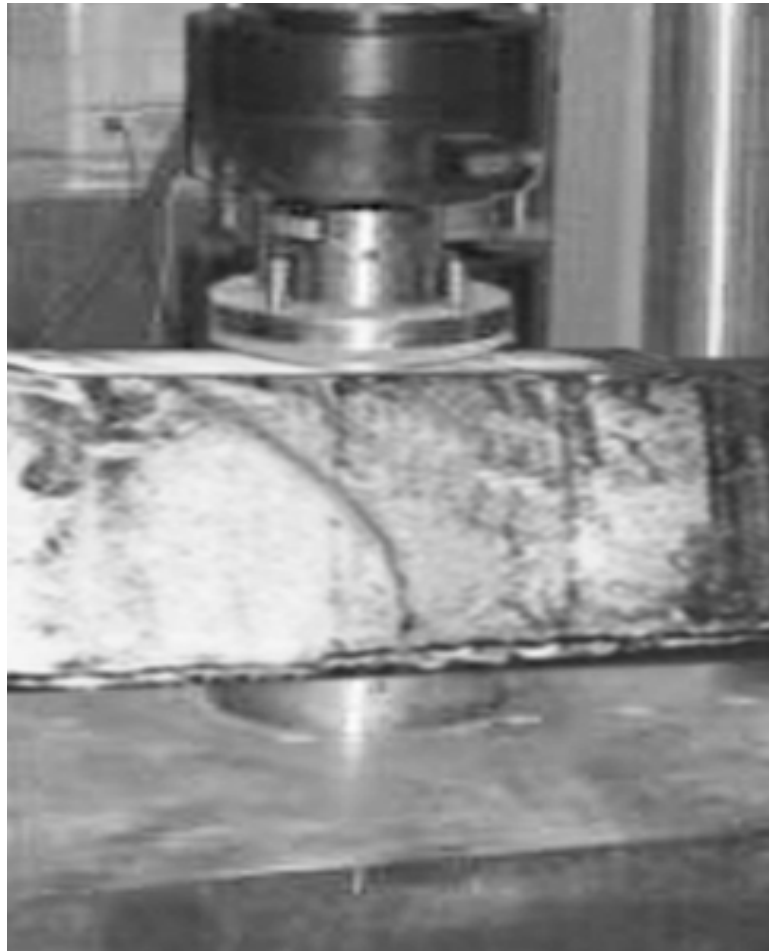
Figure (4): Shear Failure of Beam with GFRP.

For all the beam specimens repaired by GFRP sheets, it was observed that most of the crack patterns recorded were similar to those of the original beams. These cracks either resulted in fracture of the GFRP layer or resulted in its delamination from the two vertical sides of the beams, as shown in Fig. (4).
