Flexural Ductility Behavior of Strengthened Reinforced Concrete Beams Using Steel and CFRP Plates

Khair Al-Deen Bsisu¹⁾, Yasser Hunaiti²⁾ and Raja Younes³⁾

ABSTRACT

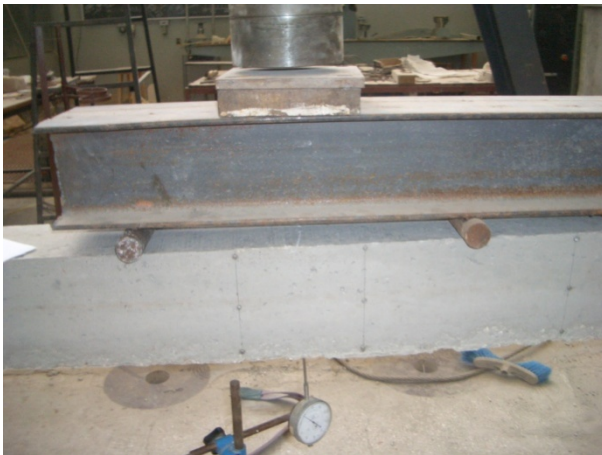
Beam specimens were tested in flexure under two equal one-third loading over a 1500 mm span, using a 1000 kN testing machine. Linear variable displacement transducers (LVDT) were used to monitor the mid-span deflection. Displacement strain gauge transducers (PI-gauges) were installed on the compression, middle and tension sides at the mid-span of the beams. Tension PI-gauge was positioned at the level of the internal reinforcement to determine the magnitude of strain in the reinforcement bars under increased loading as shown in Fig. 2.

**Figure 2: Experimental setup**

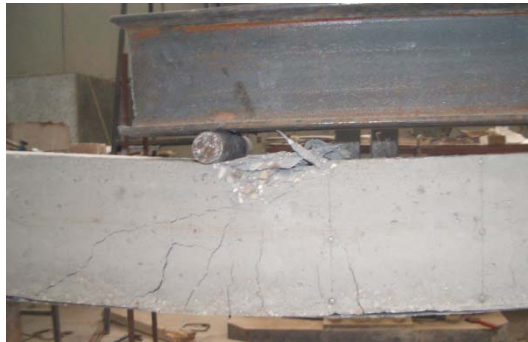
Beams Retrofitted with HSGS Plates: Failure was an excellent example of balanced failure. The maximum load reached at failure was 192kN, the mid-

span strain at the compression side was 0.0022, while the strain at the tension side at failure load was 0.0257 and maximum deflection at mid-span was 10.82 mm (Table 4). Failure mode is shown in Fig. 7, and the strain distribution over the cross-section is plotted for the 50kN, 100kN and failure loads as shown in Fig.8. The ductility value for this group of beams is 12.85, where we notice an increase in ductility for this group.

Figure 7: Failure mode of beam retrofitted with HSGS plates

Ductility of a member is defined as its ability to sustain inelastic deformations prior to failure without substantial loss of strength. A ductile system displays sufficient warning before catastrophic failure. Looking at Fig. 7, it is obvious that the beams retrofitted with HSGS plates showed the highest deformation before collapse, the second would be the beams retrofitted with NSS plates, the un-retrofitted beam comes third

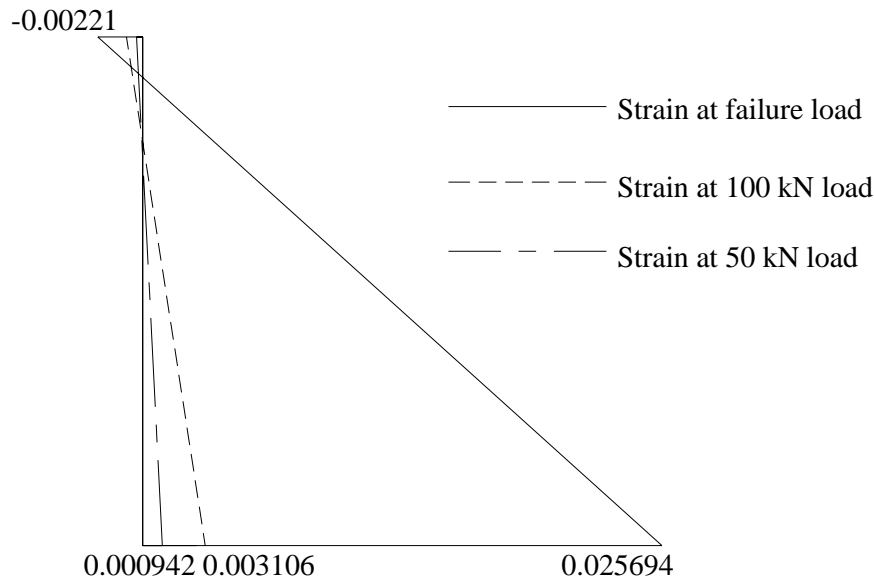
Figure 8: Strain distribution for beam retrofitted with HSGS plates

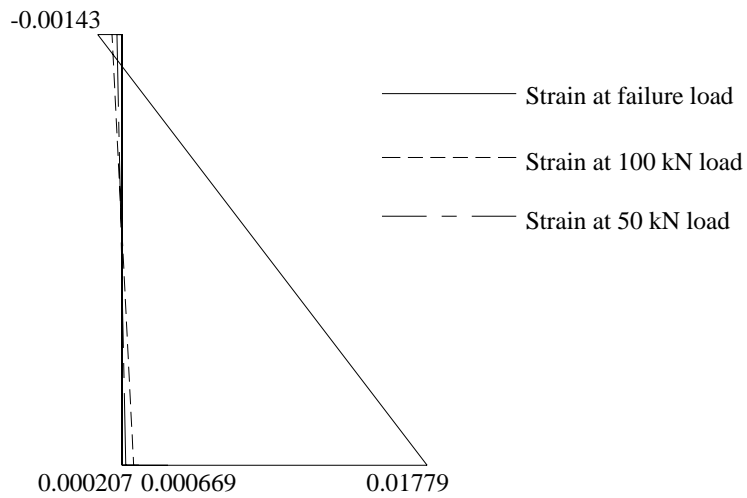
Beams Retrofitted with NSS Plates: Failure was an excellent example of tension failure. The maximum load reached at failure was 188kN, the mid-span strain at the compression side was 0.0014, while the strain at the tension side at failure load was 0.018 and maximum deflection at mid-span was 9.8mm (Table 5). Failure mode is shown in Fig. 9 and the strain distribution over the cross-section is plotted for the 50kN, 100kN and failure loads as shown in Fig. 10. The ductility value for this group of beams is 8.85,

Figure 10: Strain distribution for beam retrofitted with NSS plates

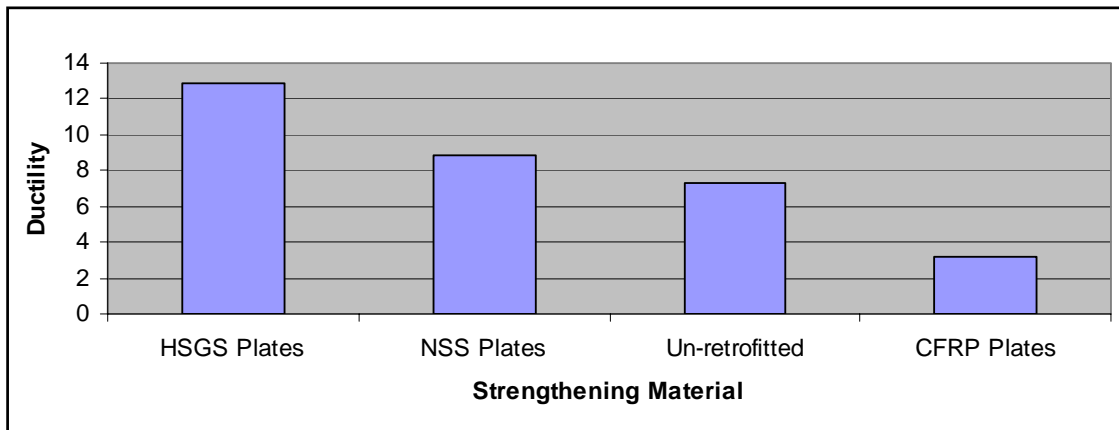
Ductility values (the ratio of the ultimate deformation to that at the first yielding of steel reinforcement) are shown in Table 6 in descending order, we notice that the beams retrofitted with HSGS plates have the highest ductility value (12.85) compared to that of the other beams, beams retrofitted with NSS plates come second with a ductility value of 8.85, the control beam comes third with a ductility value of 7.35, while beams retrofitted with FRP plates

come in the last place with a ductility value of 3.2. These values are presented graphically in Fig. 11.

Figure 11: Ductility value of each strengthening material
