Mechanical Performance of Construction Errors in Implementation of T-Reinforced Concrete Beams

The objective of this study is to identify and evaluate the construction errors during the implementation of concrete T-beams. This research was borne out of the need to investigate some of the many factors responsible for the failure of structures, like the impact of misplacement of slab reinforcement, the effect of irregular arrangement of slab reinforcement and the effect of change in bar diameter of slab reinforcement on the structural behavior of T-beam sections. An experimental program was implemented on nine specimens, which were divided into eight specimens of T-beams, in addition to one specimen which was designed so that the section was a rectangular section without slab to identify the performance of slab in load resistance. Eight specimens of T-beams were designated to simulate the possible defects in the field. The results indicated that the faulty placement of slab reinforcement leads to a lower bending moment capacity of the slab and the steel strain of slab decreased as the height of slab reinforcement decreased. The irregularity of the reinforcing bars in the concrete sl

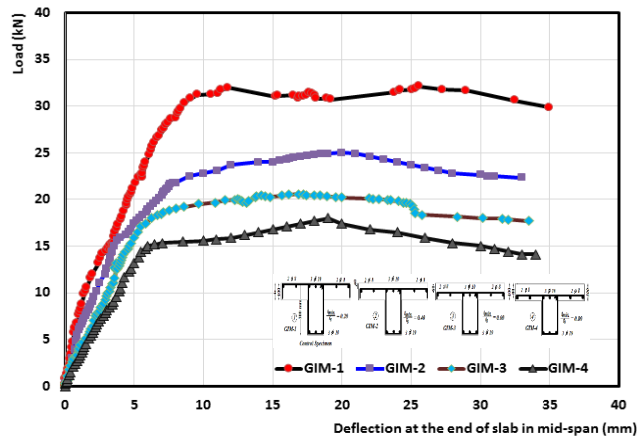
Figure (5): Comparison between the tested specimens of group I

The measured deflection values were plotted against the corresponding applied loads, from the start of applying the load up to failure. The load-deflection curves of the tested specimens in all groups are plotted in Figs. (5-7) and cracking load P_{cr} , ultimate load P_u ,

From the relation between load and deflection of specimens of group I, it was noticed that the tested specimens demonstrated linear deflection behavior before cracking. Upon cracking, stiffness was reduced as the load increased. For specimens GIM-2, GIM-3 and GIM-4, lower values of ultimate load and deflection were noticed compared with the control specimen GIM-1. The area under the load-deflection relationship up to failure is called toughness. Toughness is the ability of

the material to withstand or absorb mechanical energy as shown in Table (3). It can be concluded from comparison of group I that the rate of increase for the ratio of slab reinforcement misplacement was less than the ultimate load value of the tested specimens, but the rate of decrease in the ultimate load was not the same as the rate of increase in the percentage of wrong placement in slab reinforcement. A lower position of the reinforcement leads to a lower bending moment capacity of the slab and can also lead to a brittle behavior in case of collapse.

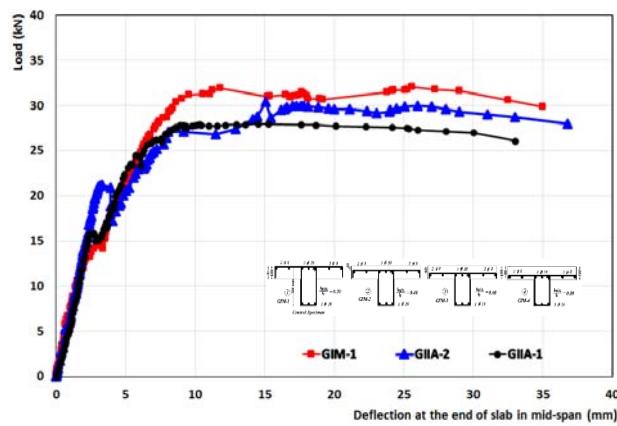
Figure (6): Comparison between the tested specimens of group II

It can be deduced from the results of group II that well-arranged distribution of reinforcement improves the ductile behavior of the slab and reduces the corresponding deflections. Meanwhile, the eccentricity of the main steel creates a sort of non-uniform stress distribution over the section and accelerates failure.

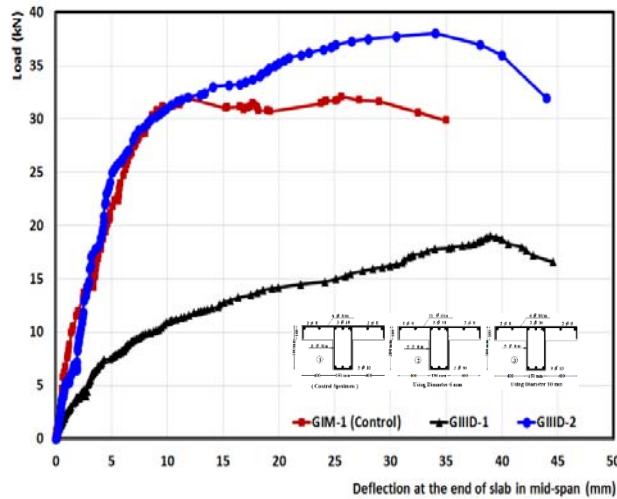
Figure (7): Comparison between the tested specimens of group III

A comparison of group III showed that the use of 10 mm diameter in the reinforcement of the slab exhibited high resistance to loads, while on the contrary, 6 mm diameter reinforcement offered a weak resistance to the loads affecting the slab. Load-deflection responses for specimens GIM-1 and GIID-2 showed approximately the same trend, and no significant difference was observed at low loading level, while the third specimen GIID-1 exhibited a significant difference in values of the deflection from the beginning of loading.

It is concluded from the test results of group III that increasing the diameter of slab reinforcement while keeping reinforcement ratio constant enhanced the behavior of T-beam to withstand the loads and increased the ductility of the T-beam. Also, to improve the efficiency of T-beam section under the loading effect, the minimum bar diameter for the reinforcement of the slab was set at 8mm, because 6mm diameter reinforcement was found to be weak in resisting loads.

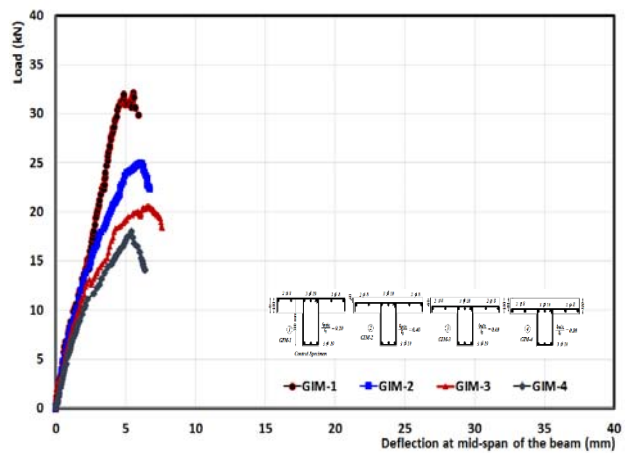
Figure (8): Load-deflection relationship at the mid-span of the beam for specimens of group I

Figure (8) displays the applied load against the vertical deflection at the mid-span of the reinforced concrete beams for group I. It is apparent that the shape of the load-deflection curves in the elastic region before cracking is the same for the all specimens. However, it appears that after cracking, both specimens GIM-1 and GIM-2 produced higher values of deflection than specimens GIM-3 and GIM-4 for the same level of loading. The maximum deflection of specimens GIM-1, GIM-2, GIM-3 and GIM-4 was 5.9mm, 6.7mm, 7.55mm and 6.3mm, respectively at failure load. It could be said that the harmful effect resulting from wrong position of slab reinforcement is more defective on the behavior of the slab and the attached beam than the correct place for reinforcing steel for the slab.

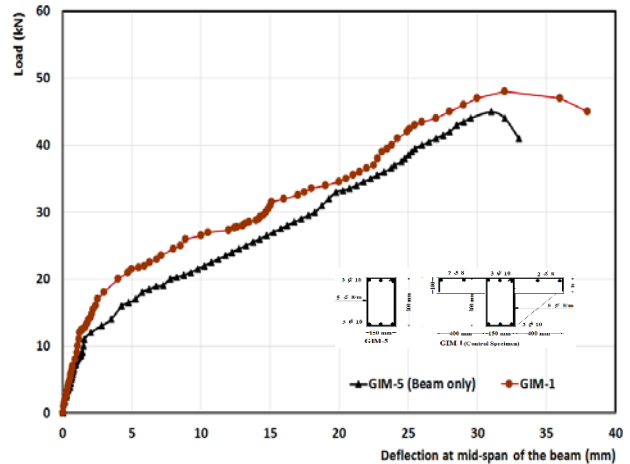
Figure (9): Load-deflection relationship at the mid-span of the beam for specimens GIM-1 and GIM-5

It can be observed from the load-deflection relationship for the two specimens GIM-1 and GIM-5 shown in Figure (9) that specimen GIM-1 demonstrated higher deflection than specimen GIM-5 and the failure load of specimen GIM-1 was higher than that of

specimen GIM-5. The maximum load of specimen GIM-5 is less than the ultimate load of specimen GIM-1 and the toughness is increased with the increase of the stiffness of specimen GIM-1. This indicates that the specimen with a slab (flange) has a higher performance in resisting loads affecting it compared to the specimen which does not have a slab (rectangular beam). This is mainly attributed to the existence of the flange in the T-section that resulted in higher stiffness than in the R-section. T-beams are more efficient than rectangular beams where a part of the slab contributes to the resistance of the loads.

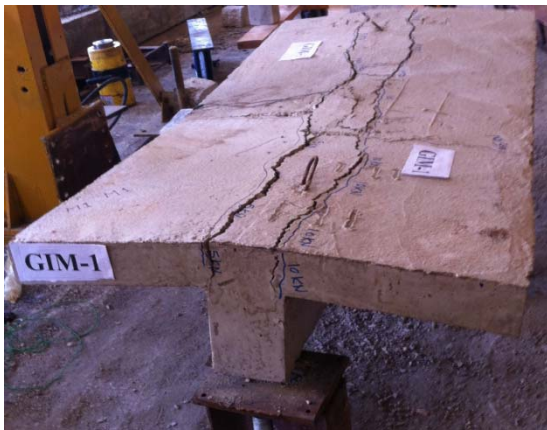
Figure (12): Crack pattern in the slab of specimen GIM-1

For Group I: Figure (12) shows the pattern of cracks for control specimen GIM-1. The first visible crack was initiated in the borderline between slab (flange) and beam (web) at a load equal to 10kN on both sides of the slab. These cracks were inclined in the direction of the slab towards the loading effect; i.e., the crack started in the region of the maximum tensile stress. These cracks extended on the boundary between the slab and the beam along the entire length of the specimen. Then, by increasing the loading value, the existing cracks grew wider and deeper until failure occurred in the slab and then cracks became inclined towards tensile stress trajectories. At later stages of loading, cracks were concentrated on the section of the maximum bending moment and failure occurred in the slab at the load of 32kN in the connected region between slab and beam.

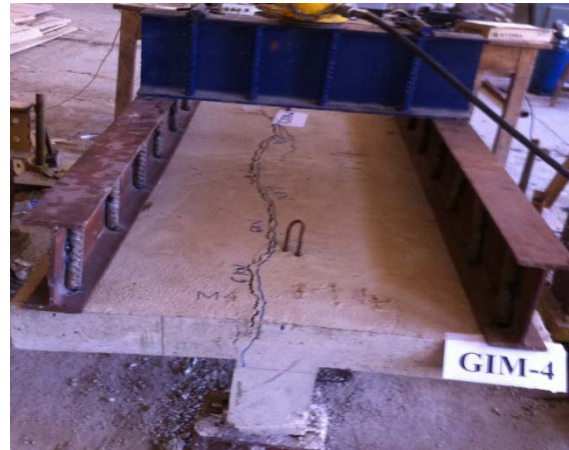
Figure (15): Crack pattern in the slab of specimen GIM-4

For the remaining specimens of group I, it was observed the first cracks visible by the naked eye were at one side of the border line between slab (flange) and beam (web) spread along the length of the specimen. These cracks started at a load of 5kN, 4.5kN and 6kN for specimens GIM-2, GIM-3 and GIM-4, respectively. At failure, the width of the cracks was noticeably wider and highly propagated at the face of the intersection between slab and beam, where the height of reinforcement in slab reduced. Failure occurred at a load equal to 25kN, 20.5kN and 18.5kN for specimens GIM-2, GIM-3 and GIM-4, respectively. Based on test observations, failure of specimens GIM-2, GIM-3 and GIM-4 could be classified as pronounced sudden and flexural mode of failure in the slab, where the misplacement of slab reinforcement affected the efficiency of the slab, leading to faster failure in the slab. Figures (13), (14) and (15) show the photos of specimens GIM-2, GIM-3 and GIM-4, respectively after failure.

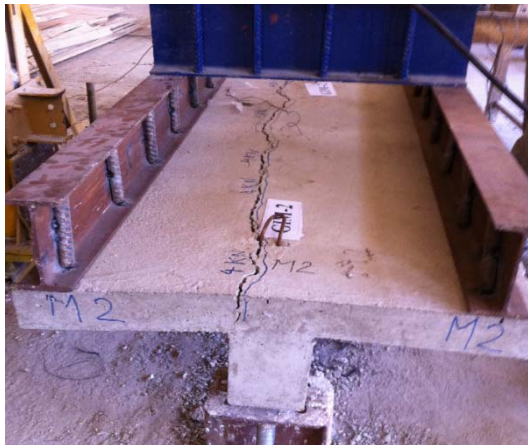
Figure (13): Crack pattern in the slab of specimen GIM-2

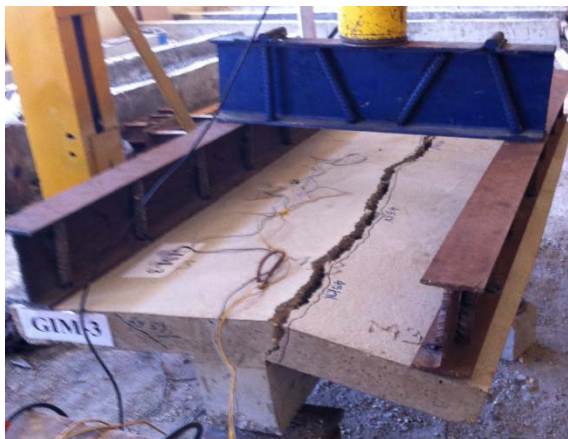
Figure (14): Crack pattern in the slab of specimen GIM-3

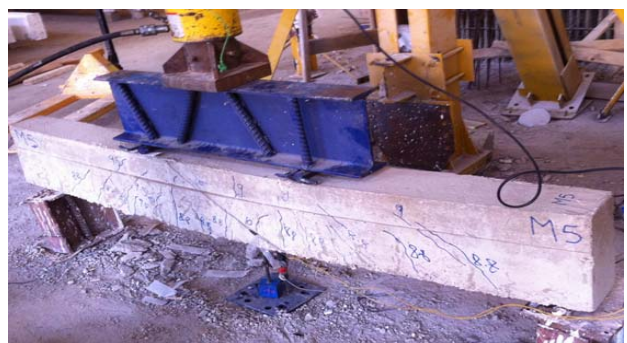
Figure (16) (a): Crack pattern in the beam of specimen GIM-5

The appearance of the tested specimen GIM-5 after loading is shown in Figures (16) (a) and (16) (b). Specimen GIM-5 showed typical cracking behavior of under-reinforced concrete simple beam and failed in ductile flexural tension. At early loading levels, vertical cracks appeared in the region of shear towards loading points at a load equal to 8.8 kN. Upon increasing the load, the cracks started at maximum tensile stresses (region of maximum bending moment). With increasing the load, the number, width and extension towards the compression zone of the cracks increased. Cracks were concentrated at the section of the maximum bending moment and at later stages of loading, failure occurred in the middle third of the beam span. However, at a load of 45kN, the specimen failed with ductile mode failure when the load reached its peak value.

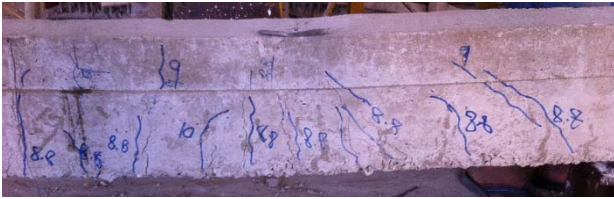
Figure (16)(b): Cracking pattern of specimen GIM-5 (mid-span of the beam)

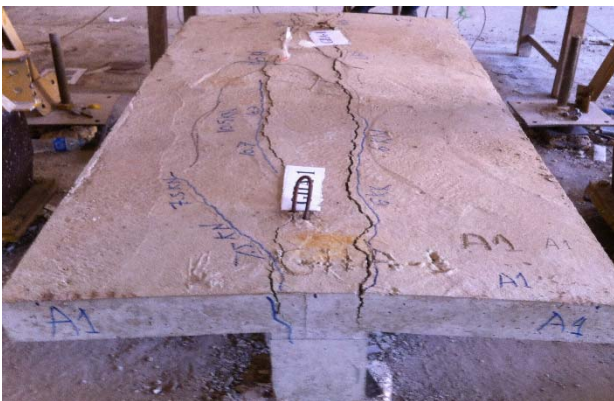
Figure (17): Crack pattern in the slab of specimen GIIA-1

For Group II: Specimens GIIA-1 and GIIA-2 exhibited basically the same cracking pattern and final mode of failure in nature of loading. The failure of these specimens was flexural tensile at maximum bending moment region (the vicinity region between slab connection and the beam), where the moment is concentrated in this region. Also, the cracks started to appear in the region where there are no reinforcing bars in the slab and propagated towards the loading points. The first crack occurred at a load of 7.5kN and 12kN for specimens GIIA-1 and GIIA-2, respectively. As the load was further increased, the crack became wider and extended at both sides of the beam along the overall length of the specimen. Specimens GIIA-1 and GIIA-2 failed primarily at the ultimate conditions in a flexural mode, which occurred at loads equal to 28kN and 30.5kN, respectively. Failure occurred along the entire borderline between beam (web) and slab (flange) interface. The cracking patterns of tested specimens GIIA-1 and GIIA-2 at failure are shown in Figures (17) and (18), respectively.

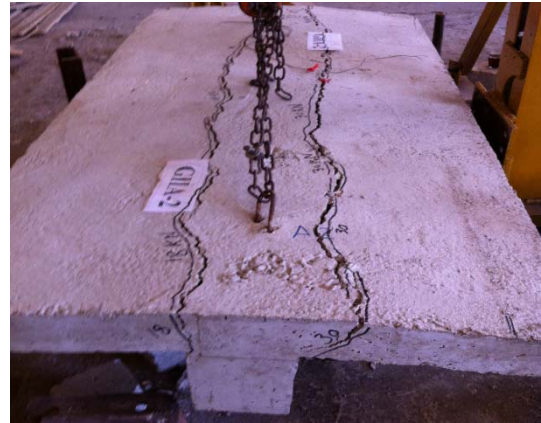
Figure (18): Crack pattern in the slab of specimen GIIA-2

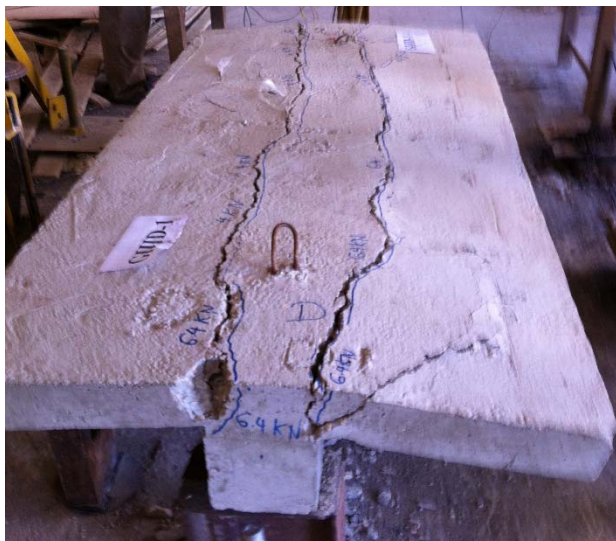
Figure (19): Crack pattern in the slab of specimen GIID-1

For Group III: Crack patterns for specimens GIIID-1 and GIIID-2 are depicted in Figures (19) and (20), respectively. The first cracks were horizontal flexural cracks in the vicinity of the tension zone within and near the constant moment region at the connection of the slab (web) with the beam (flange) at a load of 4.60kN and 7kN for specimens GIIID-1 and GIIID-2, respectively. These cracks continued along the overall length of the specimen (i.e., parallel to the loading effect). At higher loading stages for specimen GIIID-1, the rate of formation of new cracks significantly decreased. Moreover, the existing cracks grew wider, especially the first cracks formed. The specimen failed at a lower loading value of 19kN in the region of negative moment concentration affecting T-beam section where tension reinforcement of the slab was yielded, indicating that 6mm diameter reinforcement was weak in load resistance. For the second specimen GIIID-2, with the increase in load, cracks appeared along the borderline between the beam and the slab. The width of the cracks increased with the increase in the loading effect till specimen failure occurred at a load value of 38kN. Crushing of concrete in one corner of the specimen occurred when loading increased. This specimen exhibited high resistance to loads compared with specimens GIM-1 and GIIID-1.

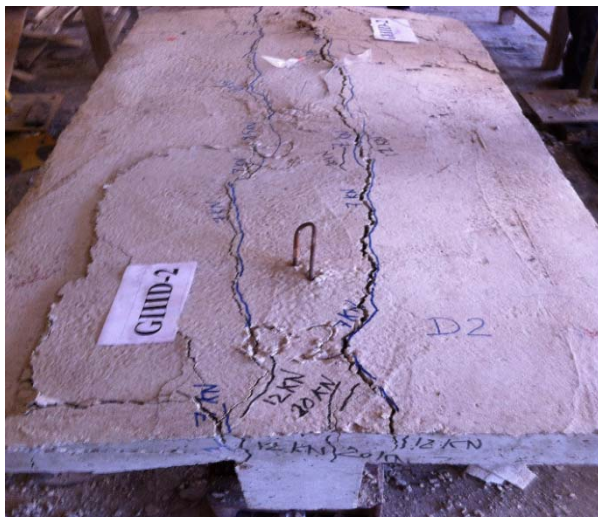
Figure (20): Crack pattern in the slab of specimen GIID-2
