## Flexural Ductility Behavior of Strengthened Reinforced Concrete Beams Using Steel and CFRP Plates

Reinforced concrete beams are commonly retrofitted using Carbon Fiber Reinforced Plastic (CFRP) plates as the technique is both inexpensive and unobtrusive. However, tests have shown that CFRP plates tend to debond at low strains, which can severely limit the ductility. Structural strengthening of beams subjected to flexure can be achieved using different retrofitting materials. The mostly used other retrofitting materials are; high strength galvanized steel plates (HSGS plates) and normal strength steel plates (NSS plates). This paper reports the behavior of retrofitted beams with each of these three materials. The experimental results of this study suggest that (HSGS plates) can be used to increase the strength of reinforced concrete structures with little, if any, loss of ductility.

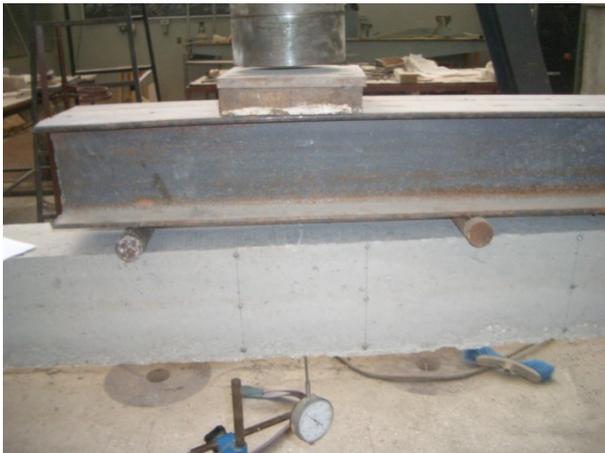
Beam specimens were tested in flexure under two equal one-third loading over a 1500 mm span, using a 1000 kN testing machine. Linear variable displacement transducers (LVDT) were used to monitor the mid-span deflection. Displacement strain gauge transducers (PI-gauges) were installed on the compression, middle and tension sides at the mid-span of the beams. Tension PI-gauge was positioned at the level of the internal reinforcement to determine the magnitude of strain in the reinforcement bars under increased loading as shown in Fig. 2.

**Figure 2: Experimental setup**

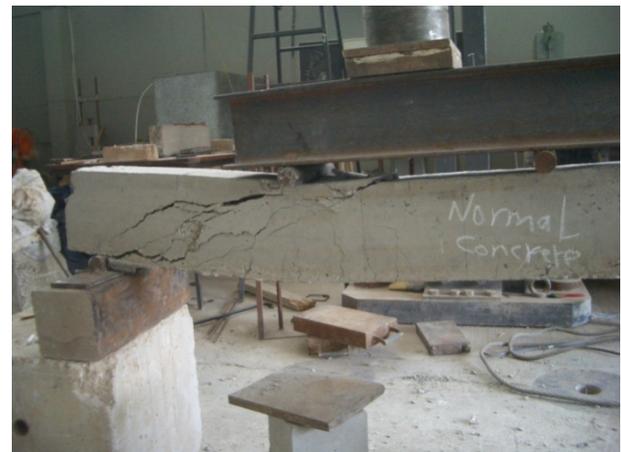
**Control Beam:** The behavior of the control beam under loading was typical of a beam subjected to flexural stresses, failure load was at 145 kN. Crack pattern showed that uniformly spaced cracks were formed in the bending region which formed concrete blocks connected by the dowel action of the bottom

steel, at the point of maximum diagonal shear cracks the mid-span strain at the compression side was 0.00121 and at the tension side it was 0.0148. Maximum deflection at mid-span was 10.9 mm.

**Figure 3: Failure of the control beam**

Strain values of the control beam are shown in Table 2, the failure mode is shown in Fig.3 and the strain distribution over the cross-section is plotted for the 50kN, 100kN and failure loads as shown in Fig.4. The ductility value for the control beam is 7.35.

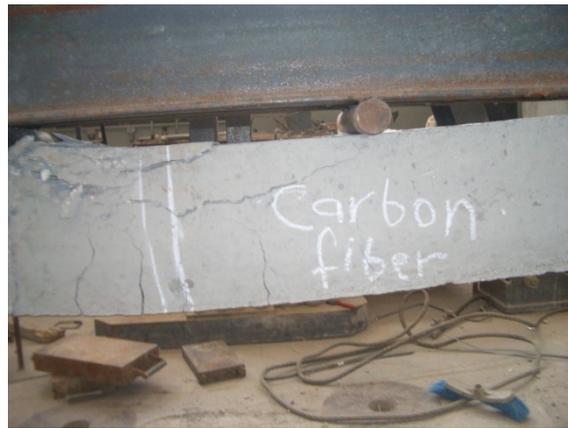
**Beams Retrofitted with CFRP Plates:** Failure was typical of a brittle compression failure, debonding at the cracked region followed by crushing of the concrete at the top. The maximum load reached at failure was 190 kN, the mid-span strain at the compression side was 0.0028, while the strain at the tension side at failure load was 0.0064. Maximum deflection at mid-span was 13mm. Average of the beams' experimental data for this group is shown in Table 3, failure mode is

Figure 5: Failure mode of beam retrofitted with CFRP plates

shown in Fig. 5, and the strain distribution over the cross-section is plotted for the 50kN, 100kN and failure loads as shown in Fig.6. The ductility value for this group of beams is 3.2, where we notice a drop in ductility for this group of beams.

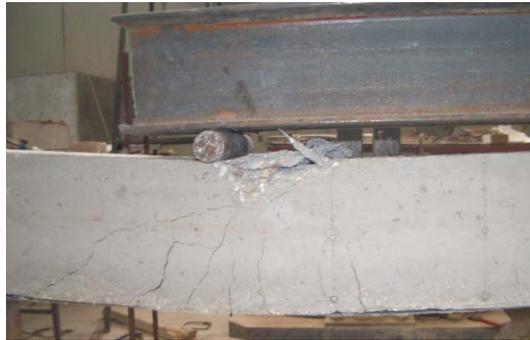
**Beams Retrofitted with HSGS Plates:** Failure was an excellent example of balanced failure. The maximum load reached at failure was 192kN, the mid-

span strain at the compression side was 0.0022, while the strain at the tension side at failure load was 0.0257 and maximum deflection at mid-span was 10.82 mm (Table 4). Failure mode is shown in Fig. 7, and the strain distribution over the cross-section is plotted for the 50kN, 100kN and failure loads as shown in Fig.8. The ductility value for this group of beams is 12.85, where we notice an increase in ductility for this group.

Figure 7: Failure mode of beam retrofitted with HSGS plates

Ductility of a member is defined as its ability to sustain inelastic deformations prior to failure without substantial loss of strength. A ductile system displays sufficient warning before catastrophic failure. Looking at Fig. 7, it is obvious that the beams retrofitted with HSGS plates showed the highest deformation before collapse, the second would be the beams retrofitted with NSS plates, the un-retrofitted beam comes third
