Experimental Studies on Reinforced Hollow-Block Concrete Sections

Falah M. Wegian¹⁾ and Falah A. Almottiri²⁾

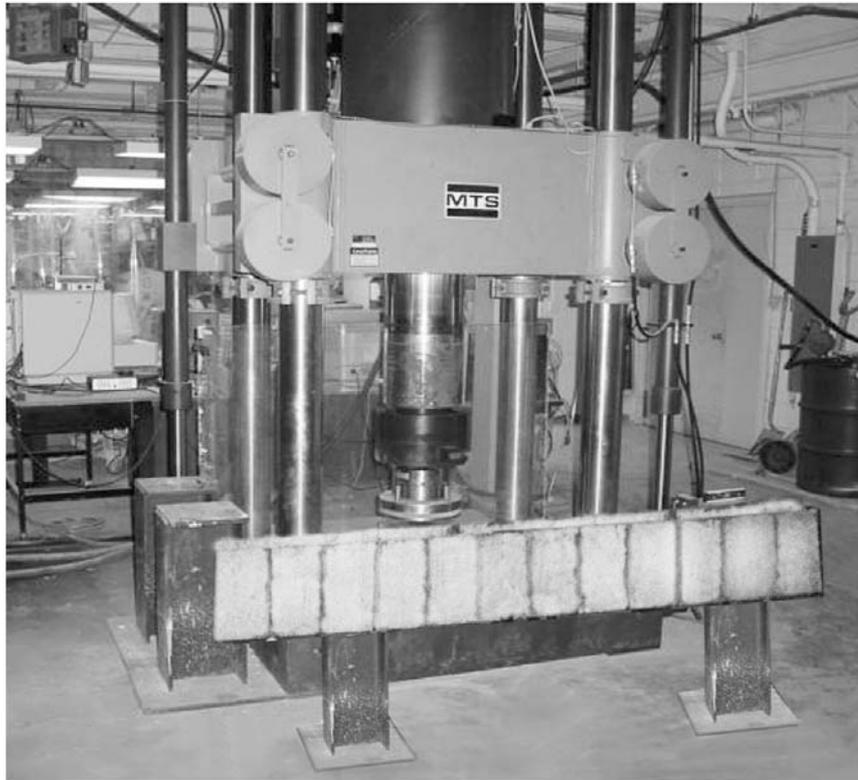
Figure (1): Test Set-up.

In both short (S) and long (L) types of reinforced concrete beams, used as Control Beams (CB), the reinforcement was 2 ϕ 12 steel rebars with a cross sectional area of 2.66 cm². Similarly, the concrete hollow-block beams, both (S) and (L), which were reinforced with steel rebars (HBS), had exactly the same amount of reinforcement; 2 ϕ 12 steel rebars. The concrete hollow-block beams that were reinforced with 2 ϕ 6 wire meshes (HBW) had a cross sectional reinforcement area of 0.57 cm² for both (S) and (L) types. Obviously, this value is much less than the minimum allowed for reinforced concrete and masonry constructions. These specimens were included in this study to be able to evaluate the failure mode of non-reinforced masonry beams and their reliability. All beams were subjected to one concentrated load acting at mid-span, as shown in Fig (1).

The specimens were tested using a 980 kN Universal Testing Machine; a dial gauge having a travel of 25 mm was used to record the vertical deflection at the bottom of the mid-span of the beam.

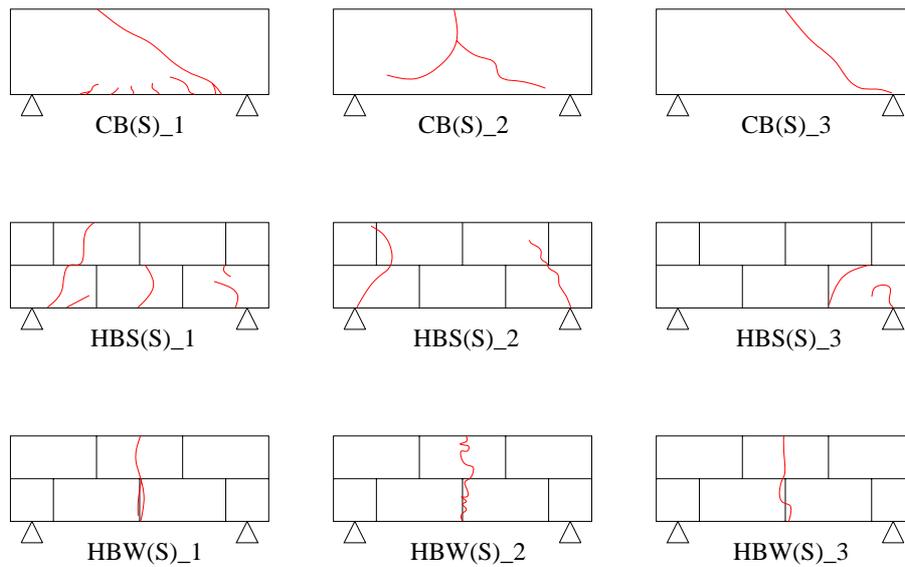
Figure 2(a): Crack Batterns for Short Beams.

Different failure modes were recorded for the different beam types. The recorded crack patterns for the different beams tested in this study are given in Figure 2(a, b). The investigation of failure modes can be grouped as follows:

Figure 2(a) shows that short beam specimen types BC(S) and HBS(S) mainly developed shear cracks. The exception was HBS(S)-3 which developed cracks near

one of its supports. Its failure was due to the bearing because its supports were not even.

Here, it should be noted that flexural cracks appeared in the flexural span as the load was increased in all the beam specimens. However, further increase of load caused the development of the shear cracks which resulted in the final failure of the beams. Accordingly, it can be stated that ultimate strength of the masonry beams reinforced using steel bars was due to shear and that failure of the reinforced concrete specimens was similar to the masonry beam specimens.

For the HBW(S) beam specimens, cracks developed near mid-span and started from bottom to top. These

cracks indicate clearly that the lightly reinforced beam specimens failed due to pure flexure.

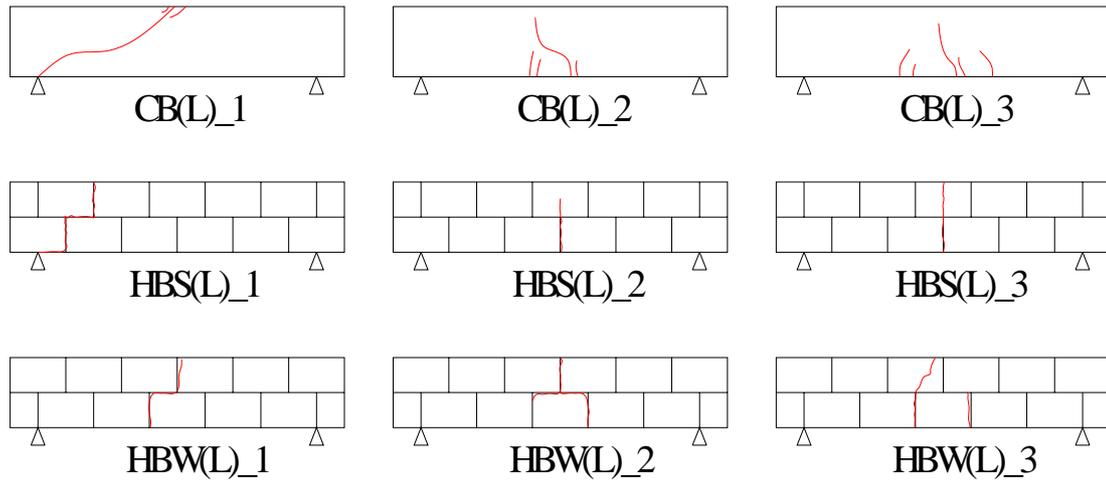
Figure 2(b): Crack Patterns for Long Beams.

Figure 2(b) shows that failure modes of CB (L) and HBS (L) varied from flexural to shear failure. Here, it has to be noted that the ratio of span-to-depth of the beam specimens is five. Flexural cracks in HBS (L) specimens always passed through the masonry joints located at the mid sections of the beams. HBW (L) beam specimen failed in flexure. Here, it has to be noted that the flexural cracks were initiating from masonry joints nearest to the mid-span. In two cases, two cracks developed in the bottom part and they were joined in the upper half. This indicates that the cracks propagated easier through the masonry joints.

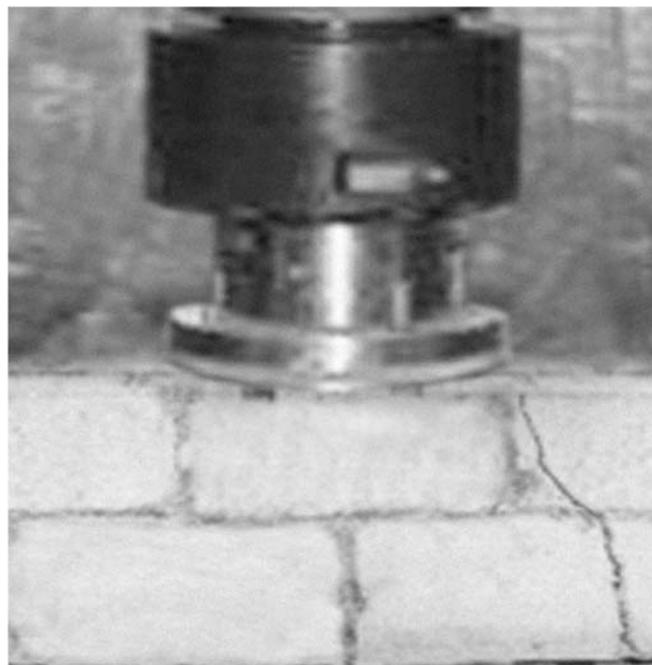
Figure (3): Shear Failure for Beam Tests.

After the initial fracture, the cracks for both groups (small and long beams) opened relatively rapidly. In all cases of the beams failing in shear, the complete collapse of the specimens was prevented due to the dowel action of the reinforcing bars, as shown in Fig. (3).

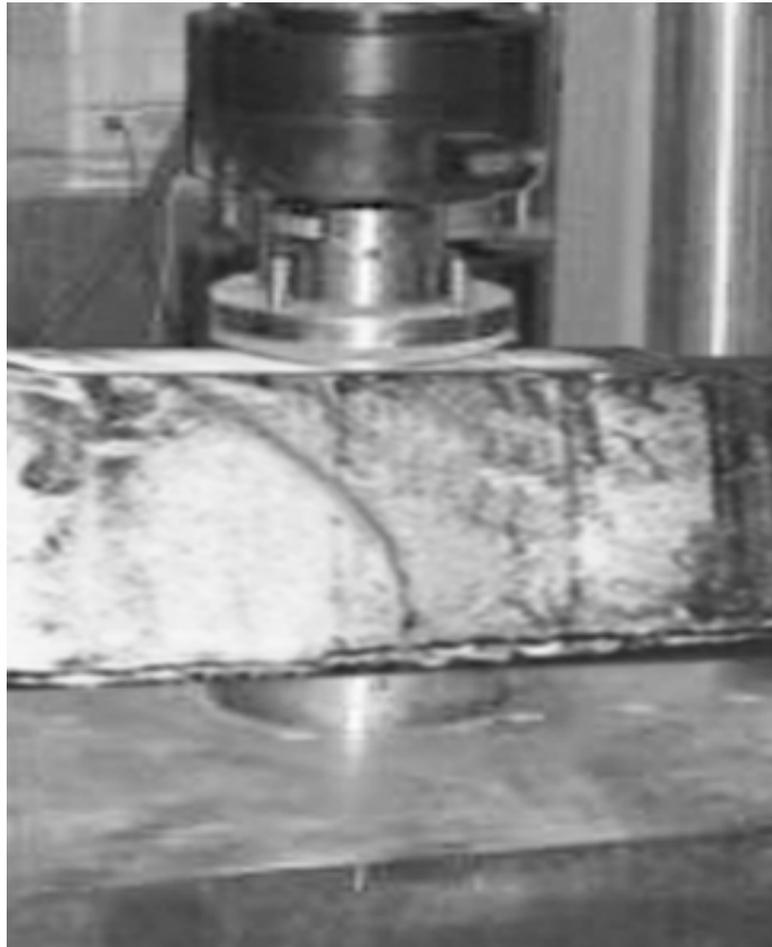
Figure (4): Shear Failure of Beam with GFRP.

For all the beam specimens repaired by GFRP sheets, it was observed that most of the crack patterns recorded were similar to those of the original beams. These cracks either resulted in fracture of the GFRP layer or resulted in its delamination from the two vertical sides of the beams, as shown in Fig. (4).
