Deterioration and Damage Evaluation of the Monument of Qasr al-Bint, Petra-Jordan and a Suggested Conservation Program

Site investigation was made in order to assess and evaluate the existing structural conditions of Qasr al-Bint. The damage and deterioration forms of the structure were mapped and represented by schematic drawings and pictures and their causes were defined. A conservation program is suggested in order to preserve the artistic and historical values of this monument and to strengthen it against any possible earthquake in the future. The conservation program must utilize the same materials and suitable techniques used locally. The program must restore the horizontal diaphragms of the floor over the interior section and the roof of the whole building and ensure that these diaphragms are well interconnected to the walls. The conservation program must provide adequate reinforced concrete tie beams at the middle third of the wall thickness and below the horizontal diaphragms. These tie beams can be arranged in a two-dimensional grid along the wall lines and can be wrapped by polystyrene or isolation sheets to protect the sandstones from any adverse effects that may resul

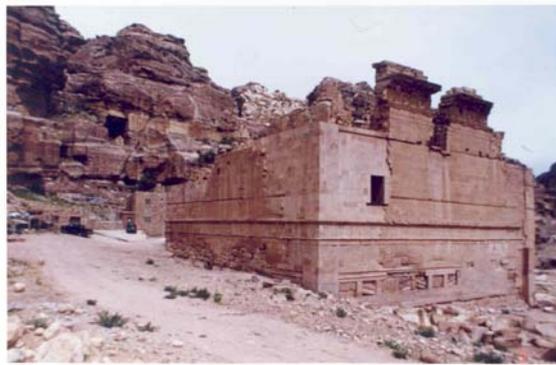
The Eastern Wall: The distribution of the weathering forms observed on this wall is shown in Figure 6. This wall suffers from a series of vertical structural cracks caused by earthquake tremors, as shown in Figure 4. The cracks divided the wall into vertical segments that are free standing without any support. In particular, the upper part of the wall might fall down due to any slight vibration caused by even a very weak earthquake. Major concrete construction was carried out at the lower part of the wall, trying to support the wall. The added concrete elements caused severe

Figure (4): The south-eastern corner

4. Large vertical cracks and separations exist at wall intersections and corners. Stone stitching across the crack is one method which can be used to make sufficient interconnection between the walls. Steel tie plates could be used, as another method, to tie separated wall sections. These plates must be embedded in rich mortar between stone courses and painted or coated with epoxy to resist corrosion.
