Mechanical Performance of Construction Errors in Implementation of T-Reinforced Concrete Beams

El-Said Abd-Allah Bayoumi¹⁾, Ahmed Gomaa Asran²⁾ and Mohamed Abdel-Azeem Eliwa³⁾

ABSTRACT

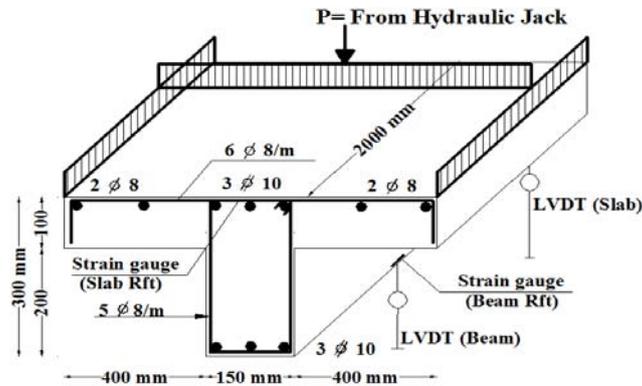
Figure (1): Details of control specimen

An experimental program was planned through which seven reinforced concrete slabs fabricated with defects in erecting practices were studied, in addition to the control specimen and the other specimen without slab (flange) (rectangular beam) to compare with control specimen to identify the importance of slab in resisting loads. The shape of the specimen consisted of a beam and a slab that was monolithically cast on the shape of character T-section. Thus, slab and beam act together in resisting the applied loads. Dimensions of slab are 950 mm (width), 100mm (thickness) and 2000mm (length), while the dimensions of projected beam are 150mm (width), 200mm (drop depth) and 2000mm (length). The dimensions and geometry of the experimental specimens are shown in Figure (1), while the dimensions of the rectangular beam are shown in Figure (2).

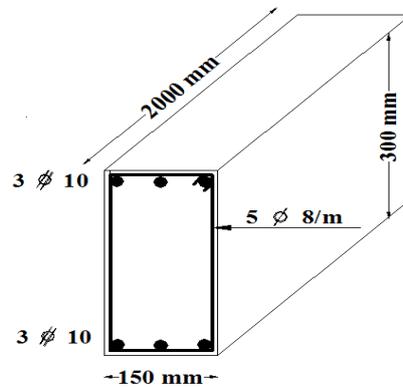
Figure (2): Details of rectangular beam

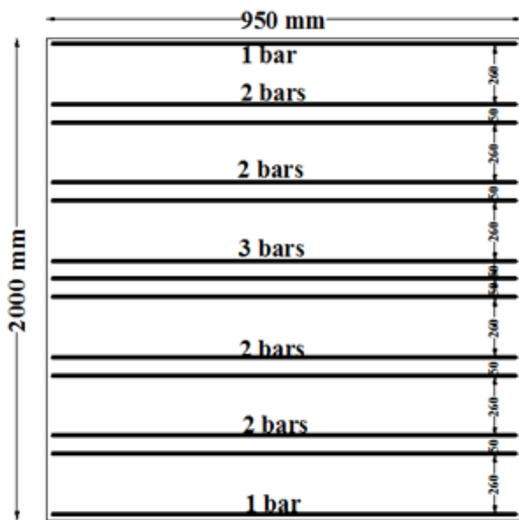
Figure (3): Plan of slab reinforcement distribution for specimen (GIIA-1)

of 260mm from the end of the slab. At the ends of the specimen, one bar was erected. Figure (3) illustrates the plan of reinforcement distribution of slab specimen (GIIA-1). In another specimen (GIIA-2), the eccentricity of slab reinforcement was in the three groups, where every group comprises three bars with two distances between the three bars. This distance was 100mm, while the distance between groups was 290mm. At the end of the specimen, two bars were erected from the two sides and the distance was 100mm. The plan of slab reinforcement distribution for specimen (GIIA-2) is

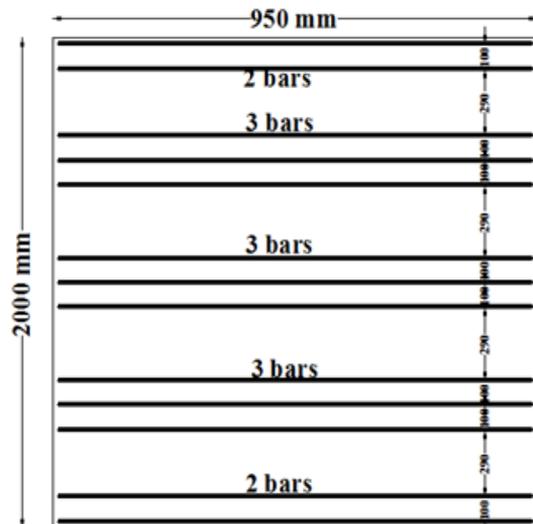
Figure (4): Plan of slab reinforcement distribution for specimen (GIIA-2)

shown in Figure (4). The last parameter comprises three specimens (GIIID-1), (GIIID-2) and control specimen (GIM-1) and identifies the change in bar diameter of slab reinforcement. The ratio of steel was not changed, but the diameter was changed. The first specimen was of a diameter of 6mm, whereas a diameter of 10mm was used in the second specimen. In the first specimen (GIIID-1), the area of steel was fulfilled by 11Ø6/m, while the second specimen (GIIID-2) comprises 4Ø10/m. Details of all tested specimens are shown in Table (1).

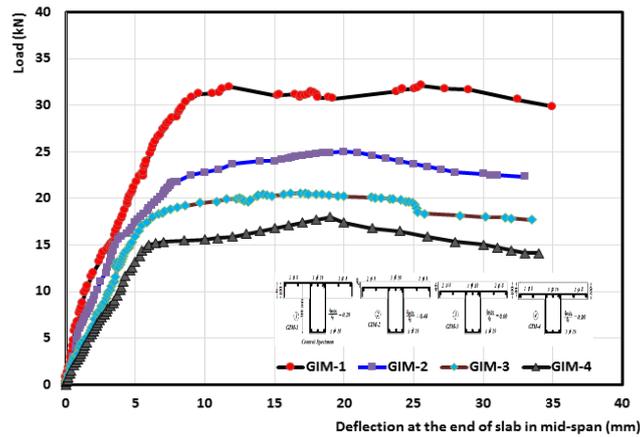
Figure (5): Comparison between the tested specimens of group I

The measured deflection values were plotted against the corresponding applied loads, from the start of applying the load up to failure. The load-deflection curves of the tested specimens in all groups are plotted in Figs. (5-7) and cracking load P_{cr} , ultimate load P_u ,

From the relation between load and deflection of specimens of group I, it was noticed that the tested specimens demonstrated linear deflection behavior before cracking. Upon cracking, stiffness was reduced as the load increased. For specimens GIM-2, GIM-3 and GIM-4, lower values of ultimate load and deflection were noticed compared with the control specimen GIM-1. The area under the load-deflection relationship up to failure is called toughness. Toughness is the ability of

the material to withstand or absorb mechanical energy as shown in Table (3). It can be concluded from comparison of group I that the rate of increase for the ratio of slab reinforcement misplacement was less than the ultimate load value of the tested specimens, but the rate of decrease in the ultimate load was not the same as the rate of increase in the percentage of wrong placement in slab reinforcement. A lower position of the reinforcement leads to a lower bending moment capacity of the slab and can also lead to a brittle behavior in case of collapse.

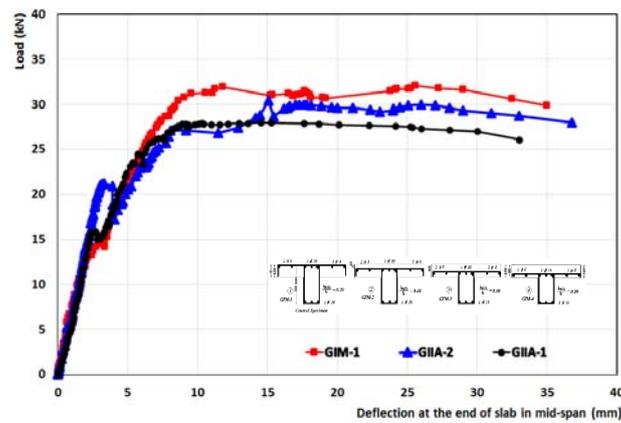
Figure (6): Comparison between the tested specimens of group II

It can be deduced from the results of group II that well-arranged distribution of reinforcement improves the ductile behavior of the slab and reduces the corresponding deflections. Meanwhile, the eccentricity of the main steel creates a sort of non-uniform stress distribution over the section and accelerates failure.

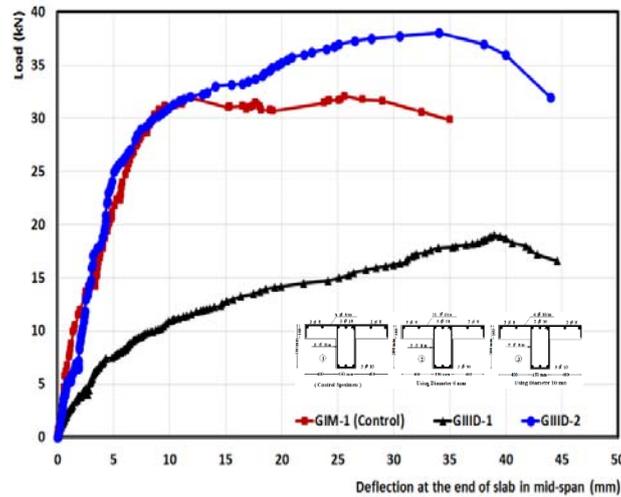
Figure (7): Comparison between the tested specimens of group III

A comparison of group III showed that the use of 10 mm diameter in the reinforcement of the slab exhibited high resistance to loads, while on the contrary, 6 mm diameter reinforcement offered a weak resistance to the loads affecting the slab. Load-deflection responses for specimens GIM-1 and GIID-2 showed approximately the same trend, and no significant difference was observed at low loading level, while the third specimen GIID-1 exhibited a significant difference in values of the deflection from the beginning of loading.

It is concluded from the test results of group III that increasing the diameter of slab reinforcement while keeping reinforcement ratio constant enhanced the behavior of T-beam to withstand the loads and increased the ductility of the T-beam. Also, to improve the efficiency of T-beam section under the loading effect, the minimum bar diameter for the reinforcement of the slab was set at 8mm, because 6mm diameter reinforcement was found to be weak in resisting loads.

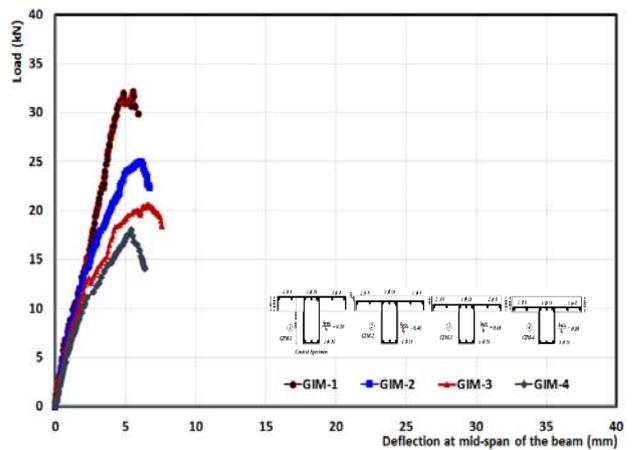
Figure (8): Load-deflection relationship at the mid-span of the beam for specimens of group I

Figure (8) displays the applied load against the vertical deflection at the mid-span of the reinforced concrete beams for group I. It is apparent that the shape of the load-deflection curves in the elastic region before cracking is the same for the all specimens. However, it appears that after cracking, both specimens GIM-1 and GIM-2 produced higher values of deflection than specimens GIM-3 and GIM-4 for the same level of loading. The maximum deflection of specimens GIM-1, GIM-2, GIM-3 and GIM-4 was 5.9mm, 6.7mm, 7.55mm and 6.3mm, respectively at failure load. It could be said that the harmful effect resulting from wrong position of slab reinforcement is more defective on the behavior of the slab and the attached beam than the correct place for reinforcing steel for the slab.

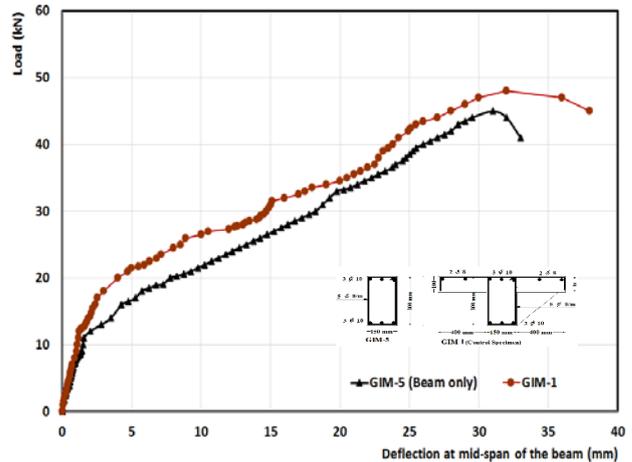
Figure (9): Load-deflection relationship at the mid-span of the beam for specimens GIM-1 and GIM-5

It can be observed from the load-deflection relationship for the two specimens GIM-1 and GIM-5 shown in Figure (9) that specimen GIM-1 demonstrated higher deflection than specimen GIM-5 and the failure load of specimen GIM-1 was higher than that of

specimen GIM-5. The maximum load of specimen GIM-5 is less than the ultimate load of specimen GIM-1 and the toughness is increased with the increase of the stiffness of specimen GIM-1. This indicates that the specimen with a slab (flange) has a higher performance in resisting loads affecting it compared to the specimen which does not have a slab (rectangular beam). This is mainly attributed to the existence of the flange in the T-section that resulted in higher stiffness than in the R-section. T-beams are more efficient than rectangular beams where a part of the slab contributes to the resistance of the loads.

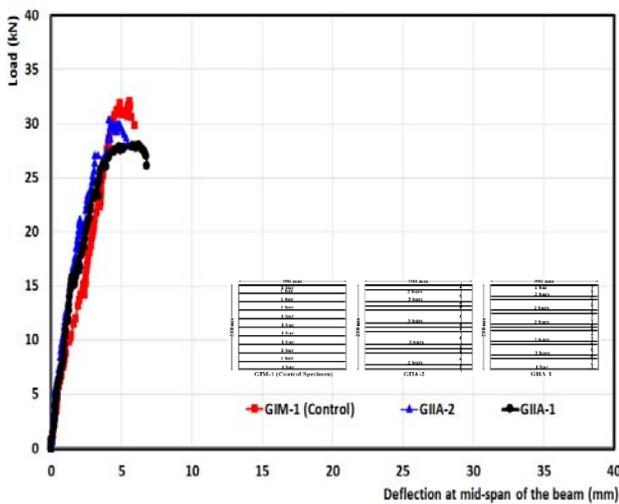
Figure (10): Load-deflection relationship at the mid-span of the beam for specimens of group II

The load-deflection curves for specimens of group II are shown in Figure (10). There are no significant differences between the three specimens in the values of deflection, especially at the beginning of loading before the initiation of cracks. The maximum deflection for specimens GIM-1, GIIA-1 and GIIA-2 at failure load was 5.90mm, 6.80mm and 5.75mm, respectively. It is evident that the irregularity of the reinforcement of the slab does not have any significant effect on the efficiency of a concrete beam connected with the slab. Furthermore, the beam attached to the slab was not significantly affected by the irregularity of the shape of the slab reinforcement.

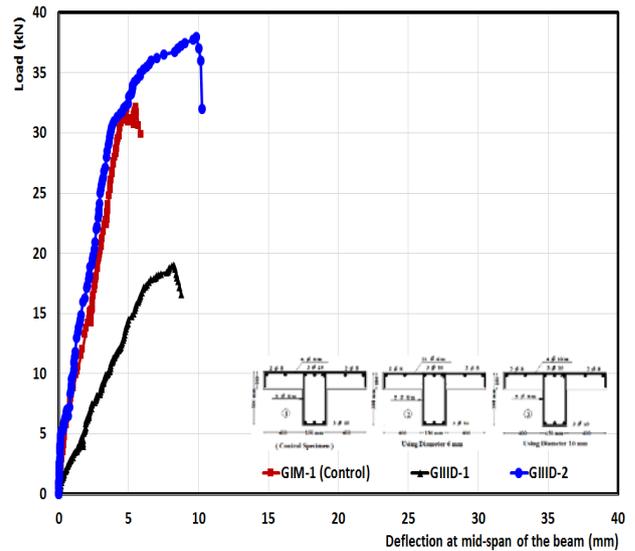
Figure (11): Load-deflection relationship at the mid-span of the beam for specimens of group III

Figure (11) shows the comparison between specimens of group III. It was found that the use of 10mm diameter in reinforcing the slab in T-section significantly improved the flexural behavior of the slab to resist the load. Thus, the behavior of the beam connected to the slab was improved to withstand loads. Also, there is no clear difference between the behaviors of specimens GIM-1 and GIID-2 with slab reinforcement with diameters of 8mm and 10mm in load-deflection values. The maximum deflection value for the beam at failure was 5.9mm, 8.75mm and

10.25mm for specimens GIM-1, GIID-1 and GIID-2, respectively. Specimen GIID-2 demonstrated higher deflection than specimens GIM-1 and GIID-1, where this specimen reinforced the slab with a diameter of 10mm, giving the beam connected to the slab a high resistance to loads. Therefore, it is preferable to use 10mm diameter in reinforcing slabs with diameters less than 10mm.

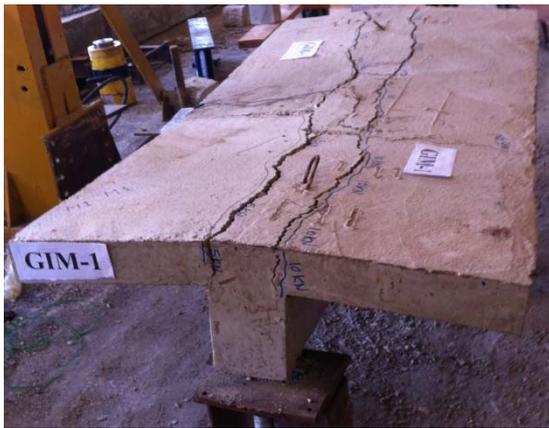
Figure (12): Crack pattern in the slab of specimen GIM-1

For Group I: Figure (12) shows the pattern of cracks for control specimen GIM-1. The first visible crack was initiated in the borderline between slab (flange) and beam (web) at a load equal to 10kN on both sides of the slab. These cracks were inclined in the direction of the slab towards the loading effect; i.e., the crack started in the region of the maximum tensile stress. These cracks extended on the boundary between the slab and the beam along the entire length of the specimen. Then, by increasing the loading value, the existing cracks grew wider and deeper until failure occurred in the slab and then cracks became inclined towards tensile stress trajectories. At later stages of loading, cracks were concentrated on the section of the maximum bending moment and failure occurred in the slab at the load of 32kN in the connected region between slab and beam.

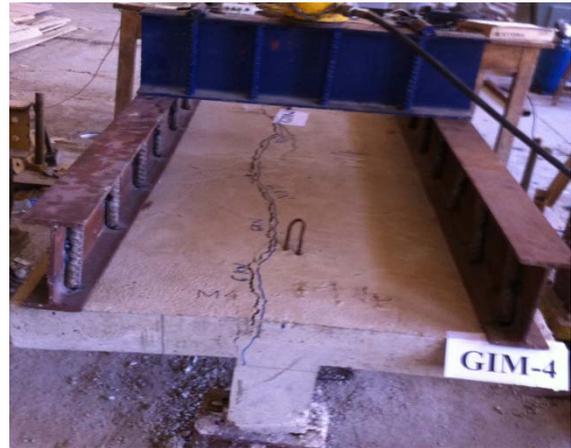
Figure (15): Crack pattern in the slab of specimen GIM-4

For the remaining specimens of group I, it was observed the first cracks visible by the naked eye were at one side of the border line between slab (flange) and beam (web) spread along the length of the specimen. These cracks started at a load of 5kN, 4.5kN and 6kN for specimens GIM-2, GIM-3 and GIM-4, respectively. At failure, the width of the cracks was noticeably wider and highly propagated at the face of the intersection between slab and beam, where the height of reinforcement in slab reduced. Failure occurred at a load equal to 25kN, 20.5kN and 18.5kN for specimens GIM-2, GIM-3 and GIM-4, respectively. Based on test observations, failure of specimens GIM-2, GIM-3 and GIM-4 could be classified as pronounced sudden and flexural mode of failure in the slab, where the misplacement of slab reinforcement affected the efficiency of the slab, leading to faster failure in the slab. Figures (13), (14) and (15) show the photos of specimens GIM-2, GIM-3 and GIM-4, respectively after failure.

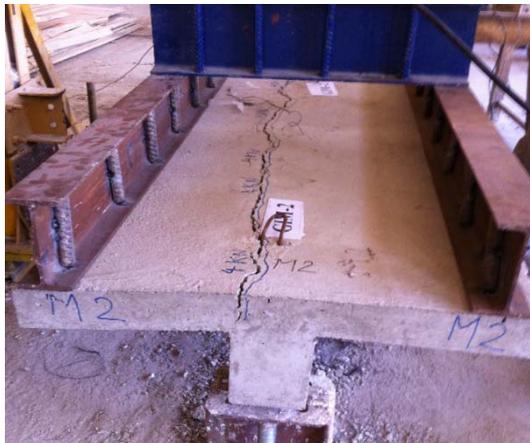
Figure (13): Crack pattern in the slab of specimen GIM-2

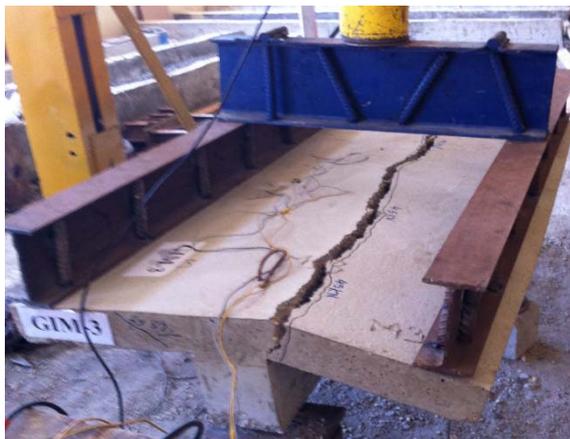
Figure (14): Crack pattern in the slab of specimen GIM-3

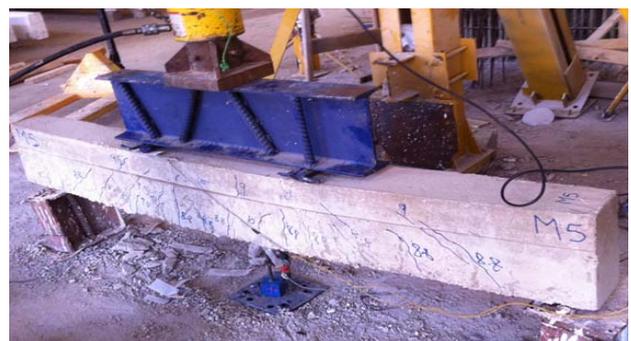
Figure (16) (a): Crack pattern in the beam of specimen GIM-5

The appearance of the tested specimen GIM-5 after loading is shown in Figures (16) (a) and (16) (b). Specimen GIM-5 showed typical cracking behavior of under-reinforced concrete simple beam and failed in ductile flexural tension. At early loading levels, vertical cracks appeared in the region of shear towards loading points at a load equal to 8.8 kN. Upon increasing the load, the cracks started at maximum tensile stresses (region of maximum bending moment). With increasing the load, the number, width and extension towards the compression zone of the cracks increased. Cracks were concentrated at the section of the maximum bending moment and at later stages of loading, failure occurred in the middle third of the beam span. However, at a load of 45kN, the specimen failed with ductile mode failure when the load reached its peak value.

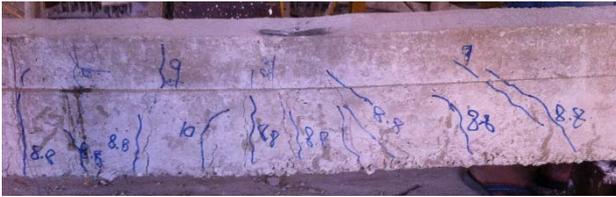
Figure (16)(b): Cracking pattern of specimen GIM-5 (mid-span of the beam)

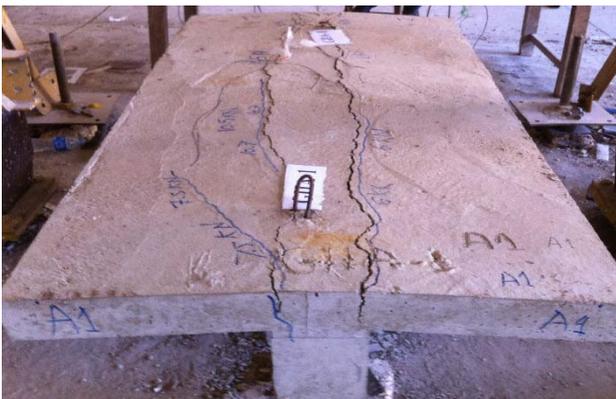
Figure (17): Crack pattern in the slab of specimen GIIA-1

For Group II: Specimens GIIA-1 and GIIA-2 exhibited basically the same cracking pattern and final mode of failure in nature of loading. The failure of these specimens was flexural tensile at maximum bending moment region (the vicinity region between slab connection and the beam), where the moment is concentrated in this region. Also, the cracks started to appear in the region where there are no reinforcing bars in the slab and propagated towards the loading points. The first crack occurred at a load of 7.5kN and 12kN for specimens GIIA-1 and GIIA-2, respectively. As the load was further increased, the crack became wider and extended at both sides of the beam along the overall length of the specimen. Specimens GIIA-1 and GIIA-2 failed primarily at the ultimate conditions in a flexural mode, which occurred at loads equal to 28kN and 30.5kN, respectively. Failure occurred along the entire borderline between beam (web) and slab (flange) interface. The cracking patterns of tested specimens GIIA-1 and GIIA-2 at failure are shown in Figures (17) and (18), respectively.

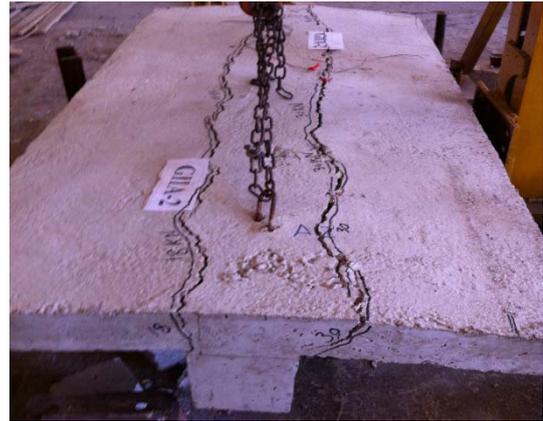
Figure (18): Crack pattern in the slab of specimen GIIA-2

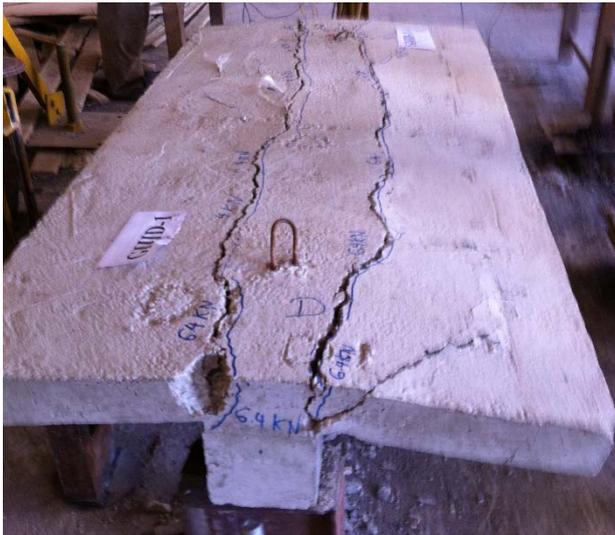
Figure (19): Crack pattern in the slab of specimen GIID-1

For Group III: Crack patterns for specimens GIIID-1 and GIIID-2 are depicted in Figures (19) and (20), respectively. The first cracks were horizontal flexural cracks in the vicinity of the tension zone within and near the constant moment region at the connection of the slab (web) with the beam (flange) at a load of 4.60kN and 7kN for specimens GIIID-1 and GIIID-2, respectively. These cracks continued along the overall length of the specimen (i.e., parallel to the loading effect). At higher loading stages for specimen GIIID-1, the rate of formation of new cracks significantly decreased. Moreover, the existing cracks grew wider, especially the first cracks formed. The specimen failed at a lower loading value of 19kN in the region of negative moment concentration affecting T-beam section where tension reinforcement of the slab was yielded, indicating that 6mm diameter reinforcement was weak in load resistance. For the second specimen GIIID-2, with the increase in load, cracks appeared along the borderline between the beam and the slab. The width of the cracks increased with the increase in the loading effect till specimen failure occurred at a load value of 38kN. Crushing of concrete in one corner of the specimen occurred when loading increased. This specimen exhibited high resistance to loads compared with specimens GIM-1 and GIIID-1.

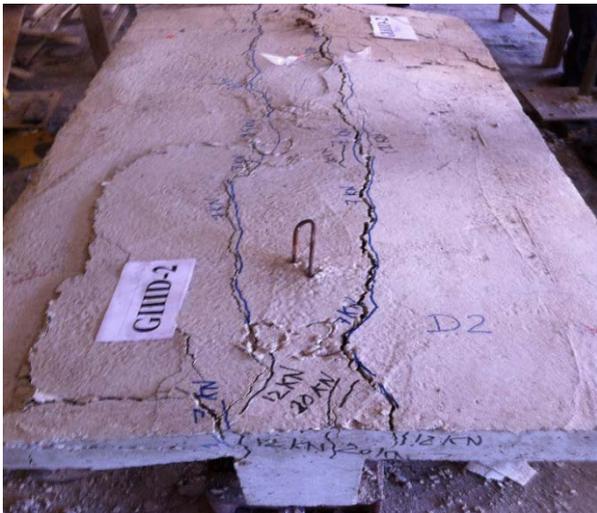
Figure (20): Crack pattern in the slab of specimen GIID-2
