Integrated Detection and Restoration Program of Water Gushing Induced Cracks in Shield Segments for Xi'an Metro in China

J.L. Qiu^{1,2)}, J.X. Lai^{1,2)*}, H.B. Fan²⁾, J.X. Chen^{1,2)} and C. Liu²⁾

ABSTRACT

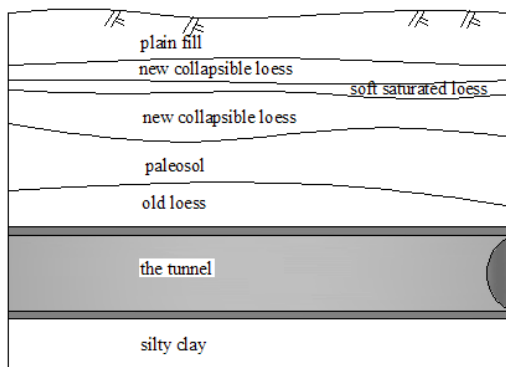
Figure (1): Typical cross-section of the shield tunnel

A subway in Xi'an was constructed using the shield tunnelling method. The depth of the tunnel is 14 m. The distance between the bottom of the tunnel and the earth surface is 20.0 m. The distance between the centres of the tracks is 12.0 m. The tunnel is located in old loess and silty clay layers. The formation distribution from top to bottom is as follows: 3.45 m of plain fill, 1 m of new collapsible loess, 0.6 m of soft saturated loess, 2.2 m of new collapsible loess, 4.4 m of paleosol, 3.3 m of old loess and 3.5 m of silty clay (Figure 1).

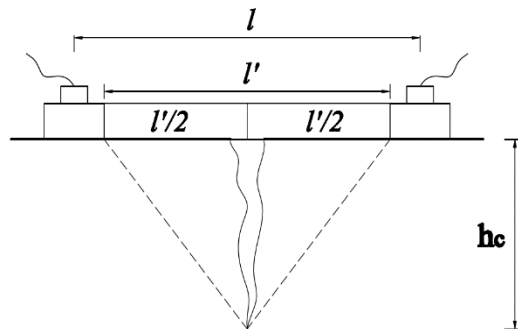
Figure (6): The principle of ultrasonic detection

The depth of the crack can be determined by measuring the crack width using a calibrated magnifying glass, positioned with handheld reinforced concrete detection radar and measurements using ultrasonic waves. The principle of ultrasonic detection is shown in Figure 6. As shown in Figure 7, cracks mainly range from 20 mm to 60 mm in depth; among those, 45 range from 20 mm to 40 mm and 32 range from 40 mm to 60 mm. The cracks primarily range from 0.05 mm to 0.3 mm in width; among those, 93 are between 0.05 mm and 0.2 mm, 14 are between 0.2 mm and 0.3 mm, 10 are between 0.3 mm and 0.5 mm and 4 are over 0.5 mm. The largest crack appears at the adjacent plate of L2B5 on Circle 495, with a maximum width of 1.0 mm and a maximum depth of 134.9 mm (Pan, 2012).
