Integrated Detection and Restoration Program of Water Gushing Induced Cracks in Shield Segments for Xi'an Metro in China

ABSTRACT

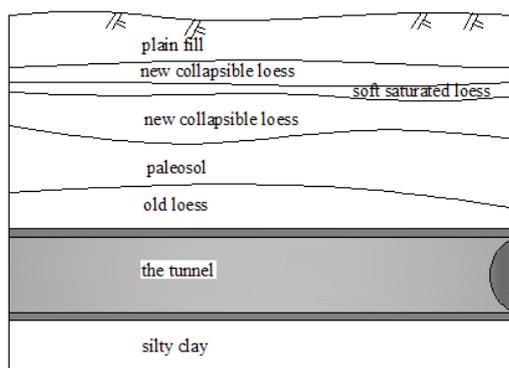
Figure (1): Typical cross-section of the shield tunnel

A subway in Xi'an was constructed using the shield tunnelling method. The depth of the tunnel is 14 m. The distance between the bottom of the tunnel and the earth surface is 20.0 m. The distance between the centres of the tracks is 12.0 m. The tunnel is located in old loess and silty clay layers. The formation distribution from top to bottom is as follows: 3.45 m of plain fill, 1 m of new collapsible loess, 0.6 m of soft saturated loess, 2.2 m of new collapsible loess, 4.4 m of paleosol, 3.3 m of old loess and 3.5 m of silty clay (Figure 1).

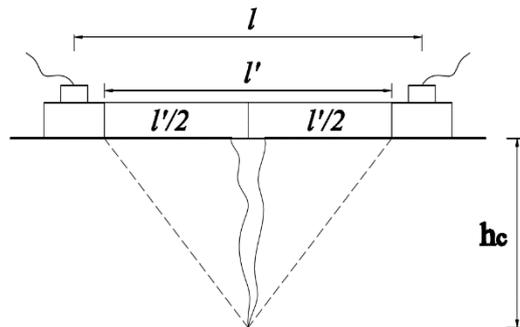
Figure (6): The principle of ultrasonic detection

The depth of the crack can be determined by measuring the crack width using a calibrated magnifying glass, positioned with handheld reinforced concrete detection radar and measurements using ultrasonic waves. The principle of ultrasonic detection is shown in Figure 6. As shown in Figure 7, cracks mainly range from 20 mm to 60 mm in depth; among those, 45 range from 20 mm to 40 mm and 32 range from 40 mm to 60 mm. The cracks primarily range from 0.05 mm to 0.3 mm in width; among those, 93 are between 0.05 mm and 0.2 mm, 14 are between 0.2 mm and 0.3 mm, 10 are between 0.3 mm and 0.5 mm and 4 are over 0.5 mm. The largest crack appears at the adjacent plate of L2B5 on Circle 495, with a maximum width of 1.0 mm and a maximum depth of 134.9 mm (Pan, 2012).
