Estimation of Failure Surface of Pa Bon Dam from Site Investigation

Kobid Panthi¹⁾ and Suttisak Soralump²⁾

ABSTRACT

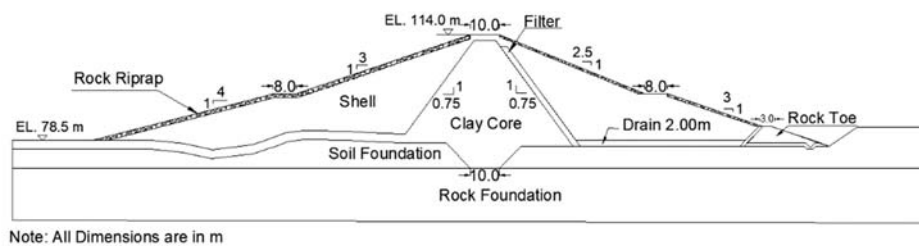
Figure (1): Cross-section of Khlong Pa Bon dam (0+272m)

The chimney drain and blanket drain with a thickness of 2 m are provided for draining out the water from the clay core and preventing the downstream slope from being saturated. The cross-section of Khlong Pa Bon dam is shown in Figure 1. The first movement of the upstream slope was observed in 2014. The geological profile along the center line of the dam is shown in Figure 2.

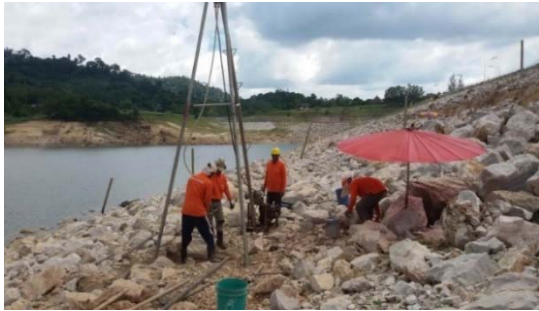
Figure (9): Conduction of bore hole investigation after the movement of the slope in 2014

Failure surface was found to be in a section containing silty clay with gravel for all the investigated sections. The corrected N value (N60) in each section (0+272, 0+297 and 0+332) was determined from this test. From the investigation, the reduction in N value was observed at two sections; i.e., around 3.5 meters and 6 meters (Figure 7) and was preliminarily identified as the location of failure surface.

The surface of failure was assumed to be 3.5 meters below the ground surface and rehabilitation work was carried out, but the movement of the dam did not stop, but rather increased each year. The test was again conducted at 0+227, 0+297 and 0+367 in 2017 near the toe zone to evaluate the existing condition. From the

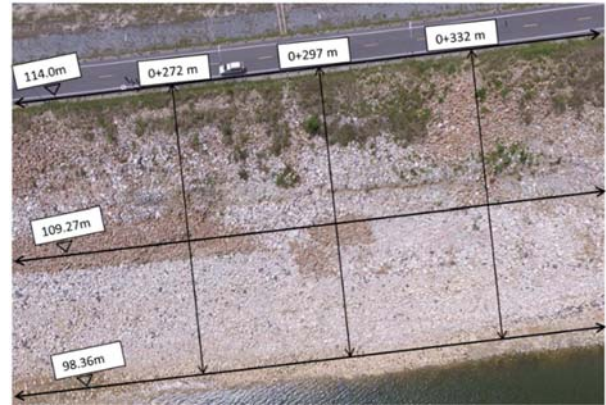
Figure (11): Location for the conduction of electrical resistivity test

Field data was analyzed using Res2dinv version 3.59 showing the specific electrical resistance values. Apparent resistivity was categorized into 5 ranges according to the resistivity values, as shown in Table 1. The results obtained from electrical resistivity test were compared with results from bore hole geological inspection, as shown in Figure 12. The anomalous area was identified as the area with resistivity in the range of 0-100 ohms and failure surface was drawn accordingly. The results obtained were compared with N-values obtained from bore hole investigation. It was found that the zone having N-values less than 12 could be categorized as very soft to stiff clay.

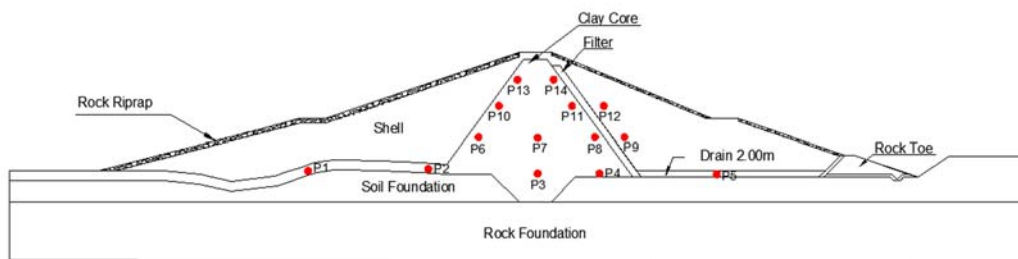
Figure (17): Piezometer installation at Pa Bon dam

The piezometer at Pa Bon dam was installed at 0+130 m, as shown in Figure 17. The analysis was based on the assumption that the movement of water in this location is similar to that in the failure zone. Most of the piezometers are located in the impervious clay core for detection of water in the core zone. 2 piezometers are located in the downstream slope to detect the presence of water, if any, while one piezometer is located at the blanket drain to determine its functionality.

Instrumentation results from various piezometers were compared with exact water levels observed during that period of time. The comparison of results obtained from various piezometers in the clay core from 2500 days to 5000 days is shown in Figure 18. The results from all the piezometers in the clay core indicate that the permeability of the clay core is very low and no significant variation of water level was observed in piezometer with actual fluctuation of water level. This behavior is observed for all the piezometers installed in the clay core as shown in Figure 18.
