Jordan Journal of Civil Engineering

Effect of Soil Type and Geometry on the Peak Flow and Depth of Breach Resulting from Overtopping Failure of Embankment Dam

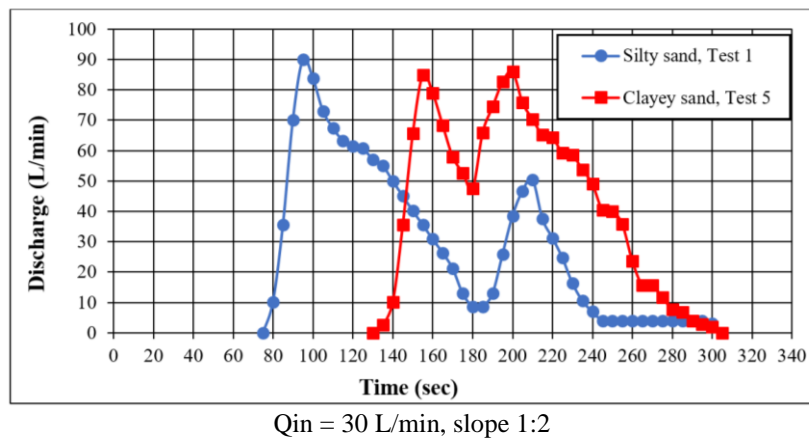
Figure 5 is the illustration of release discharge *versus* time for silty sand (Test-1) and clayey-sand (Test-5) embankment at a side slope of 1:2. The collapse occurs during Test-1 at $t = 75$ sec. from the beginning of the run.

In Test-5 for the clayey-sand embankment, the failure occurred at $t=130$ seconds, as denoted in Figure 5, and the first peak of discharge, Qp1, is 84.96 L/min recorded at $t=155$ seconds. Meanwhile, the second peak of discharge, Qp2, reached a value of 85.98 L/min at a time of 200 seconds.

depict the outflow discharge hydrograph for the two soil types used in the experiments with a 1:1 slope, and they appear very similar. In contrast, the outflow discharge charts for clayey sand soil and silty sand soil show a noticeable disparity when a 1:2 slope is used, as shown in Figures (5 and 6). When the slope of the embankment dam has a ratio of 1:1, the two peaks of discharge occur earlier, as seen in Figures (7 and 8). Furthermore, the stability failure of the clayey sand embankment dam takes more time than that of the silty sand. Furthermore, the gentle slope of the embankment dam with a ratio of 1:2 provides increased resistance to potential failure.
