Investigation of the Effectiveness of Repairs and Protection Materials/ Techniques for Alleviating Durability Problems

ABSTRACT

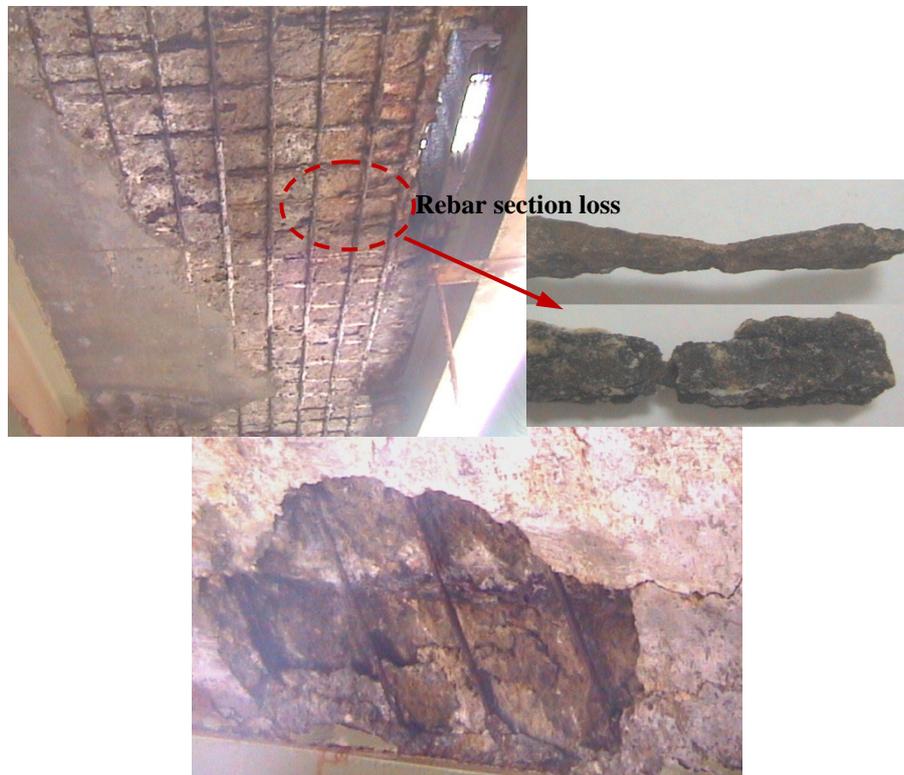
Figure (1): Severe deterioration and damage at the soffit of slabs industrial structures-Dead Sea region

Many on-shore industrial RC structures in Jordan are operating in very harsh environmental conditions. These structures are subjected to chemical seepage, abrasion and vibration during operation. As a result, severe deterioration and damage to some structural elements have occurred as shown in Figure (1), which
