Experimental Study of Using Ferro-Cement and Steel Plates in Repairing Reinforced Concrete Beams

ABSTRACT

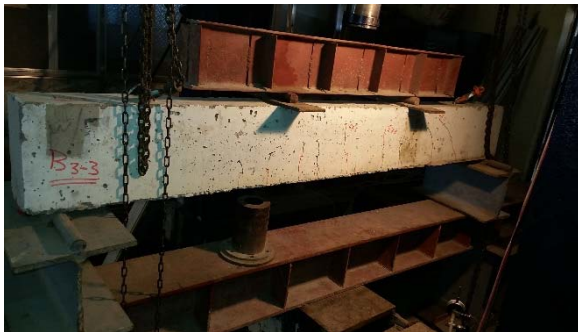
All beams were tested under static two-point loading as shown in Fig. (3). Concentrated loads were applied at third points of the beams gradually at increments of (6 kN) up to specific load before the repair process.

Figure (3): Loading arrangement of the control beam (B1)

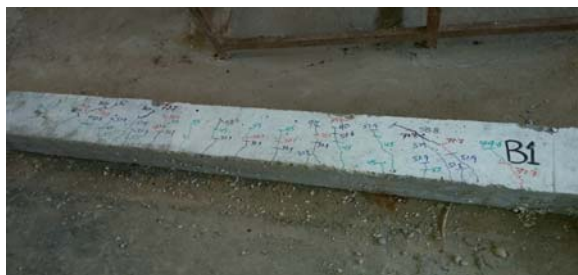
The test for the control beam (B1) was continued until failure, then ultimate load and maximum midspan deflection were recorded and given in Table (8). At successive load increase, visible flexural cracks were initially observed within the tension zone at the midspan of the beam. At large loads, these cracks extended with

the formation of new cracks at different orientations, as shown in Fig. (4).

Figure (4): Control beam (B1) after failure

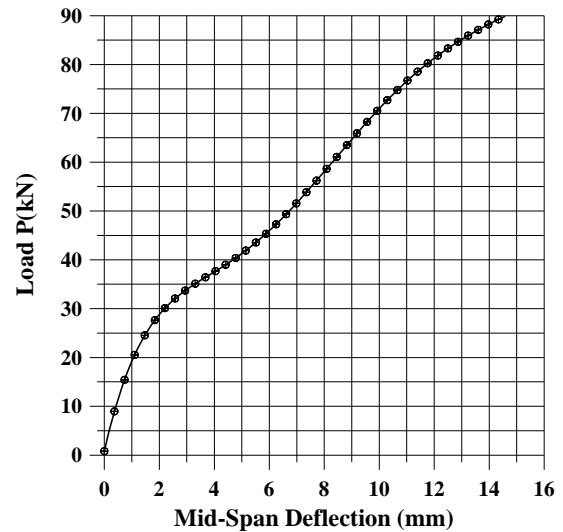
The load-deflection curve for control beam (B1) is shown in Fig. (5). This curve can demonstrate a certain tendency in which, at early stages of loading, the beam behaves elastically with no visible cracks, which explains the behavior of the beam before the first cracking load. At a further stage, the beam tends to shift from elastic behavior and turns rather to possess a non-linear behavior with visible minor tension cracks beyond which (at the third stage) yielding occurs and the beam behaves plastically.

Figure (5): Load-deflection curve of the control beam (B1)

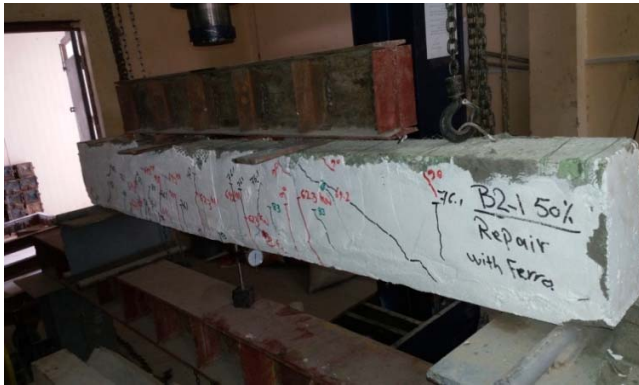
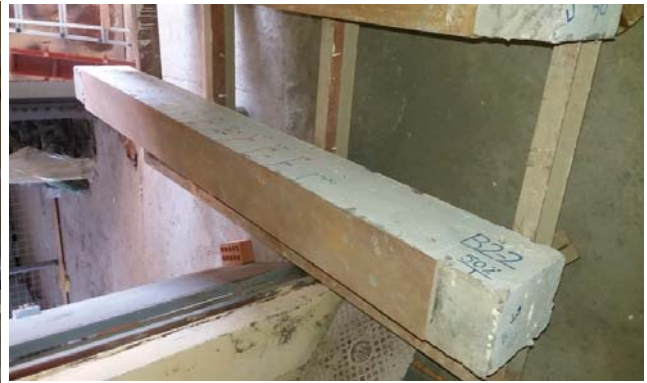
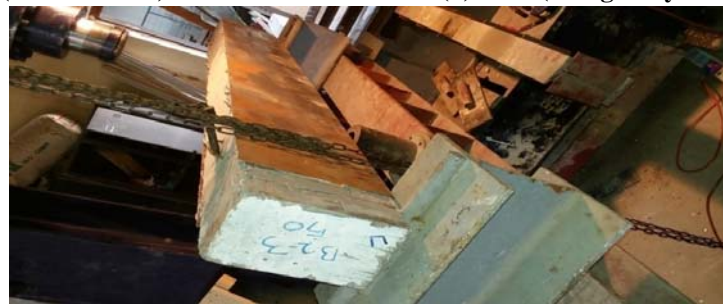
Group (1) of beams were loaded until 50% of the ultimate load, de-loaded and repaired by two methods: the first method by using ferro-cement mortar (2 layers of ferro-mesh) and the second method by using steel plates as shown in Fig. (6). Then, these beams were reloaded up to failure. The load deflection curves for this group of beams are shown in Fig. (7). This figure proved that beam (B2-1) repaired with ferro-cement mortar showed improved performance, so that the ultimate load capacity increased by 18% and at the same time, the ductility of this beam increased, which can be explained from increasing midspan deflection by 58% in comparison with the control beam. The increase in the ultimate load capacity occurs for the reason that the stiffness of the beam was increased due to using ferro-cement layer.

(a) B2-1 (ferro-cement)

(b) B2-2 (straight layer of steel plates)

(c) B2-3(U-layer of steel plates)

Figure (6): Group (1) of repaired beams

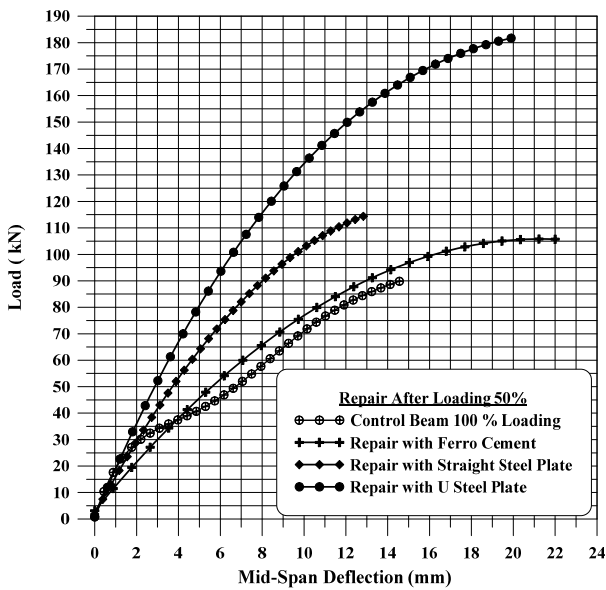
Beam (B2-2), repaired with one straight layer of steel plates, showed an increase in the ultimate load capacity by 24% with respect to the control beam, while beam (B2-3) repaired with one U – layer of steel plates showed the largest increase in the ultimate load capacity of 100% as a result of increasing the flexural strength and shear resistance of the beam.

Figure (7): Load-deflection curves of group (1) of beams (after 50% loading)

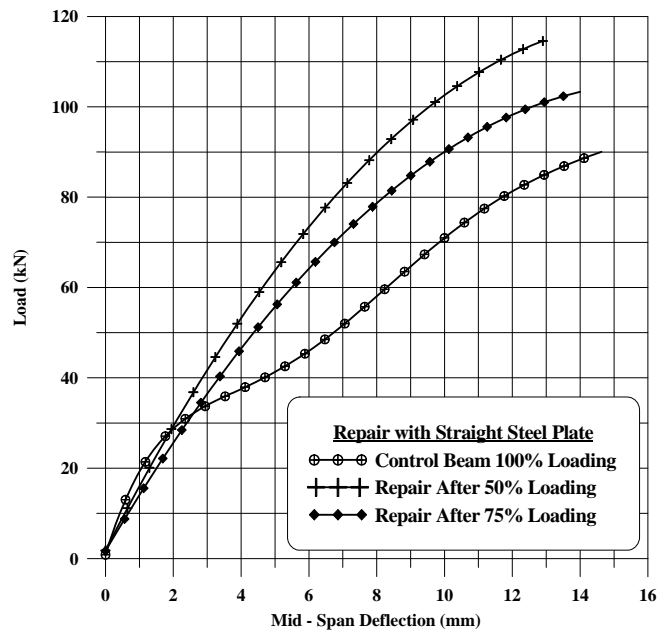
Figs. (9-12) shows the effect of using U-ferro-cement, straight layer of steel plates and U-layer of steel plates in the repair of reinforced concrete beams, respectively.

From these figures, it can be noticed that the influence of repair by the two used methods in the present study was relatively little for beams repaired after 75% loading because of great decrease in the stiffness and strength of these beams before the repair process. The modes of failure for the repaired beams are shown in Fig. (13).

Figure (10): Effect of straight steel plate repair

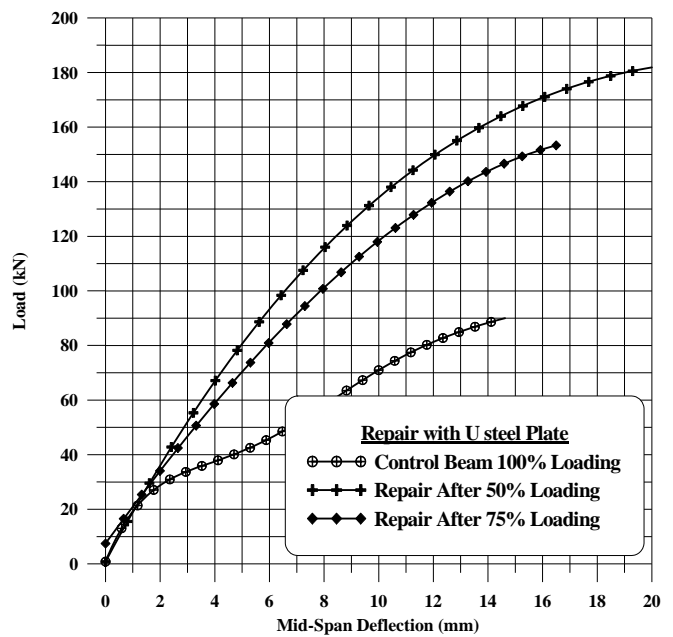
Figure (11): Effect of U-steel plate repair

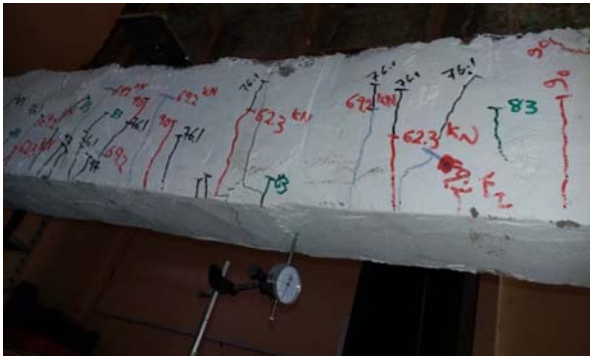
(a) Flexural failure and debonding of ferro-cement layer of beam B2-1

Figure (13): Modes of failure of the repaired beams

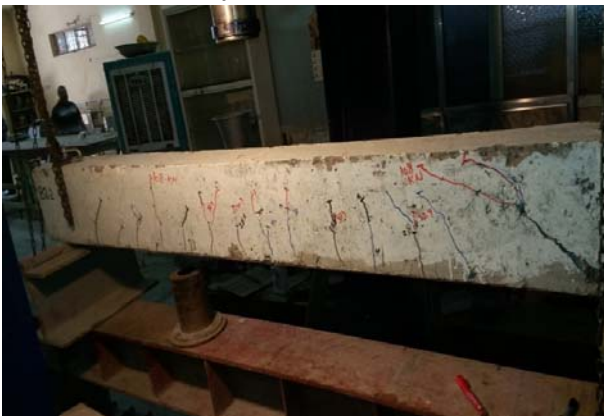
(b) Flexural and shear failure of beam B2-2

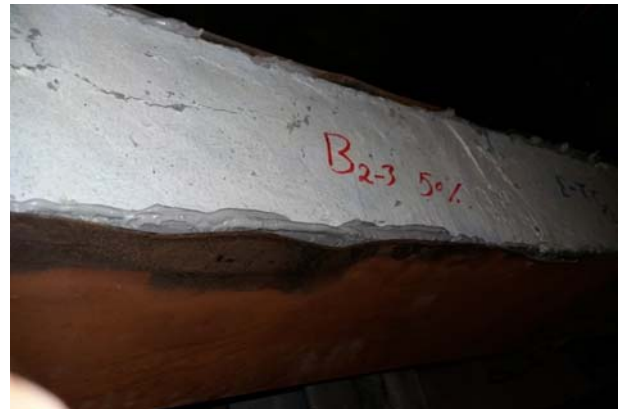
(c) Debonding of steel plates and crushing of concrete at the load points of beam B2-3
