Seismic Retrofitting Study on an Industrial Building in Aqaba - Jordan

ABSTRACT

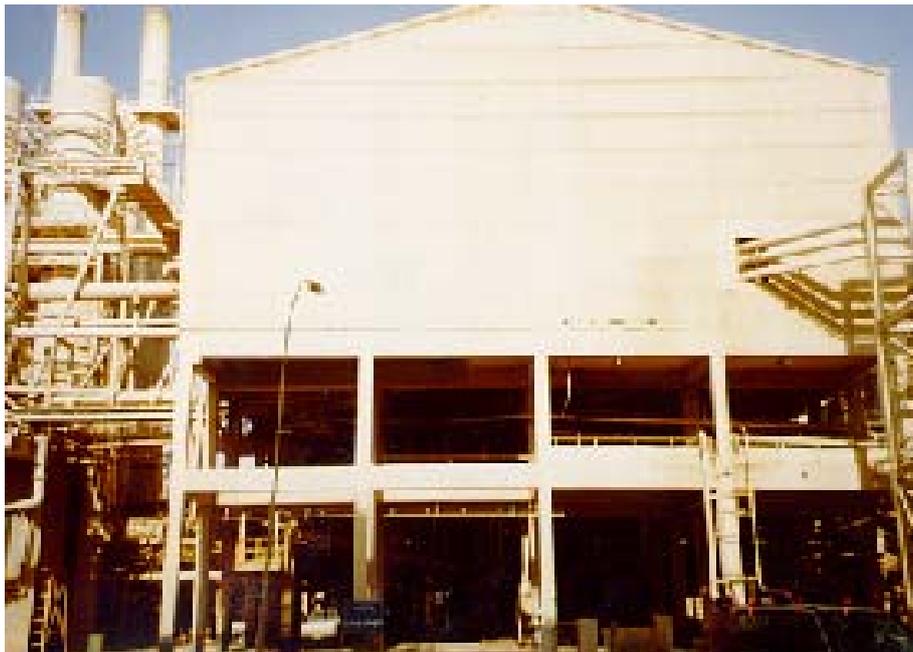
Figure (1): The industrial structure

- The structure is a 2-storey cast *in situ* reinforced concrete skeleton of 12 m height - superimposed by steel super structure of 14 m height. So, the total height of the structure is 26 m, as illustrated in Figure (1).

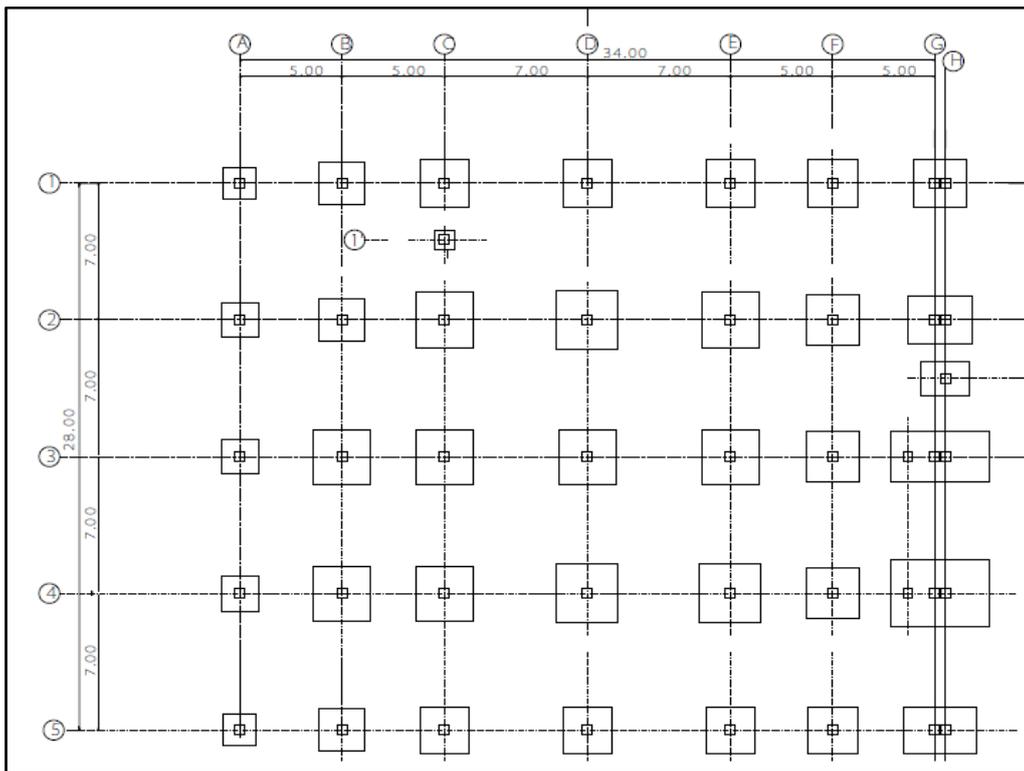
Figure (2): Footings at level - 2.00

- Isolated footing at level -2.0 from the ground.
- Combined footings along G-axis, as shown in Figure (2).

- Expansion joint of 20 mm separating the structure and another building, as illustrated in Figure (2).
- No basement is available.
- No tie beams are available between column necks.
- Ground slab at level + 0.30, based on fill materials.
- Solid slab with openings at level + 6.80 with corners thickened (thickness = 700 mm) forming a base for 14 implanted concrete columns, as shown in Figure (3).
- Concrete ring beam at level + 10.58, setting on the

- Mitigate the absence of tie beams between the isolated footings, since one of the most important pre-requisites of adequate performance of the building during an earthquake is the provision of a foundation system which would enable the base of the building to move as a unit and thus forbid the differential movement of the column bases relative to each other.

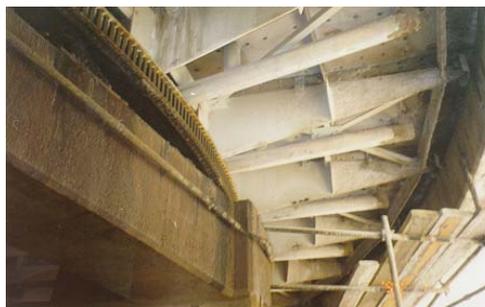
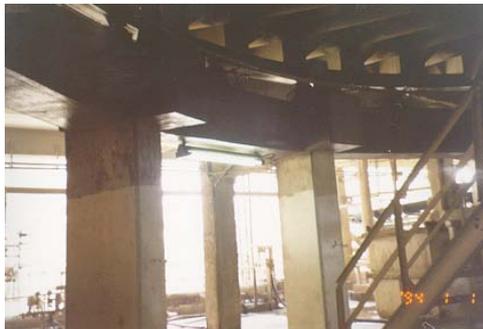
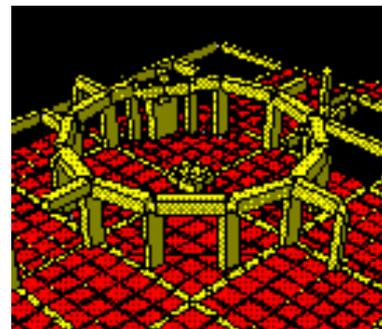
Figure (4): Ring beam at level + 10.58

implanted columns, as shown in Figure (4).

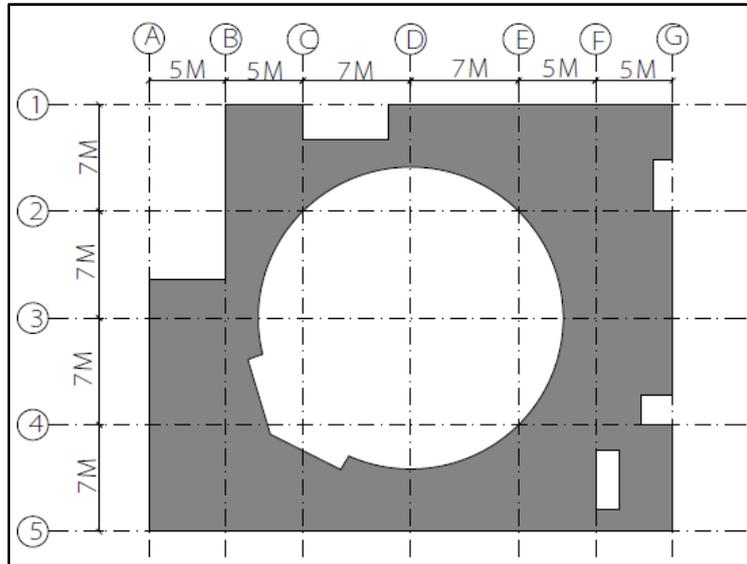
Figure (5): Solid slab at level + 11.80

- Solid slab at level + 11.80, with openings as shown in Figure (5).
- The special provisions for resisting earthquake loading were not considered in the original design.
 - Generally, no serious signs of damage or distress were observed. Nonetheless, site inspection revealed that the short columns, as illustrated in Figure (6), exhibited some signs of distress “cracking”.

The resistance capacities of the beams around the openings in the slab were also checked, and the results indicated that they were capable of transmitting lateral loads and thereby effectively acting as rigid links.

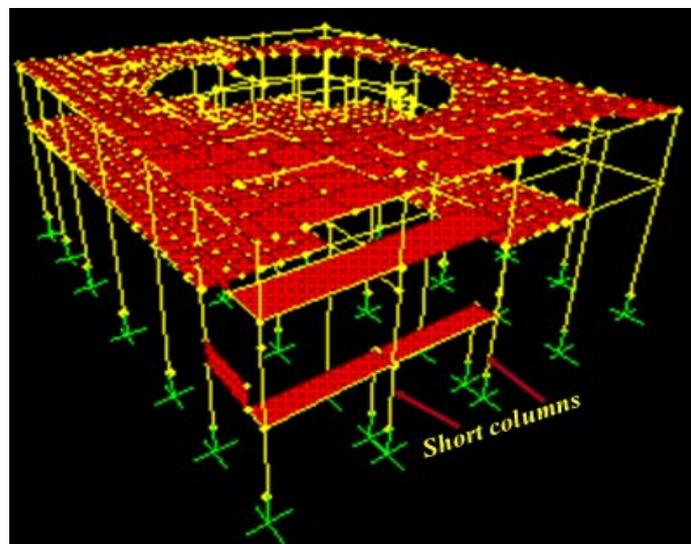
Figure (6): Short columns

The detailed inspection of all the structural elements showed that these elements in general did withstand the Nov.1995 Aqaba earthquake (6.2 on the Richter scale) with PGA of about (0.11) g at the site. Only minor damage occurred in the form of cracking of some short columns.

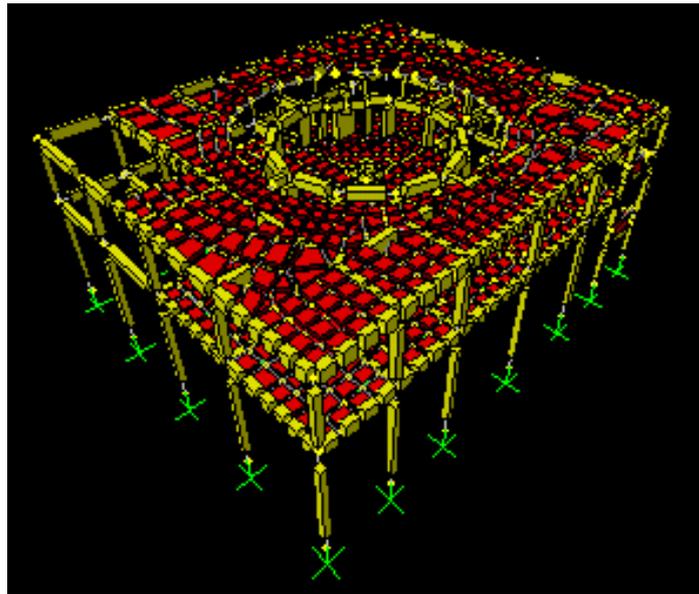
Figure (7): Finite element model of the original structure

dynamic structural analysis (Derecho, 1989; Syal and Ummat; Tanvir Wasti). This was accomplished by creating a finite element model, as shown in Figure (7)

and thereafter carrying dynamic structural analysis using SAP2000 computer software. The model consisted of beams and columns, which had been represented by frame elements, and slabs that were meshed into a series of shell elements. The model

reflected the geometric characteristics of the building, as well as its boundary conditions, material properties, relative stiffness, mass distribution, energy dissipation “damping”, dead loads and live loads,... etc.

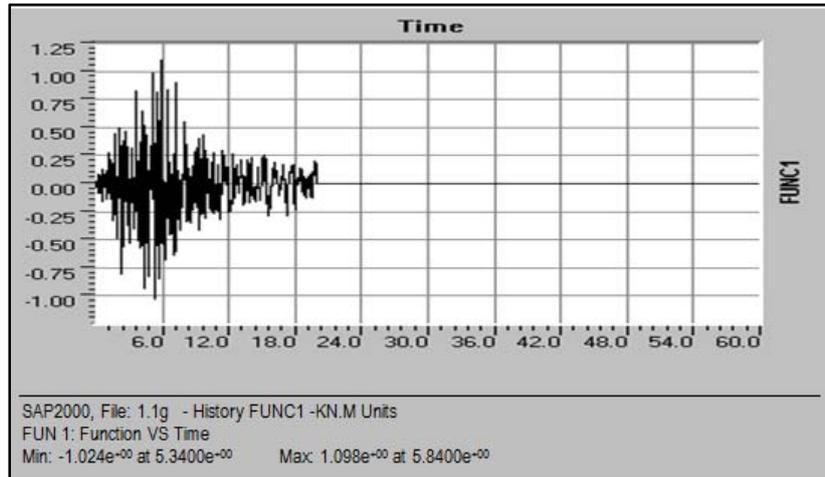
Figure (8): TH of the east/ west acceleration of the 1995 Gulf of Aqaba earthquake with PGA of 0.11g

Seismic analysis of the structure to check its adequacy and its need for structural up-grading was based on the TH of the east/west acceleration of the 1995 Gulf of Aqaba earthquake as recorded by Aqaba hotel station scaled to PGA of (0.11g, 0.156g and 0.3g), as illustrated in Figure (8). Three angles of excitation (0° , 45° and 90°) were used in the analysis to account for the directional uncertainty of earthquake motions.

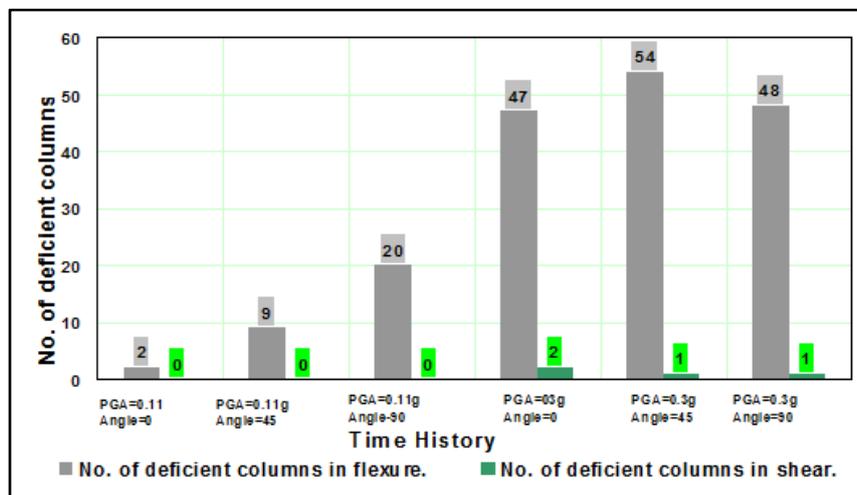
Figure (9): Columns deficient in shear and flexure

they would probably be exposed during a future earthquake event, but the beams are much stronger than the columns, thus violating the “strong columns-weak beams” design requirement for earthquake resistance (Moehle and Nicoletti, 1994). The columns themselves were deficient in resisting shear forces and bending moments generated by the TH of PGA of (0.11) g with angles of excitation different from (0°), as illustrated in Figure (9). For PGA of (0.156) g and (0.3) g, most of the columns were deficient for all angles of excitation. Furthermore, the footings were deficient regarding to stability and reinforcement considerations.

The third issue to be addressed was the detailing of reinforcement. The longitudinal steel for the short

columns was less than the code requirement. Transverse reinforcement of the columns was found

unsatisfactory. Spacing and detailing of the transverse reinforcement were not adequate to confine the concrete, and the locations of lap splices were at the ends of columns (critical locations of possible inelastic action) and not in the middle third as required by the code.

- Reduce the internal forces and effects generated from earthquakes on the deficient columns. The most efficient scheme to perform such a task is adding shear walls.
- Reduce lateral displacement (sway) of the building, especially in the long direction (X-direction), to avoid pounding with the adjacent structure. Again, shear walls may prove to be the most efficient method to achieve this goal.
- Remedy the deficiencies in reinforcement details (violations of code provisions), such as lack of confinement.

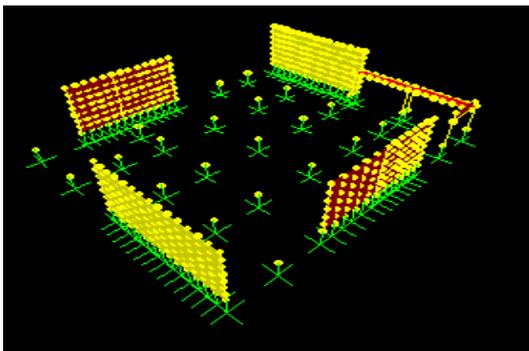
Figure (10): Locations of the proposed shear walls

To strengthen the building to resist possible future earthquake loading, it was necessary to provide a solution for the whole structure; i.e., provide a new lateral-load resisting system. Therefore, it was decided to construct shear walls of reinforced concrete at chosen locations at the periphery of the building for maximum efficiency and to avoid the difficulties of working on the inside area. After several computer analyses of different shear wall configurations, the shear wall arrangement shown in Figure (10) was deemed to be the most efficient one. New computer analyses were carried out on a modified model of the structure as shown in Figure (11) including the suggested shear walls utilizing the acceleration record of the Nov.1995 Aqaba earthquake scaled to PGA of (0.175) g (design earthquake) based on (50)% probability of non-exceedance in (50) years lifetime of the building.

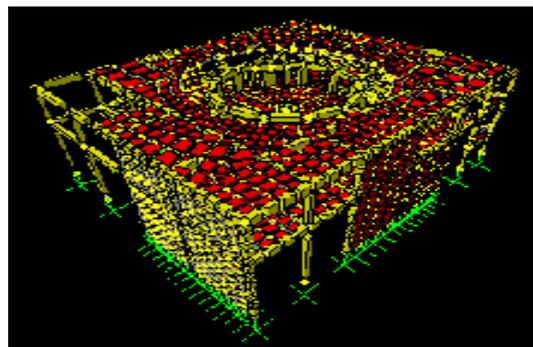
Figure (11): Finite element model of the retrofitted structure

Dynamic analysis of the structure was carried out after modifying the model to reflect the effect of adding the shear walls, hence running the analysis again and checking the response of the whole structure and its components. The existing slabs, beams, columns and foundations were evaluated to ascertain that they have sufficient strength to withstand the design earthquake elastically (PGA of 0.175g).

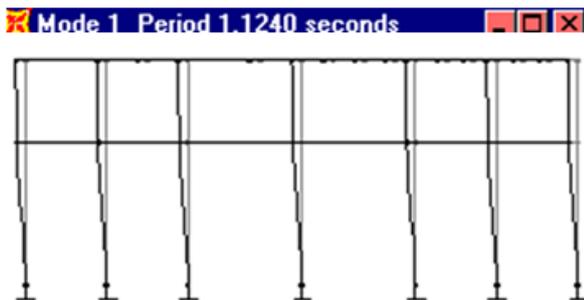
Figure (12): Natural period of vibration for the original structure

The results indicated that the columns became capable of resisting the maximum factored forces, especially bending moment forces, which were reduced to very small values as the structure became braced. The structure as a whole became stiffer with a natural period of vibration of (0.21) sec instead of (1.124) sec (original structure) as shown in Figures (12 and 13), and the sway was reduced to (3.5) mm.
